29th Annual
Geotechnical Seminar

GEO-Omaha 2012

February 17, 2012
Scott Conference Center
Omaha, Nebraska

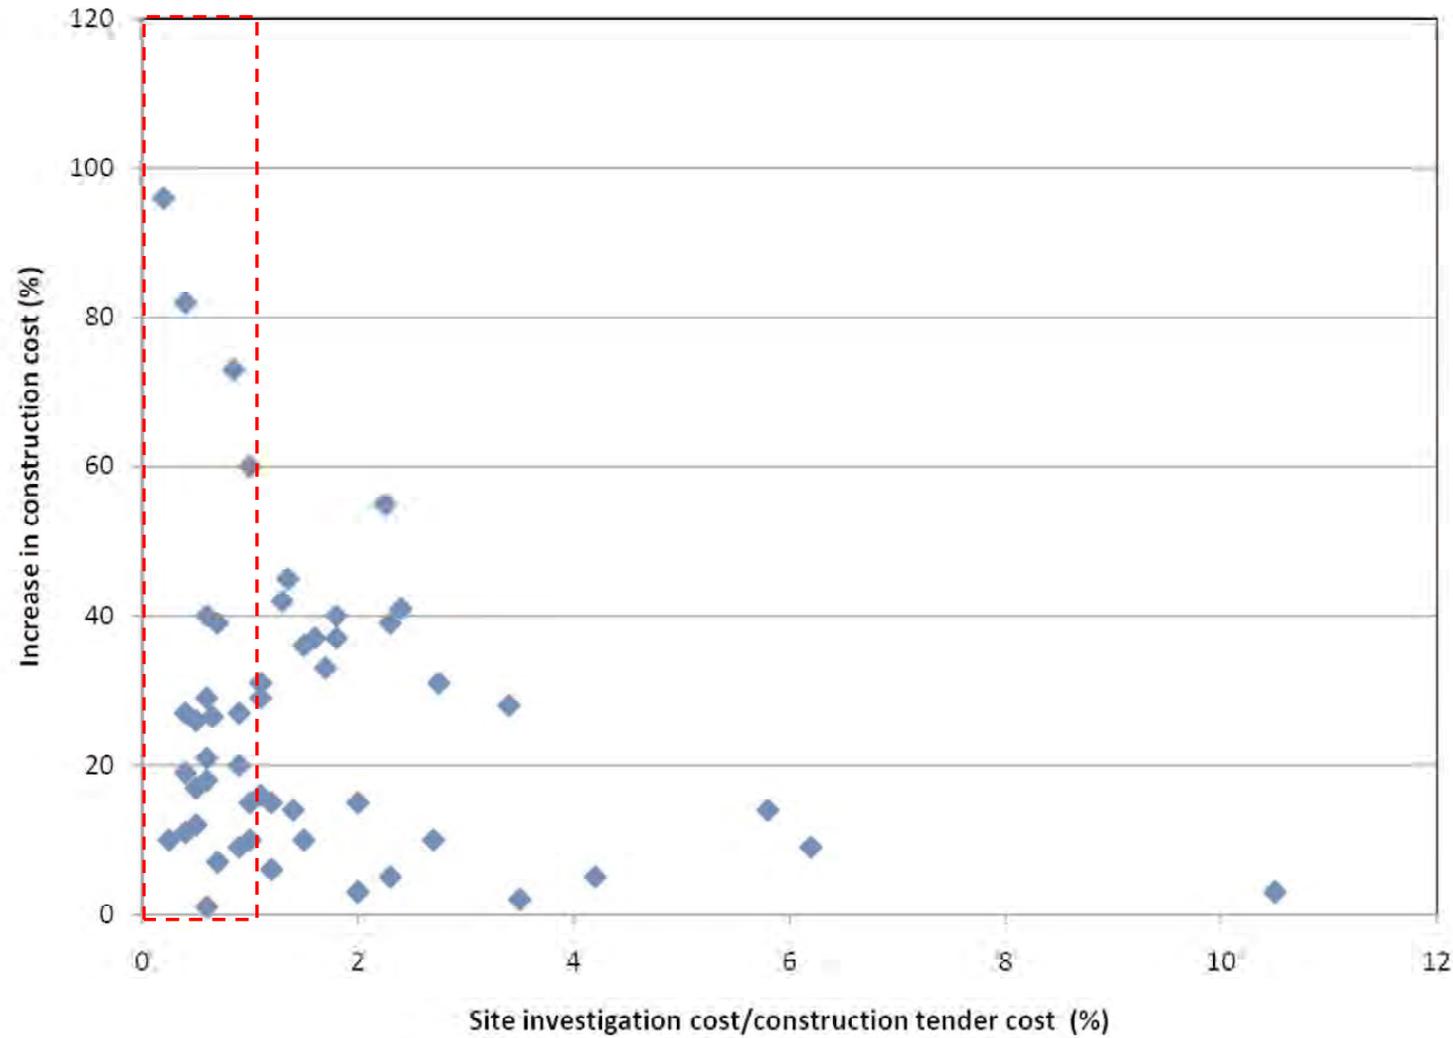
Impact of Site Investigation On Overrun

Impact of Site Investigation on highway contract cost over-runs in the UK from TRL Project Report 60

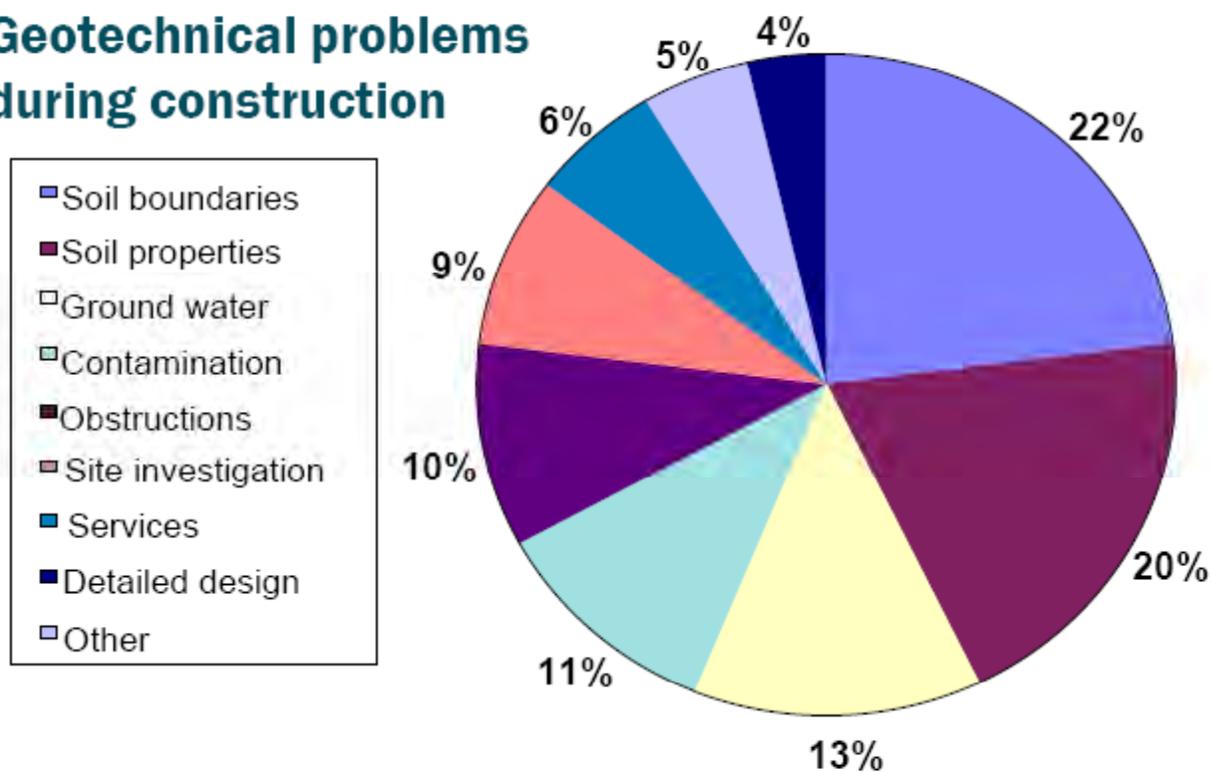
Geotechnical problems during construction

From a survey of 28 construction projects (Clayton, 2001)

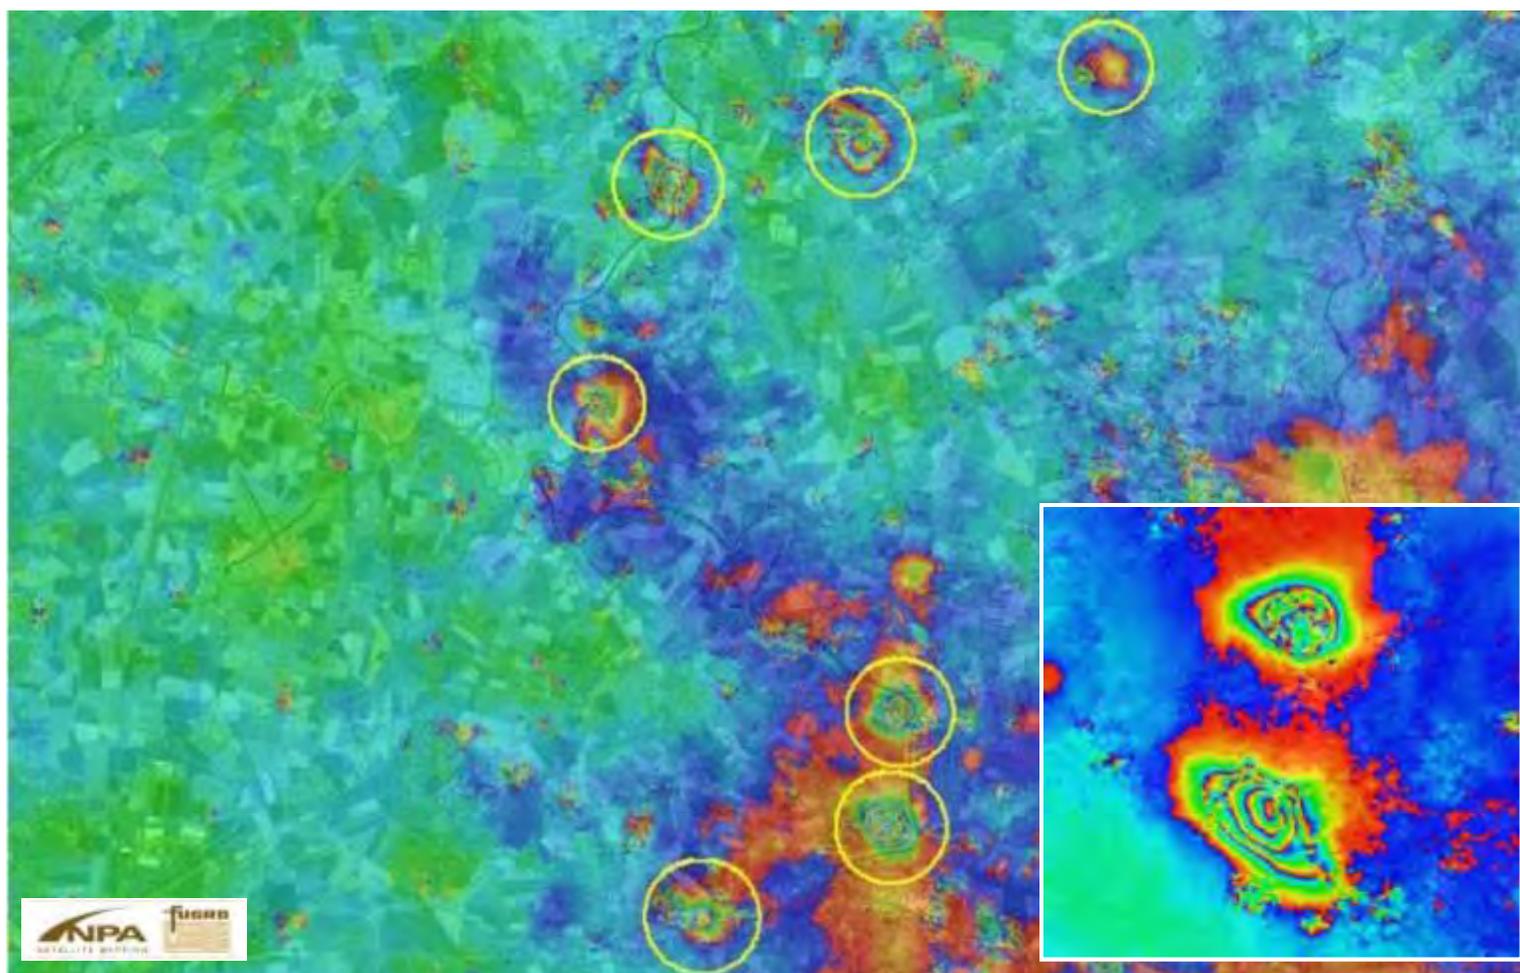
Mining subsidence

Formation of surface subsidence bowls (motion contours / interferometric fringes) correlated to underground coal mining activity over a 35 day period detected and mapped through DifSAR. Up to 15 centimetres of surface subsidence recorded.

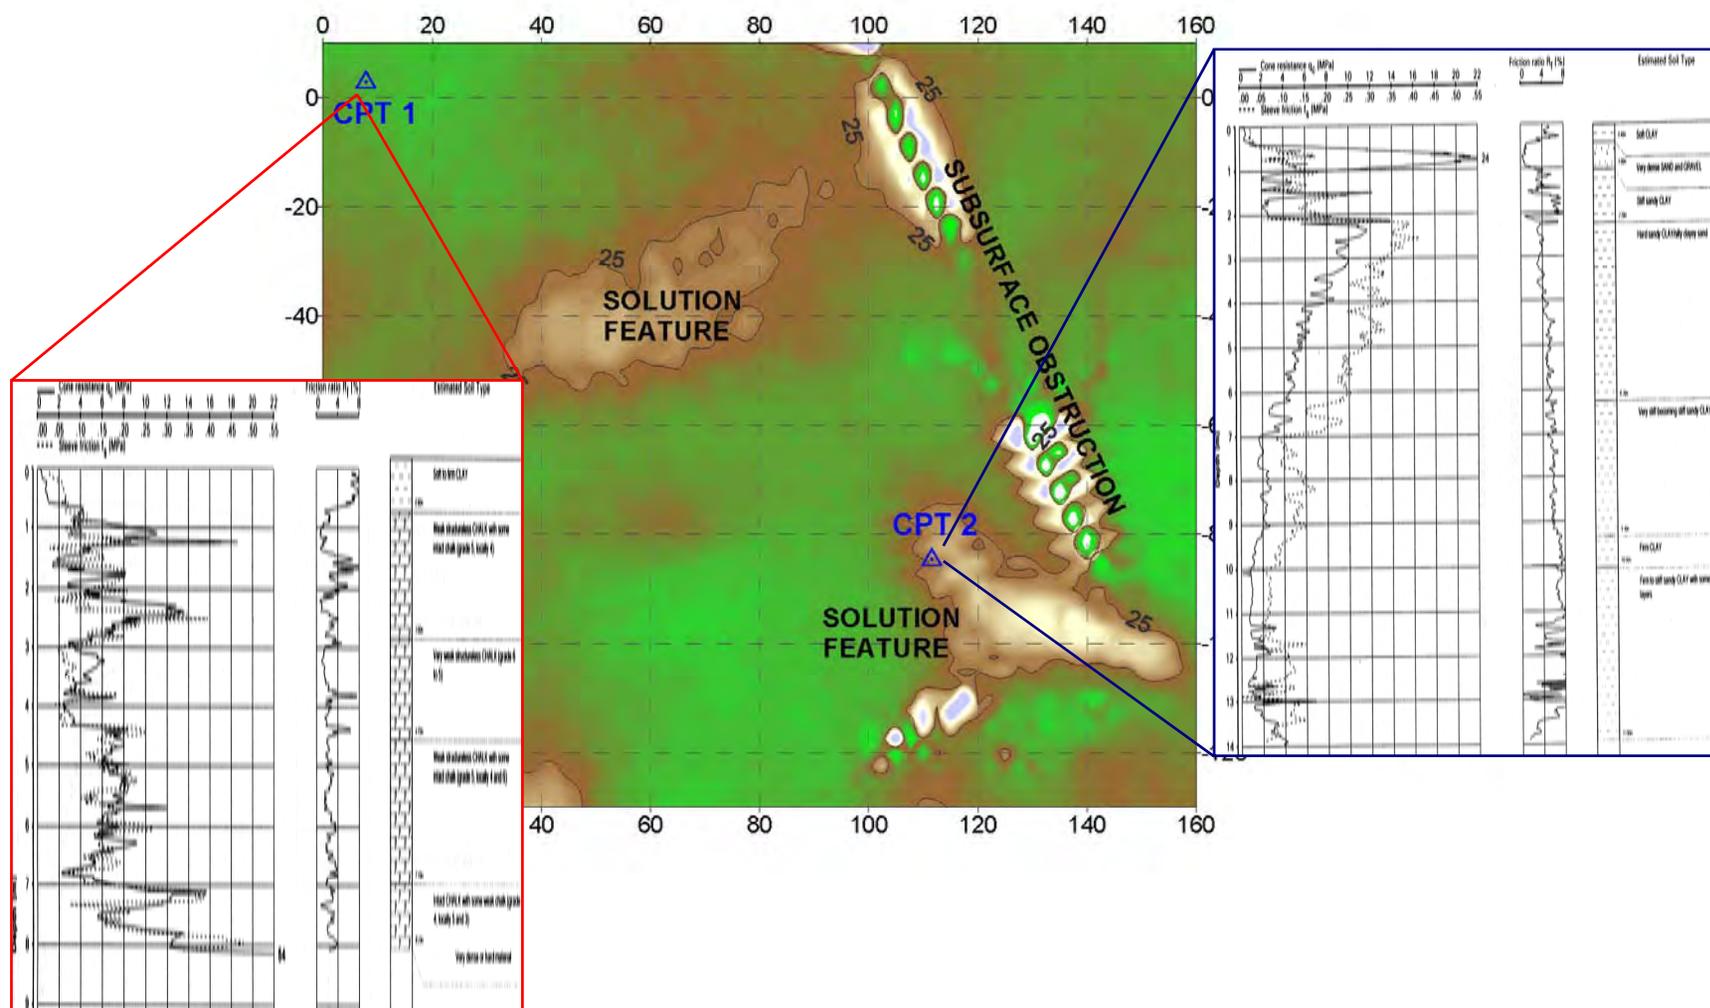
Electromagnetic Conductivity Profile

Geohazard investigation – cavities and karst

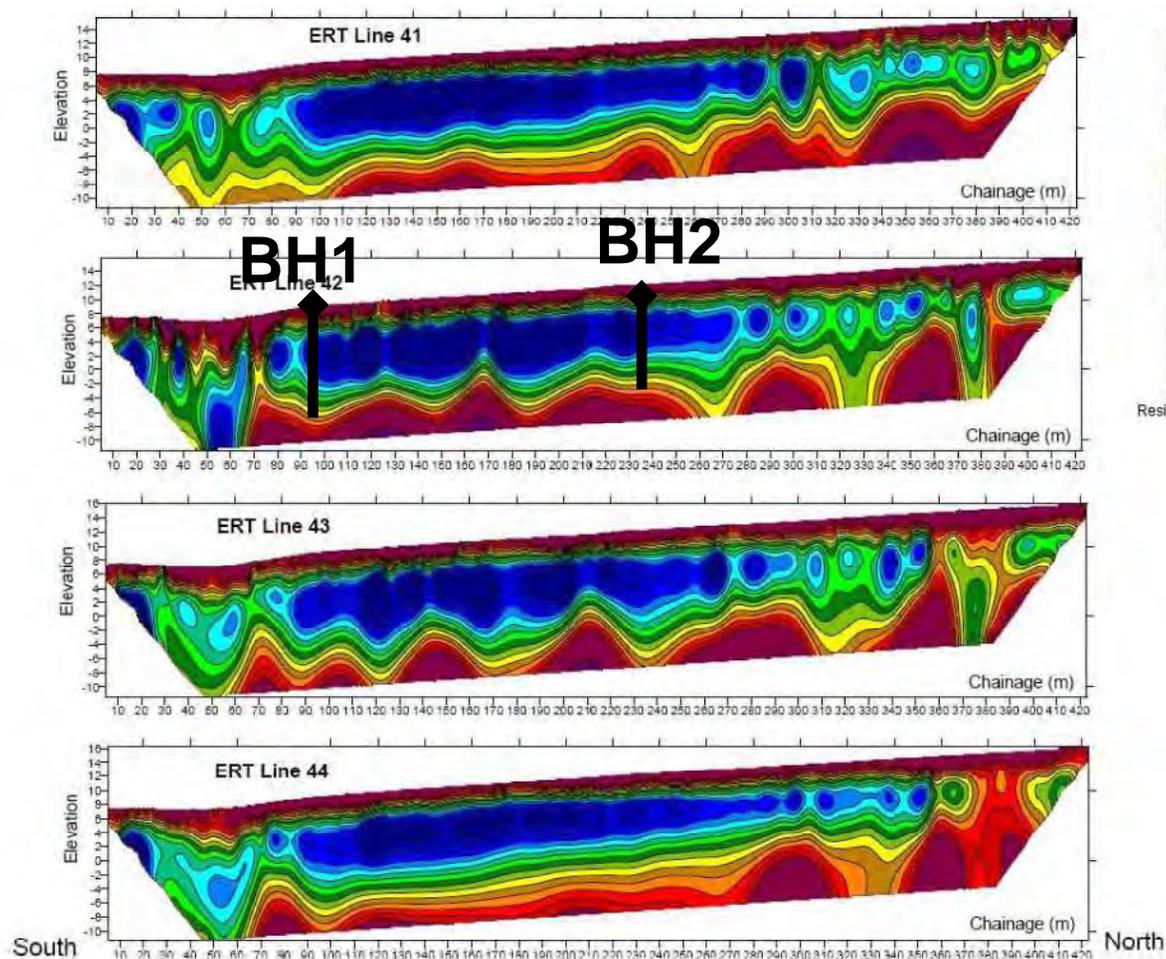
Geohazards – solution features

(2D ERT, Quaternary/
Tertiary/Cretaceous)

- Electrical Resistivity Tomography Profiles
- Spatial sampling

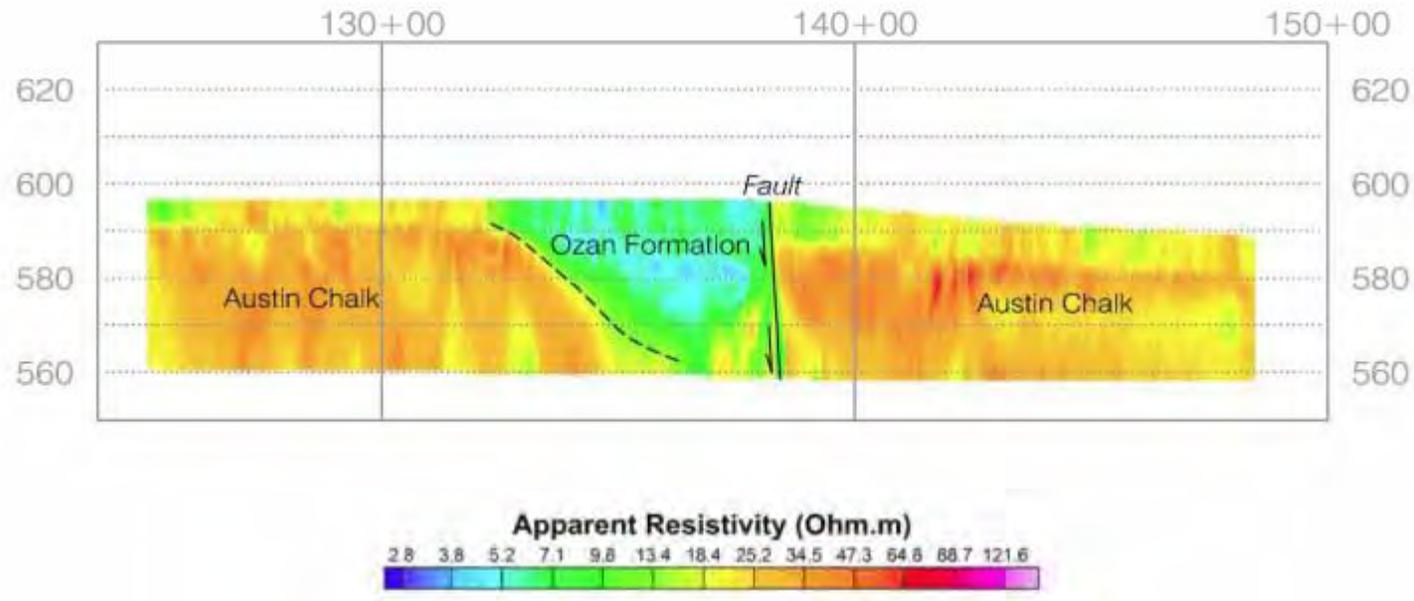
Pipeline Stationing

- 147 mile long pipeline route – 10 foot diameter, with 10-15' cover
- Boreholes planned at 1,000-2,000' spacing
- Significant features less than 1000' long that could have been missed
- Features longer than 8,000' that do not require as many boreholes to characterise
- Perform same number of boreholes but on targeted non-uniform spacing to provide more information, reducing Contractor's pricing risk and Client's cost

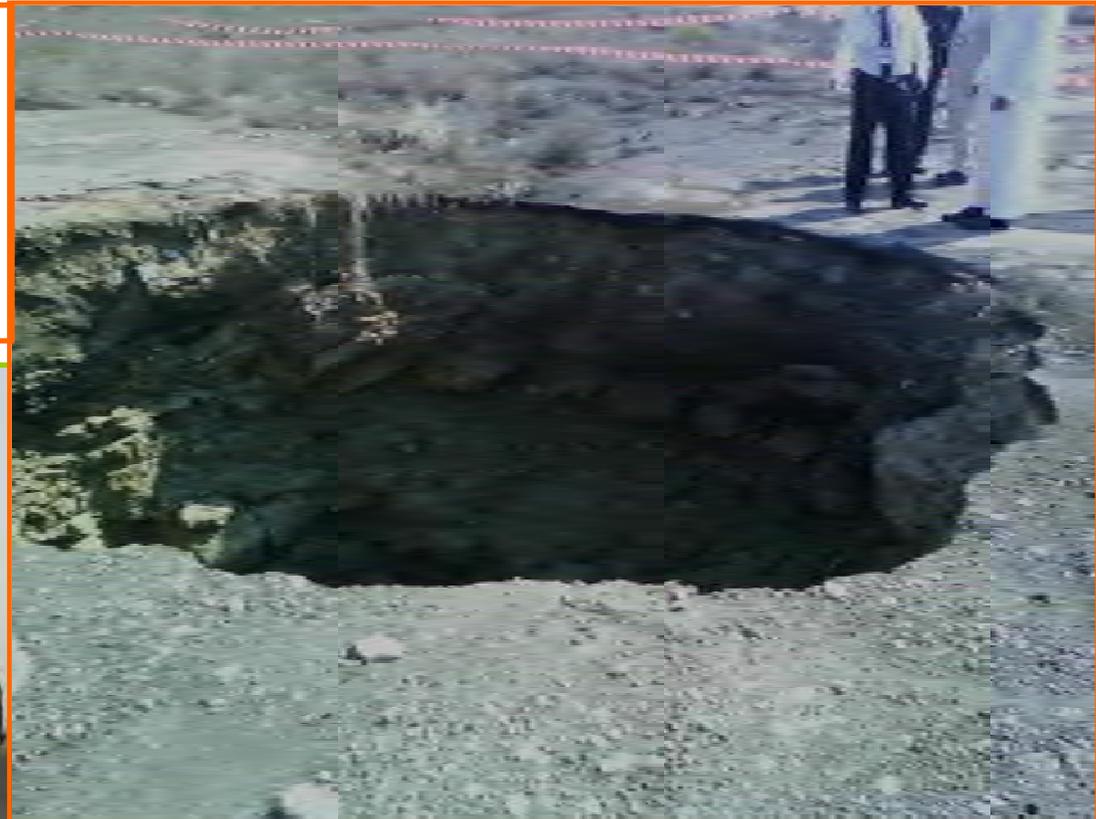
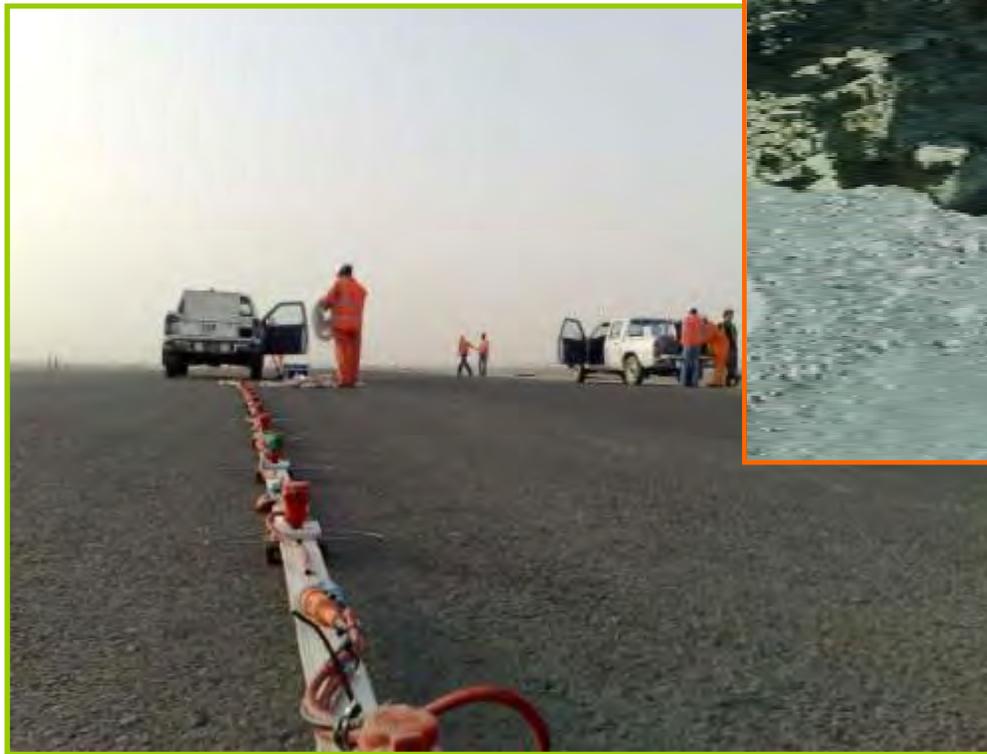
Significant cavity opens up near to major infrastructure in UAE as a result of heavy rains.

Geology = karstic limestone

Surface cavity thought to be linked to subsurface solution features.

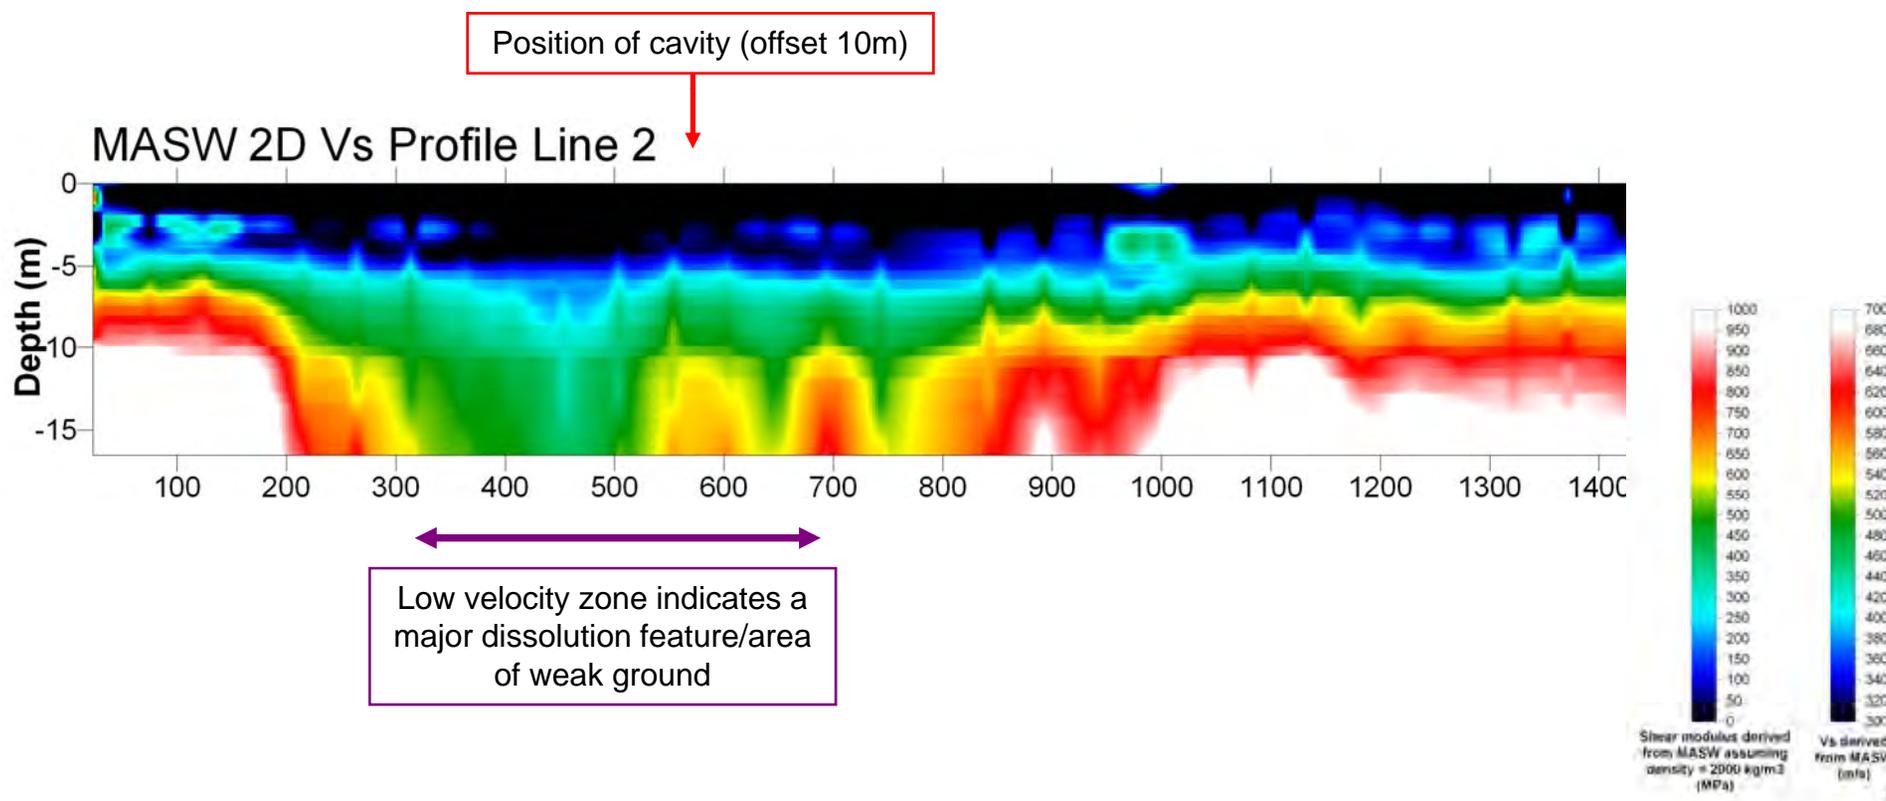
Engineering properties

Seismic investigation carried out using MASW

Measurements taken along profile lines over existing hardstanding and unsurfaced areas

By combining adjacent 1-D profiles together, a 2-D depth cross-section may be derived. Incorporating density information allows for derivation of shear modulus.

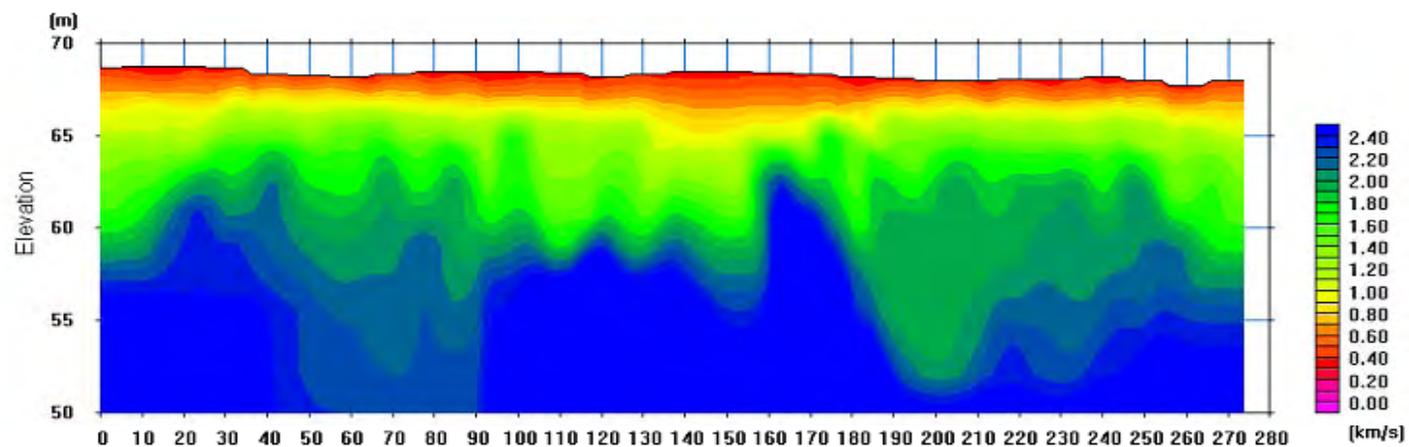
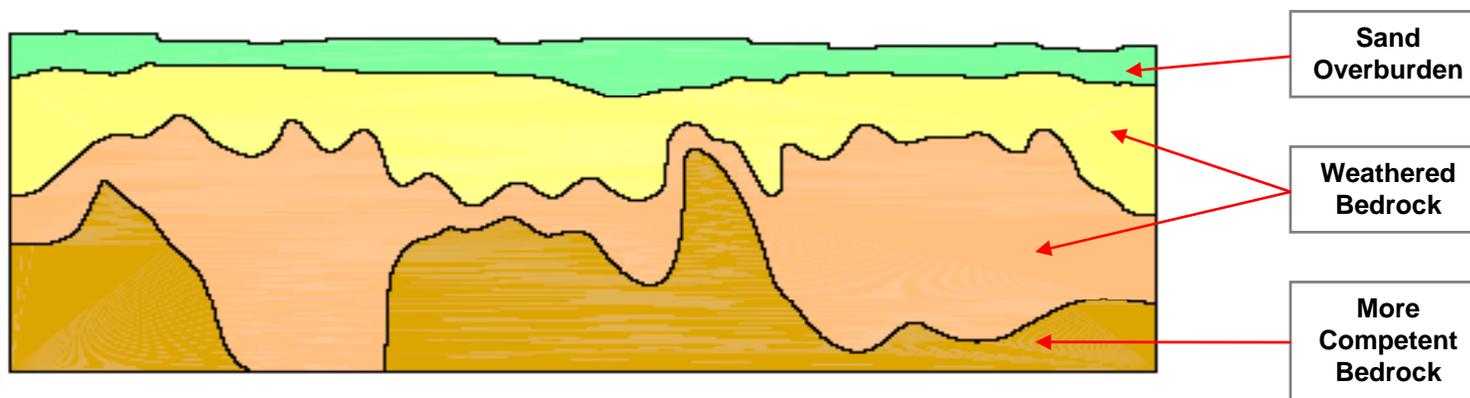
Bedrock Mapping

We use **Seismic Refraction Tomography**:

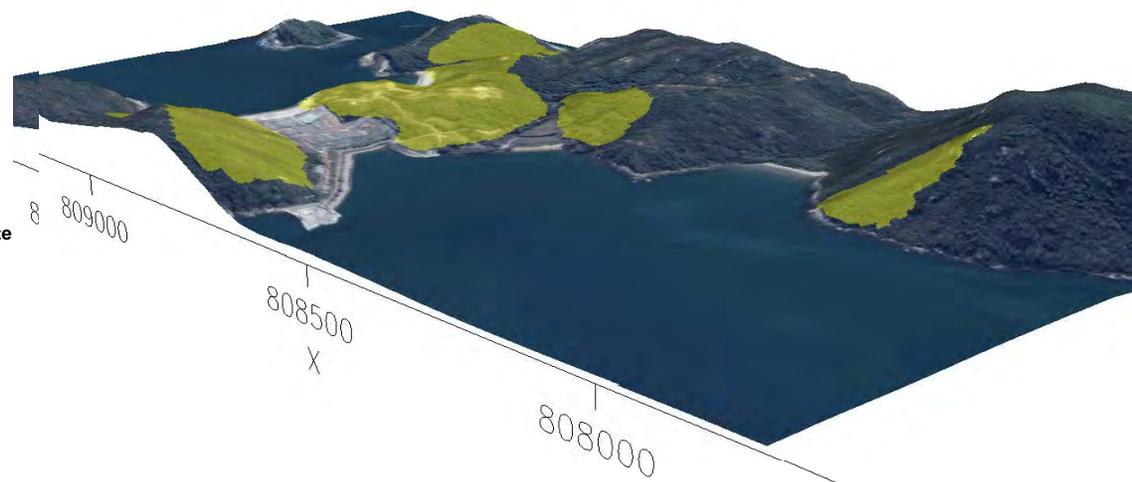
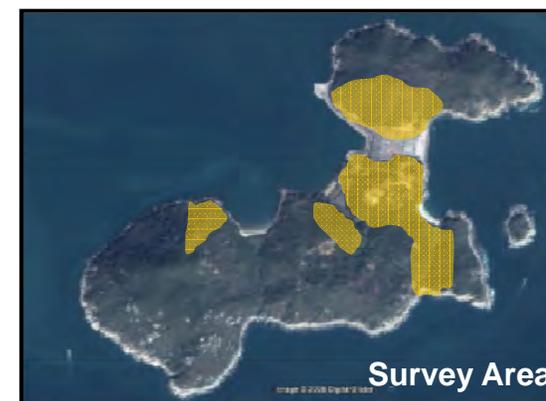
Major ground works (excavation, blasting, slope stability) required as part of installation design

Requirement for assessment of thickness of weathered material/**depth to granite bedrock**

Geophysical survey undertaken over approximately 3 hectares employing **Microgravity** in conjunction with a targeted geotechnical investigation.

An **increase in density** is expected in competent Granite, therefore variations in gravity can be used to profile the Granite surface.

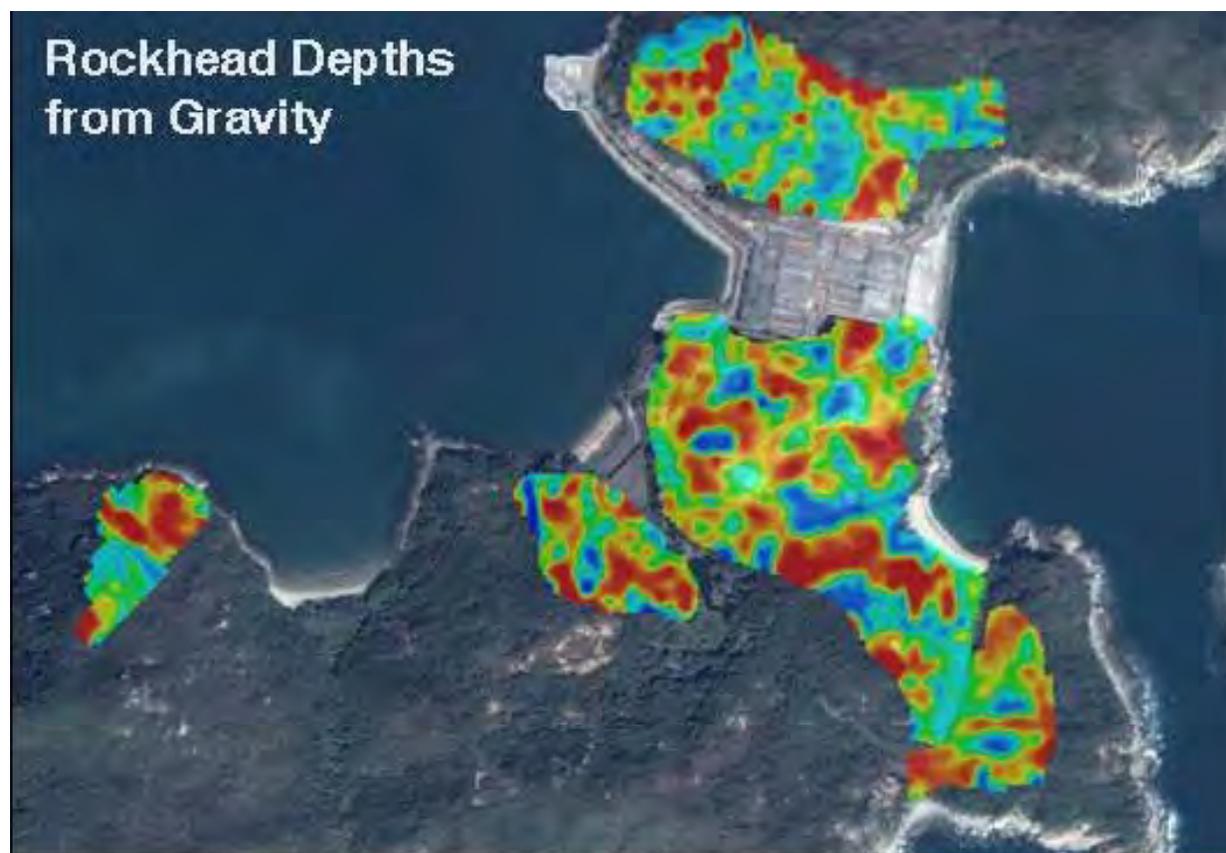
Bedrock Mapping

Mapping cover materials – microgravity example

Over 50 onshore drill-holes and trial pits were carried out.

Most locations required helicopter lifts

This example highlights the fundamental problem of spatial sampling associated with most intrusive programmes. More detailed information can be obtained by 'filling the gaps' with geophysics*.

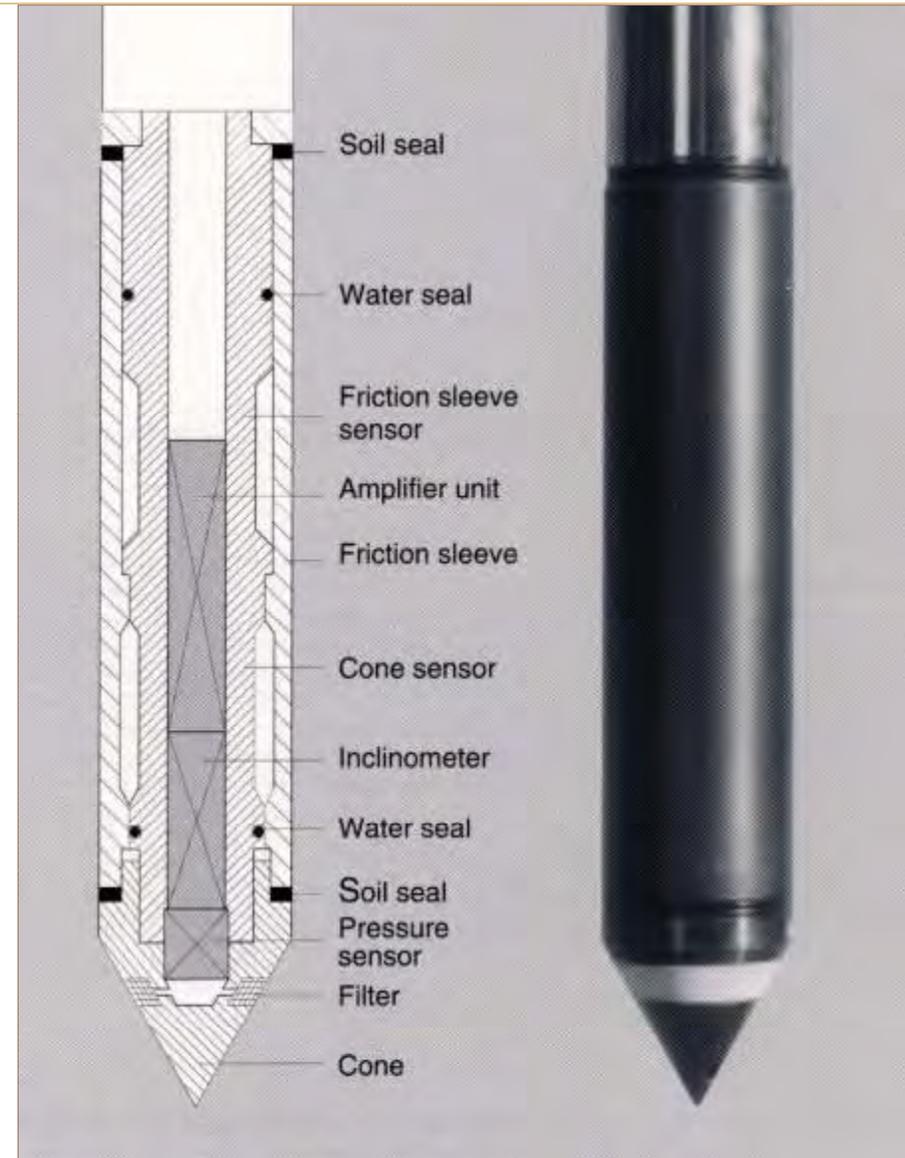
Electric PiezoCone Penetration Testing

- Hydraulically push an instrumented probe into the ground
- Generally measures end resistance, q_c ; sleeve friction, f_s ; and pore water pressure generated during penetration, u
- Additionally, geophones, temperature, electrical conductivity, pressuremeter
- Generally 10cm^2 (35.6mm dia) or 15cm^2 (43.7mm dia)
- Pushed until refusal
- Deployment systems from Land, Seabed and from Bottom of a borehole
- Inclinator measurements to correct for non vertical penetration
- Data transmission by cable, on board memory or by telemetry
- High resolution A to D means measurement of q_c to less than 5kPa

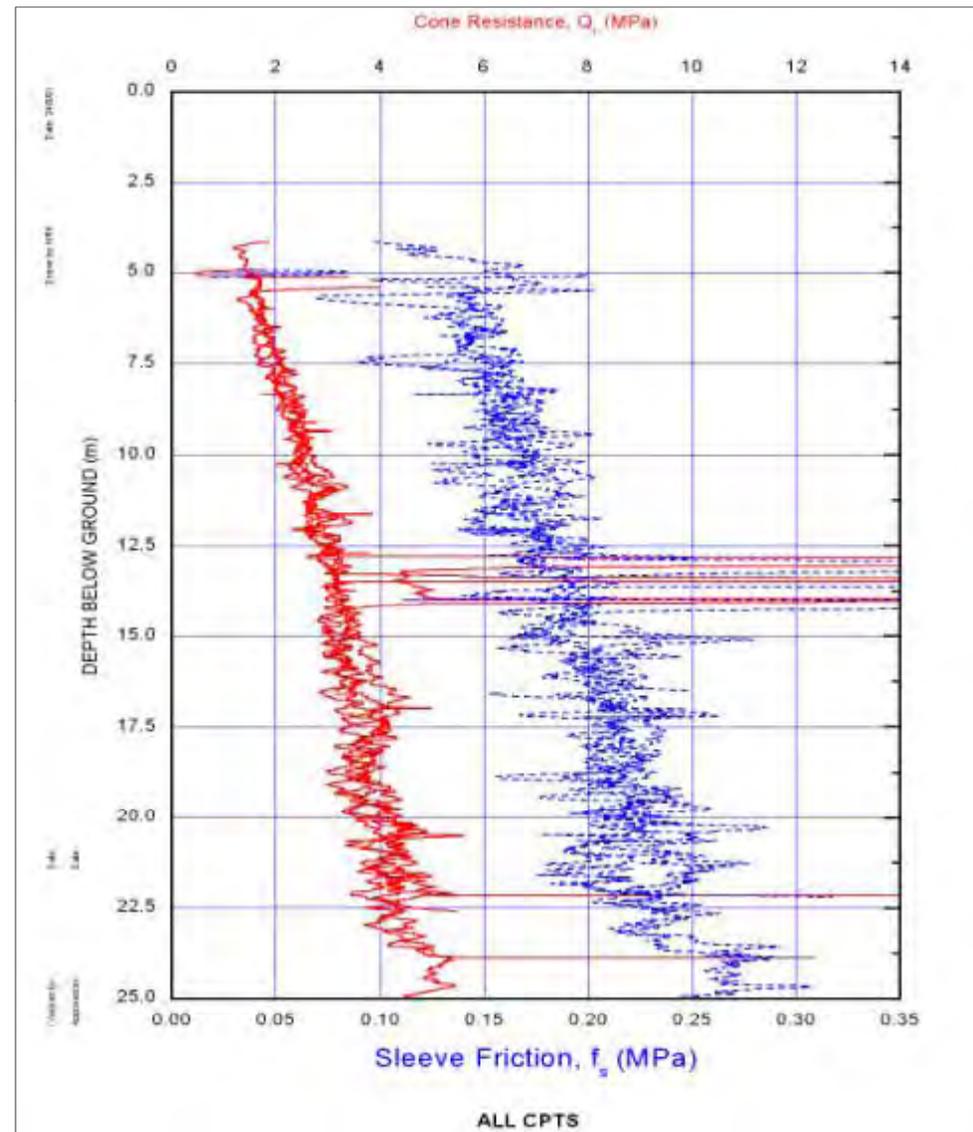
CPTs - repeatability

- overlay of 5 CPTs
- off scale Q_c at ~13m due to claystones
- the Cone broke through the claystones allowing full penetration

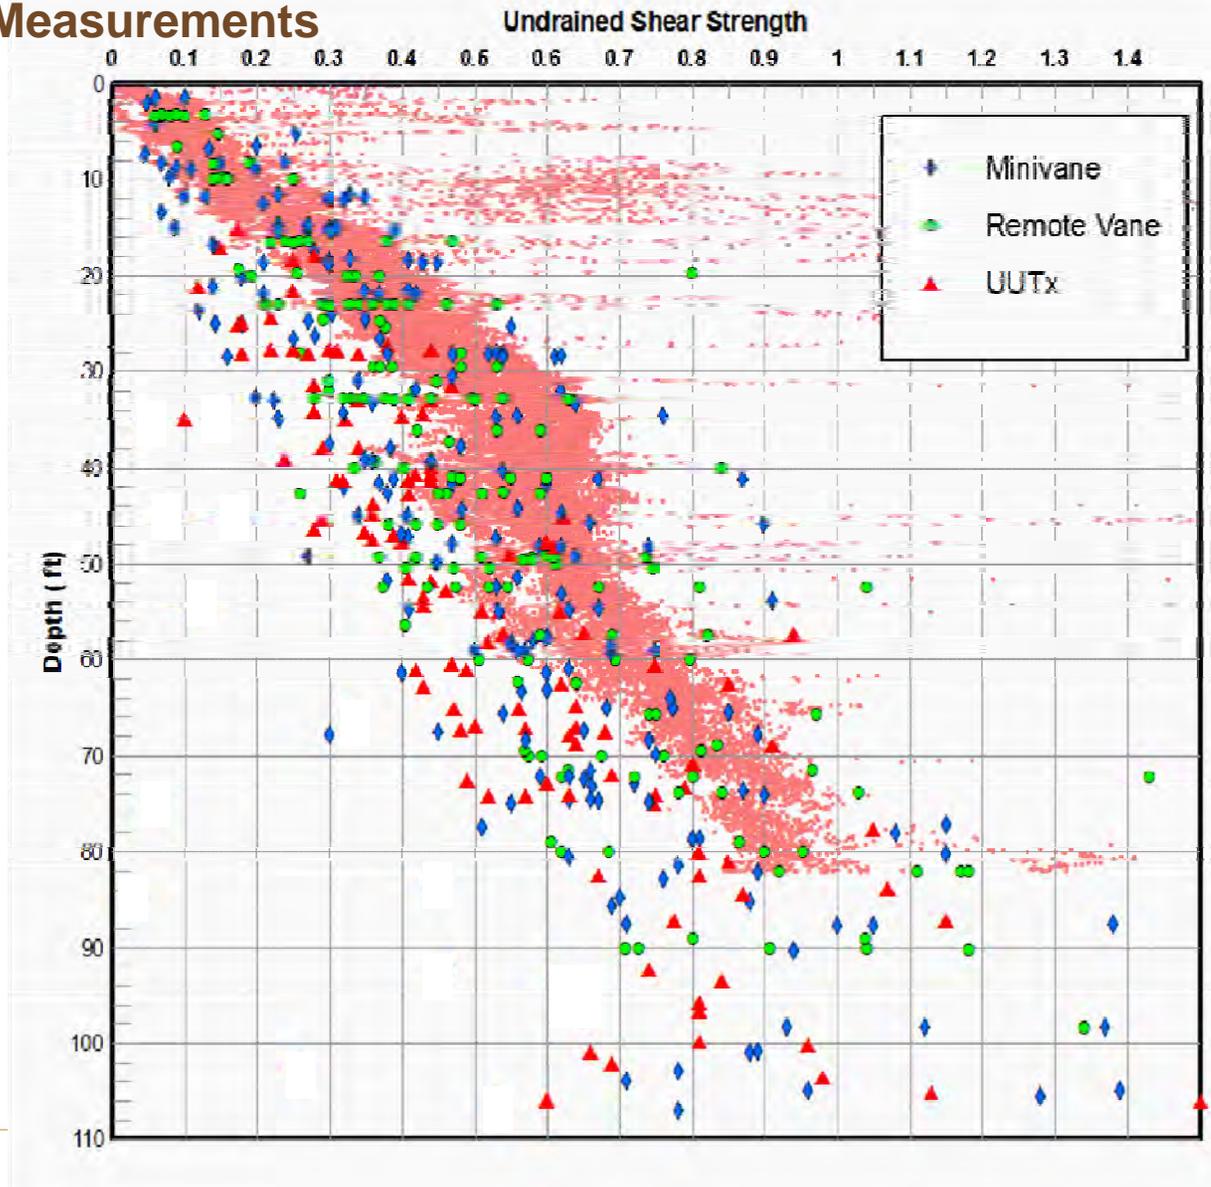
Craney Island Project - Strength Variability

Comparison of Strength Measurements

- In Situ Vane
- Laboratory Triaxial
- Laboratory Vane
- In Situ T-bar

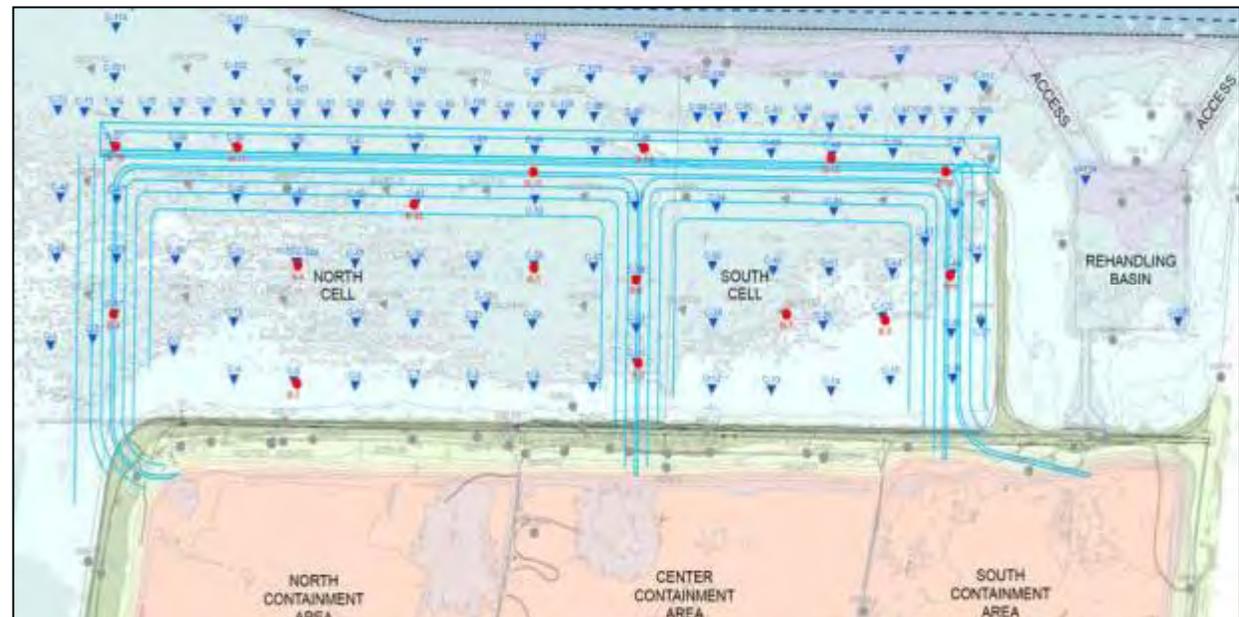
- 125 CPTs, 16 borings up to 350 ft deep, 20 T-bars, 12 vane profiles, seismic reflection survey
 - GIS used to plan and supported in real time
- 4 Offshore sand borrow sites w/seismic 125 CPTs, 225 vibracores
- 1 onshore borrow site with 90 CPTs + 90 geoprobes
- Onshore SI program 35 borings and 45 CPTs (another firm)
- 10 borings and 20 CPTs in 2000

GIS used to plan and manage the data

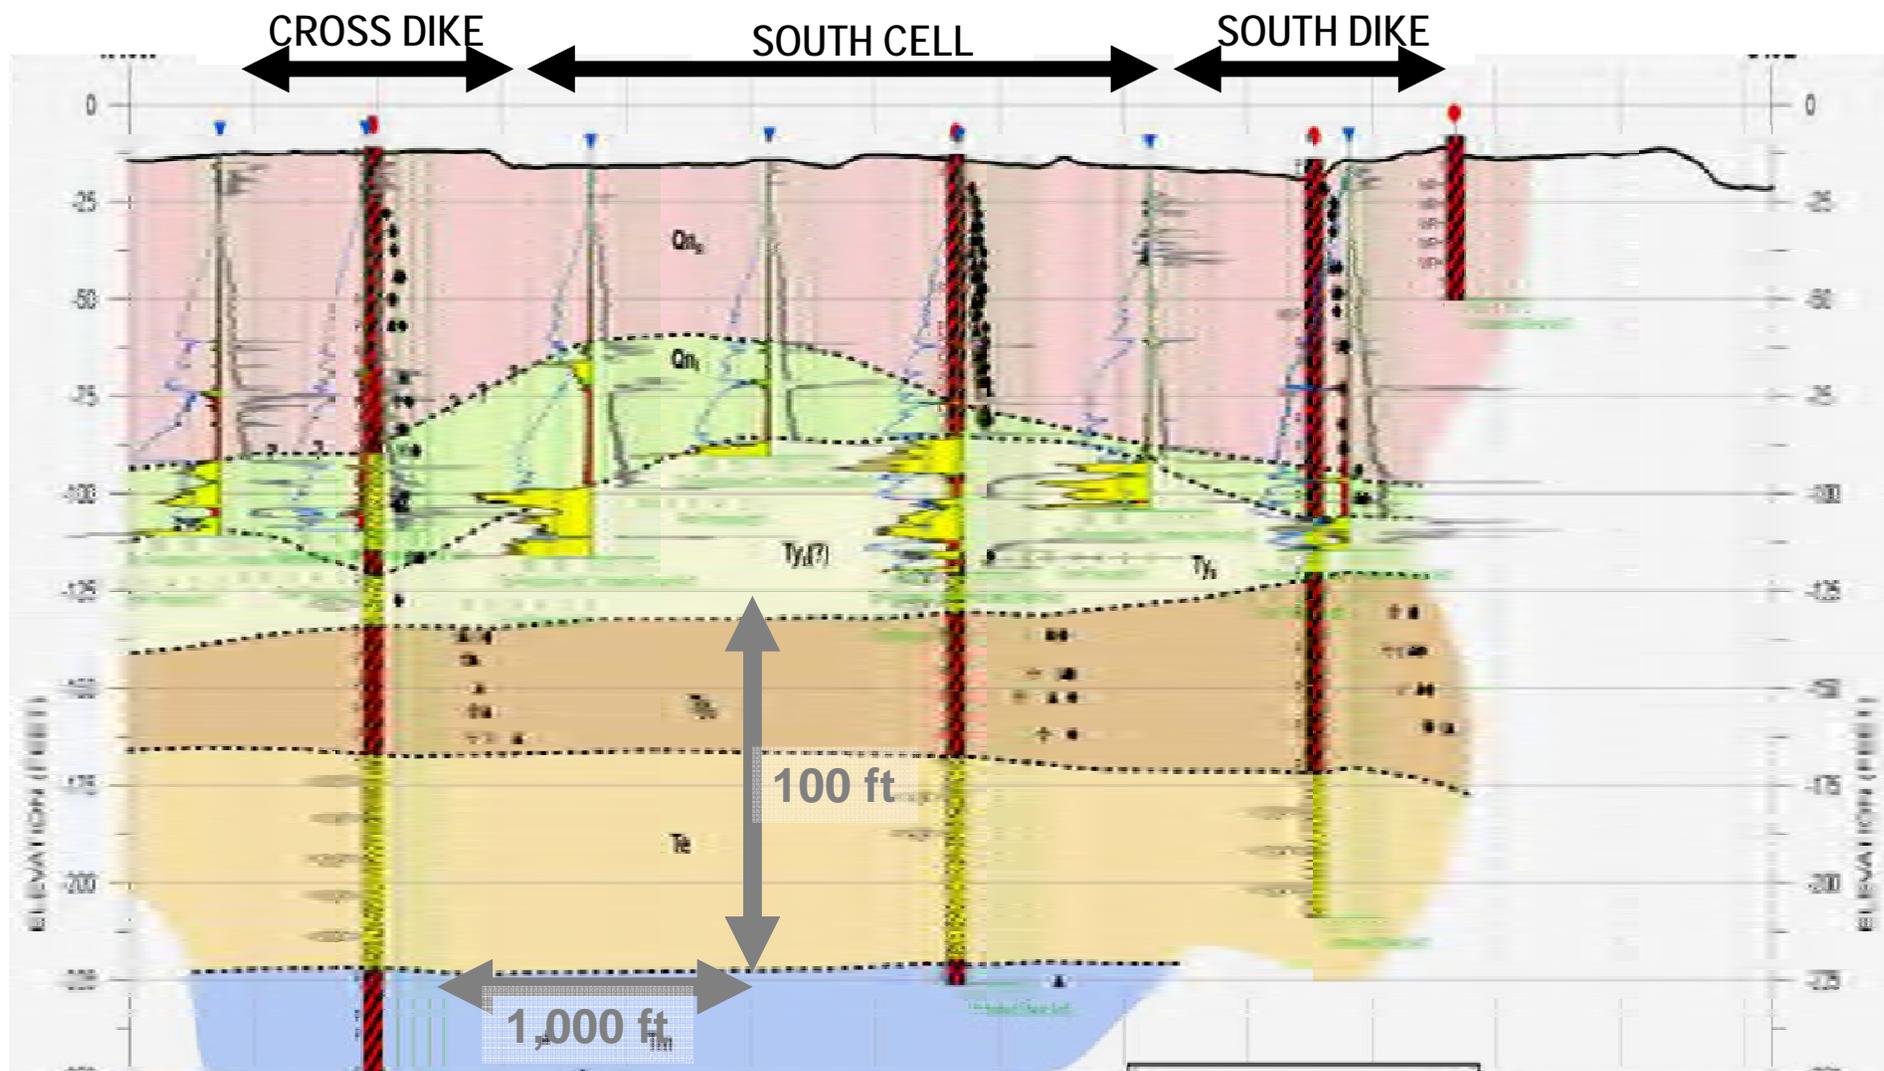
Craney Island Project Example

Subsurface Stratigraphy and Conditions – Along Eastern Dike (Future Wharf) Alignment –

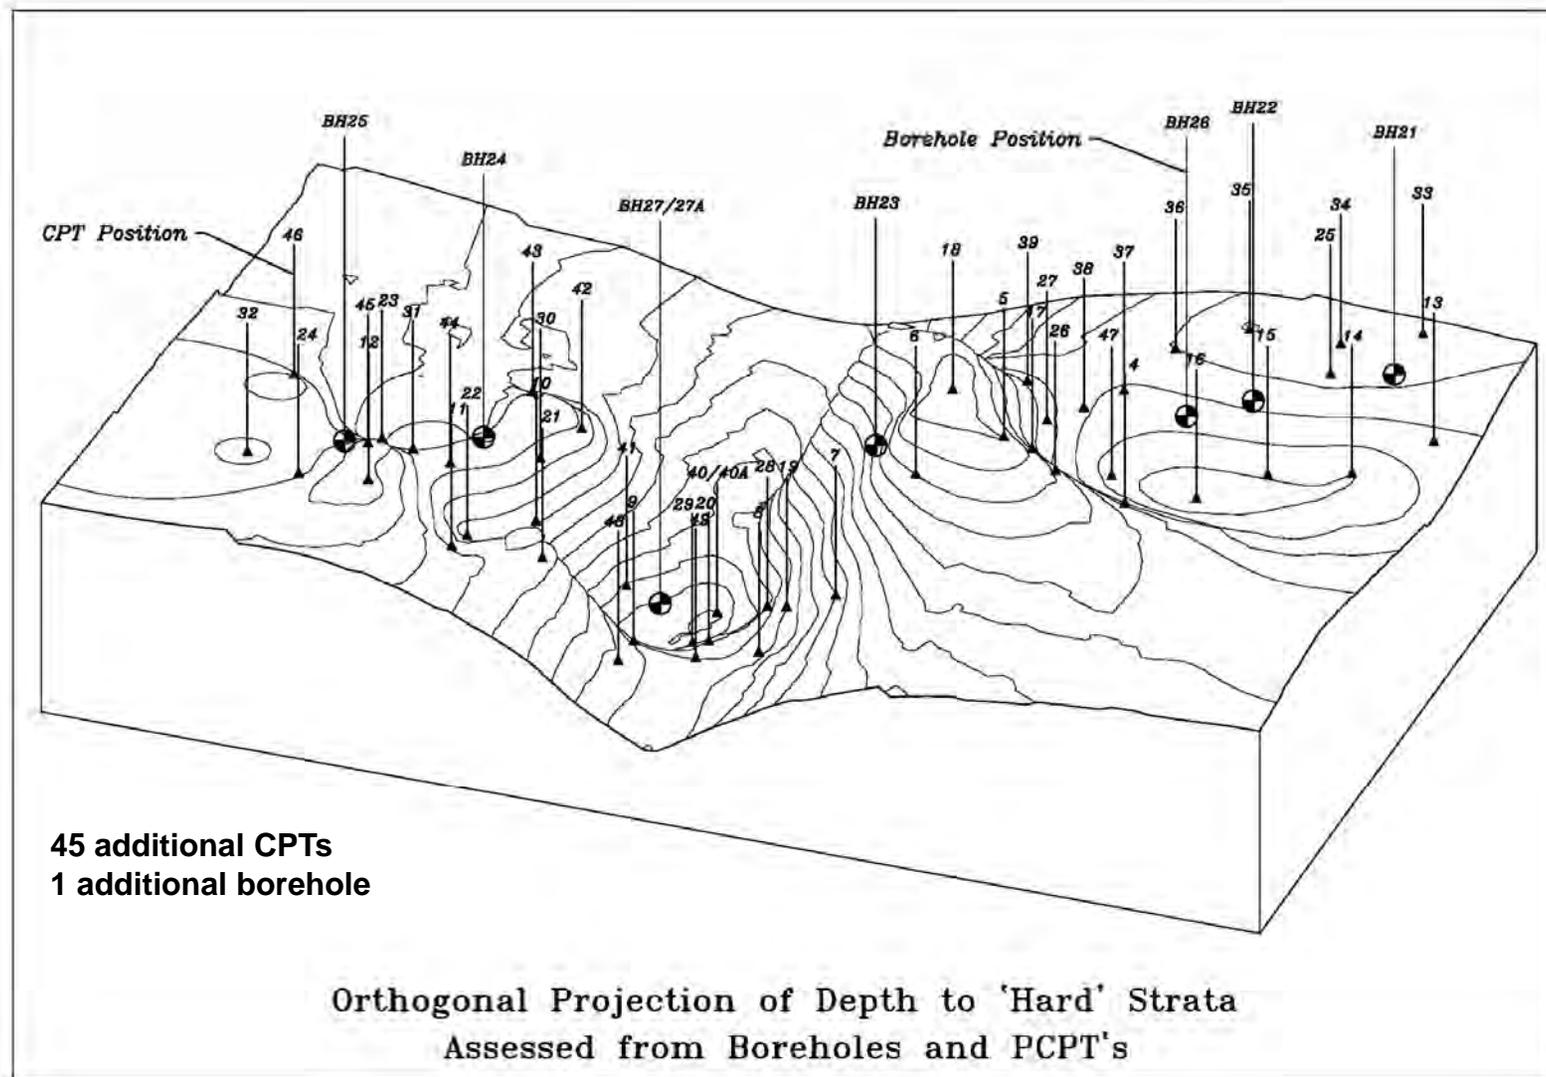
Improved Geological Model
