29th Annual
Geotechnical Seminar

GEO-Omaha 2012

February 17, 2012
Scott Conference Center
Omaha, Nebraska

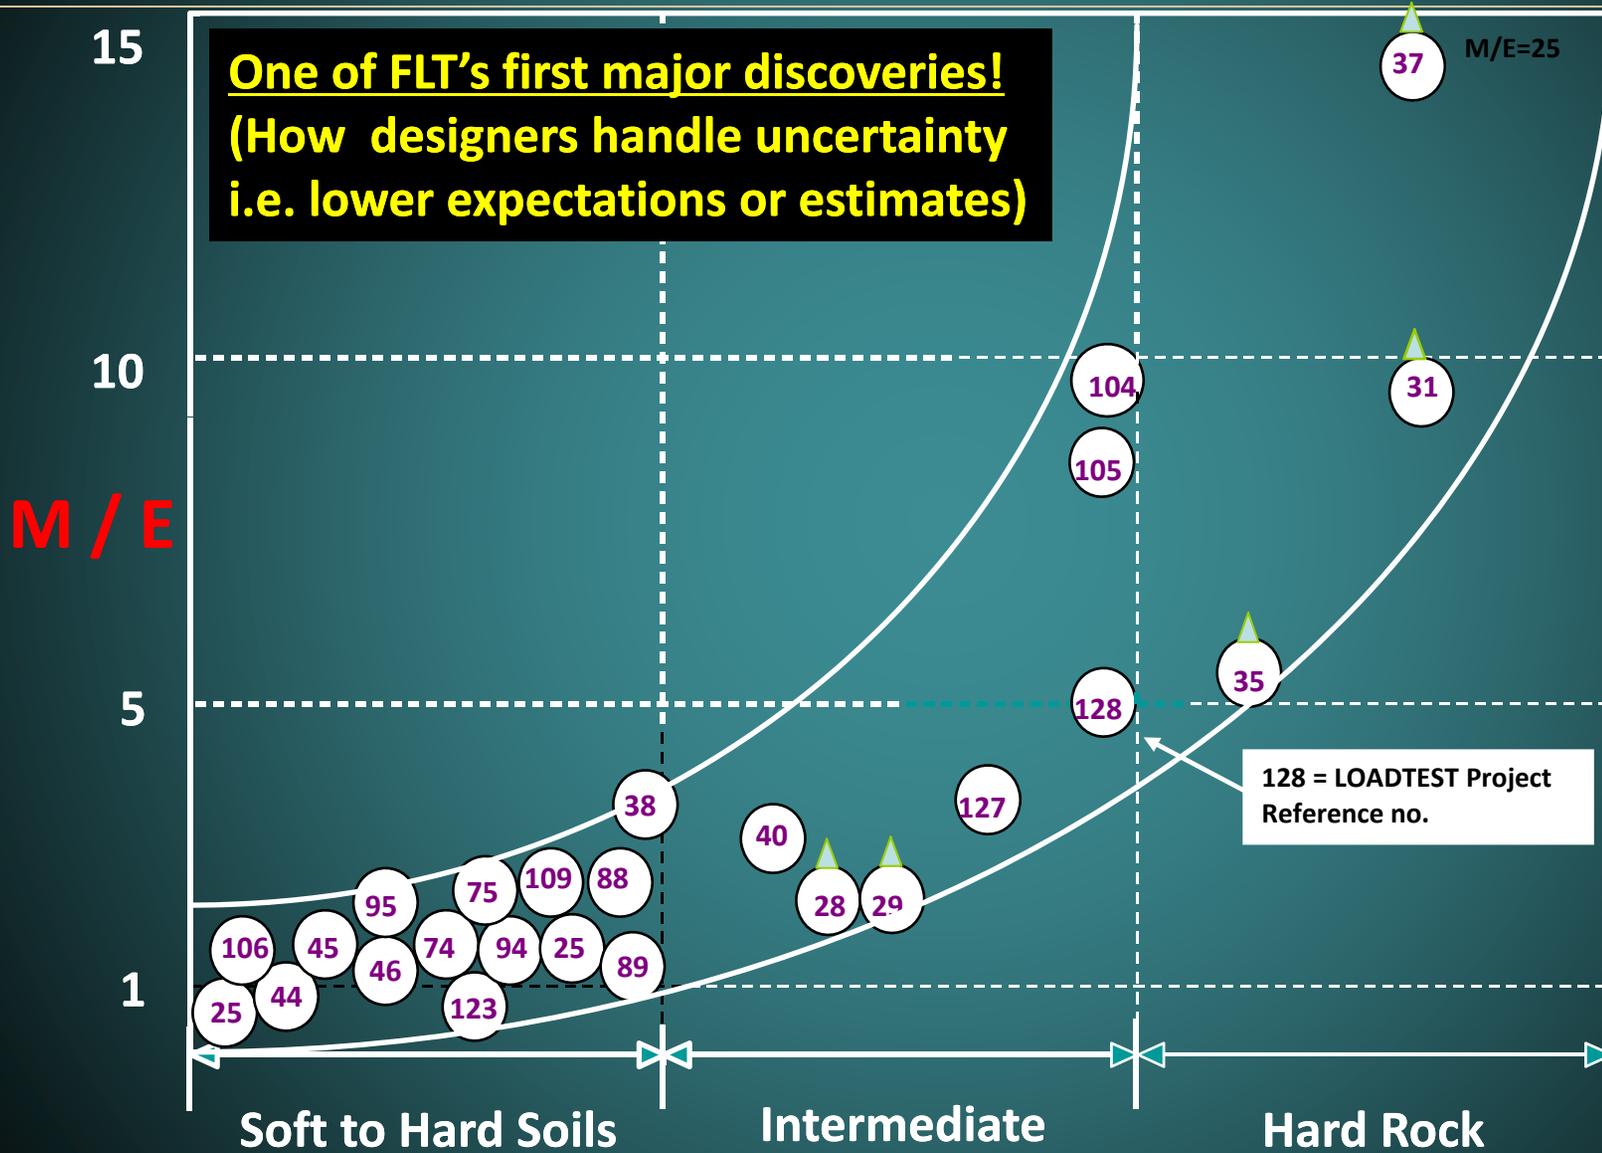
Ratio of Measured / Estimated Capacity

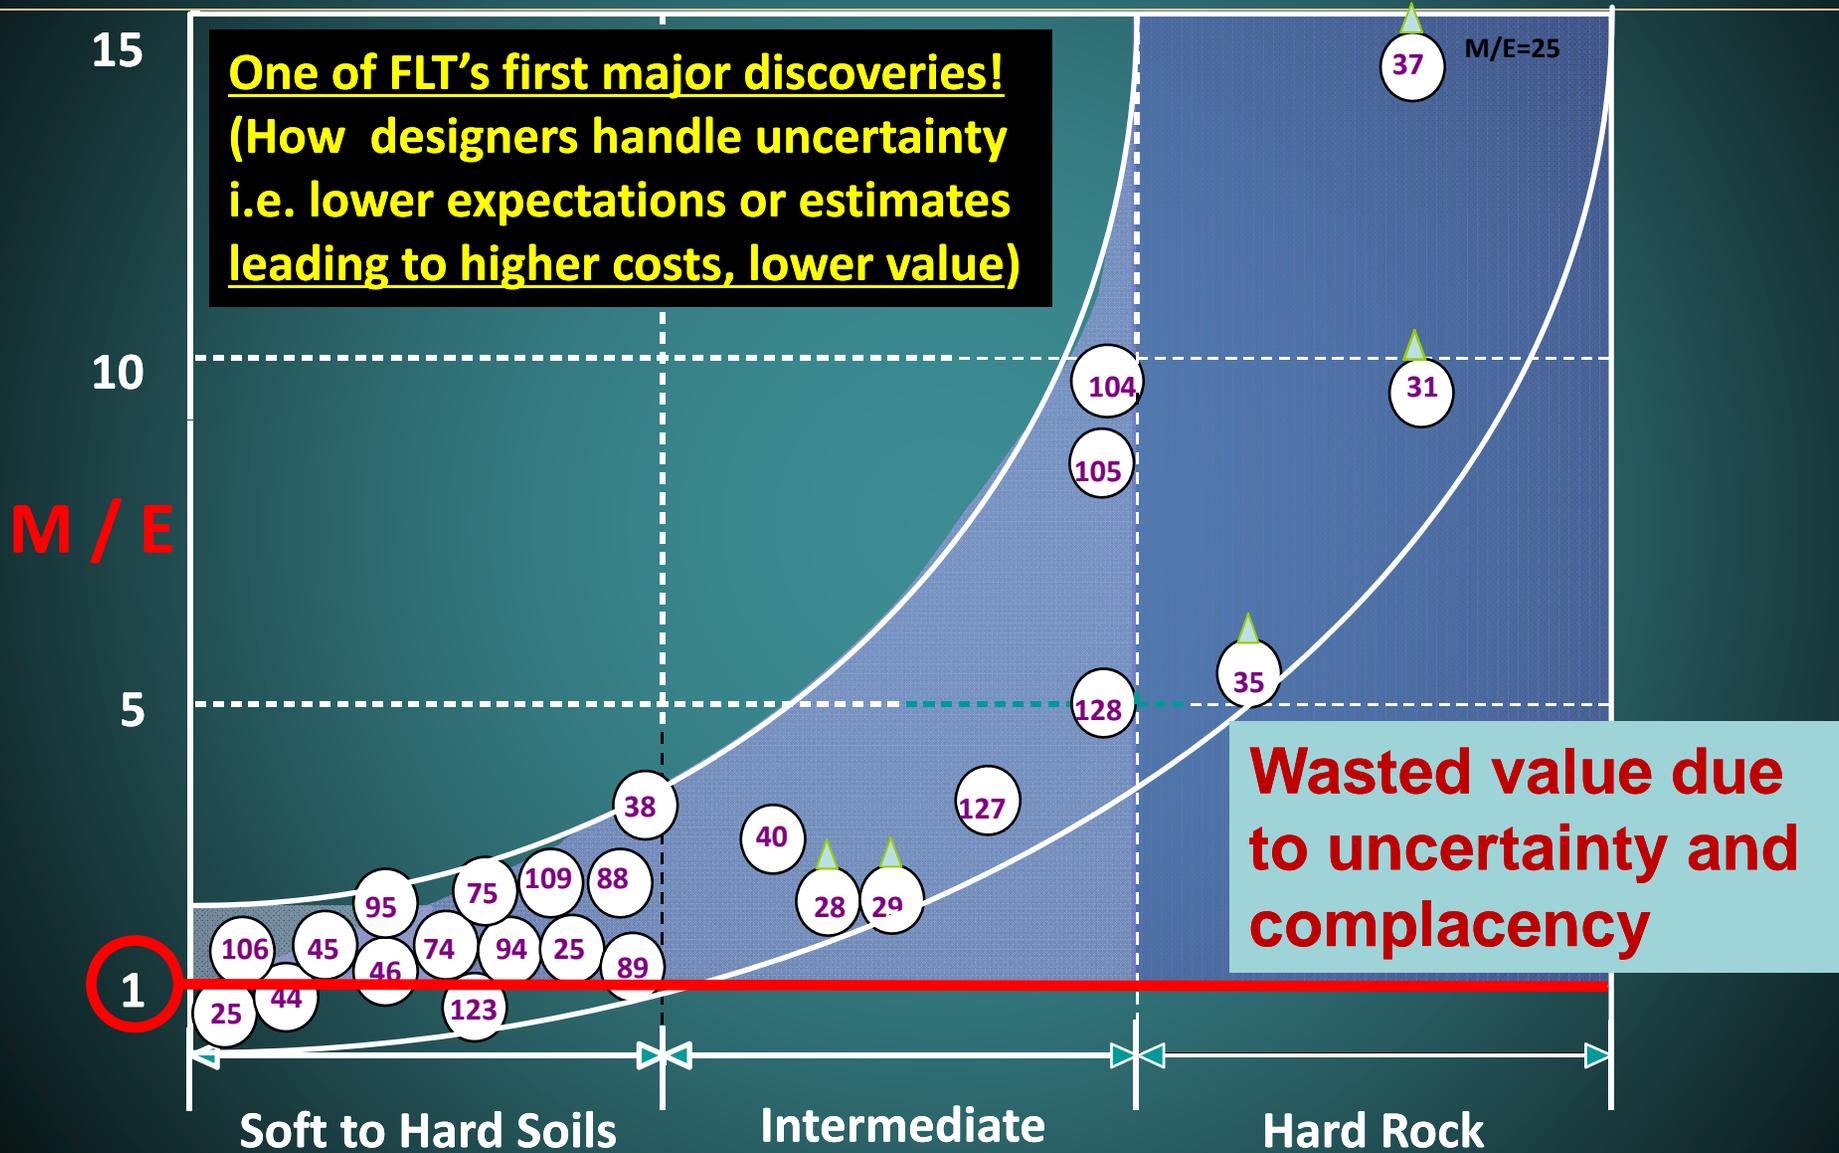
Ratio of Measured / Estimated Capacity

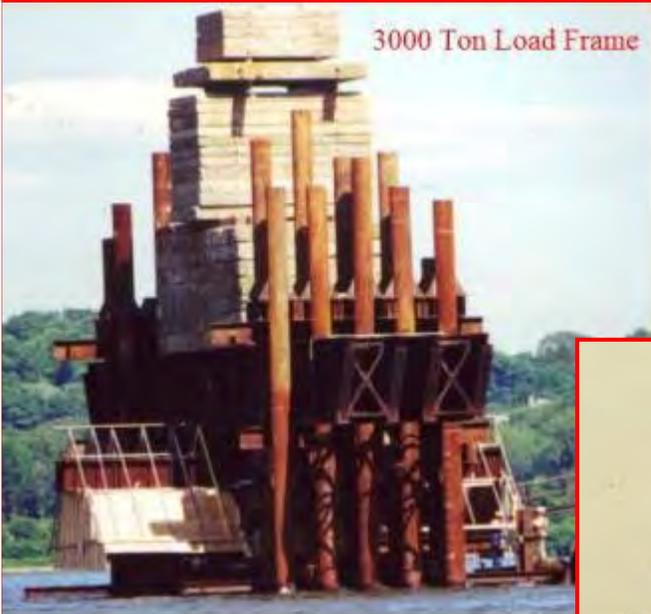
3000 Ton Load Frame

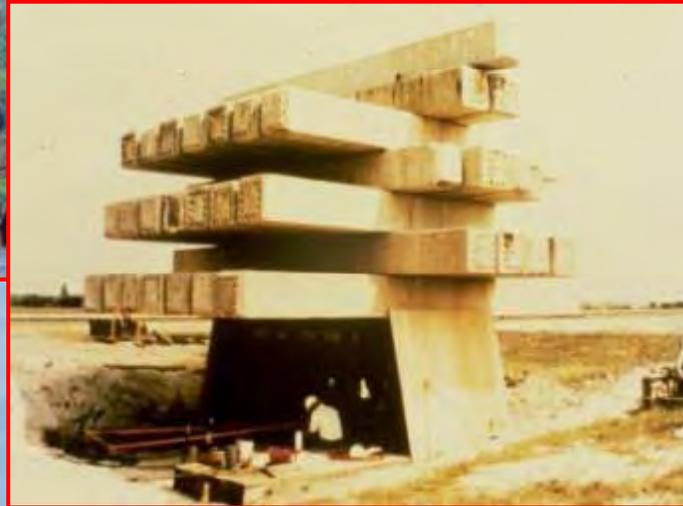
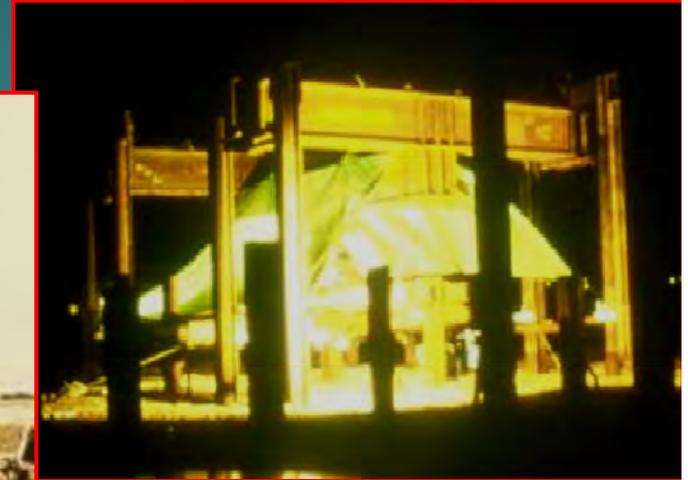
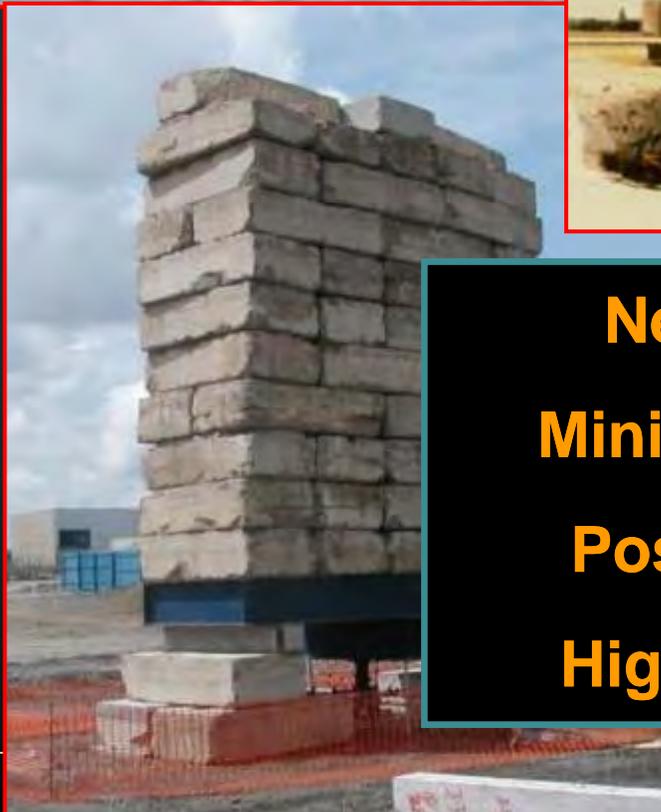
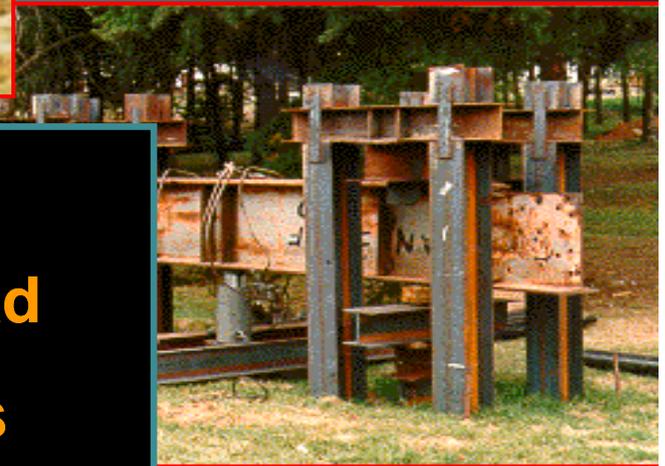
Uni-Directional Static Load Tests ASTM D1143

Need reaction frame
Minimum 2X design load
Possible safety issues
High cost (time and \$\$)

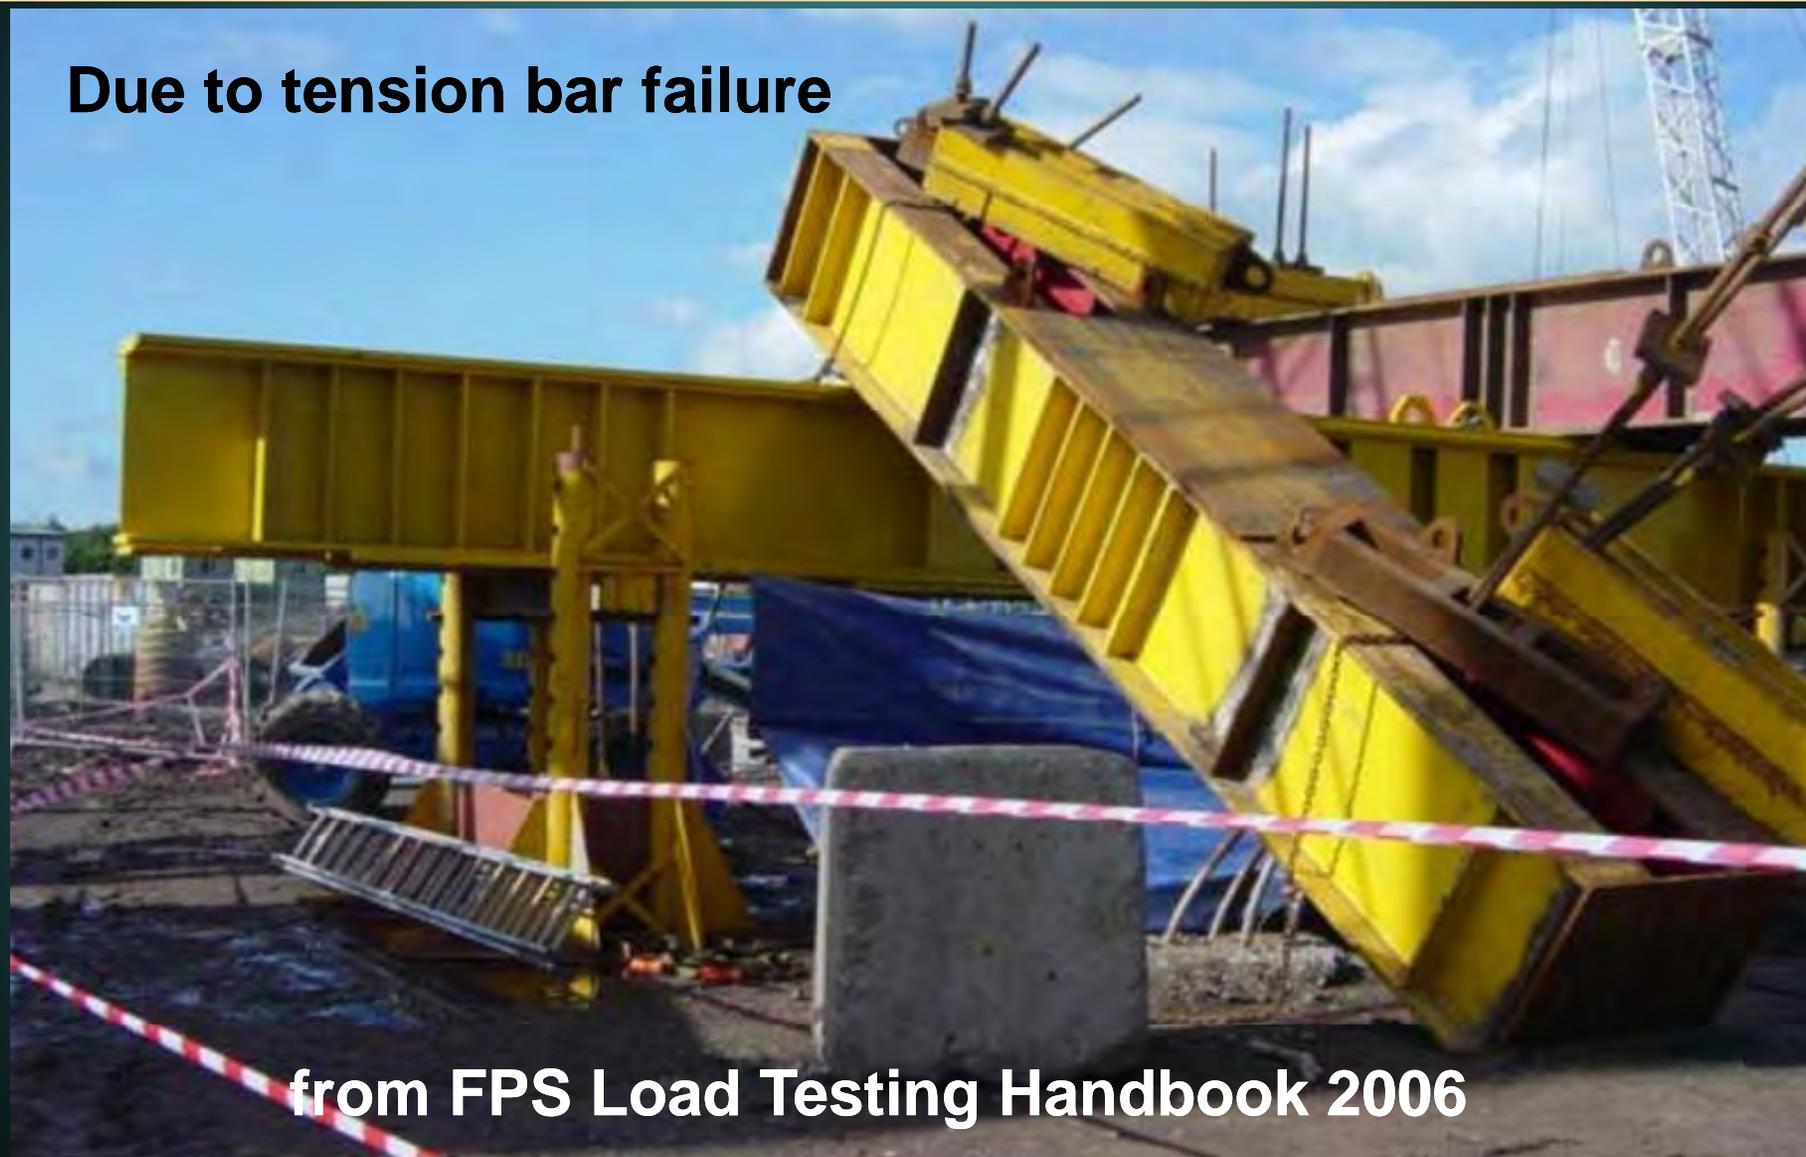
Reaction Beam Collapse

Due to tension bar failure

from FPS Load Testing Handbook 2006

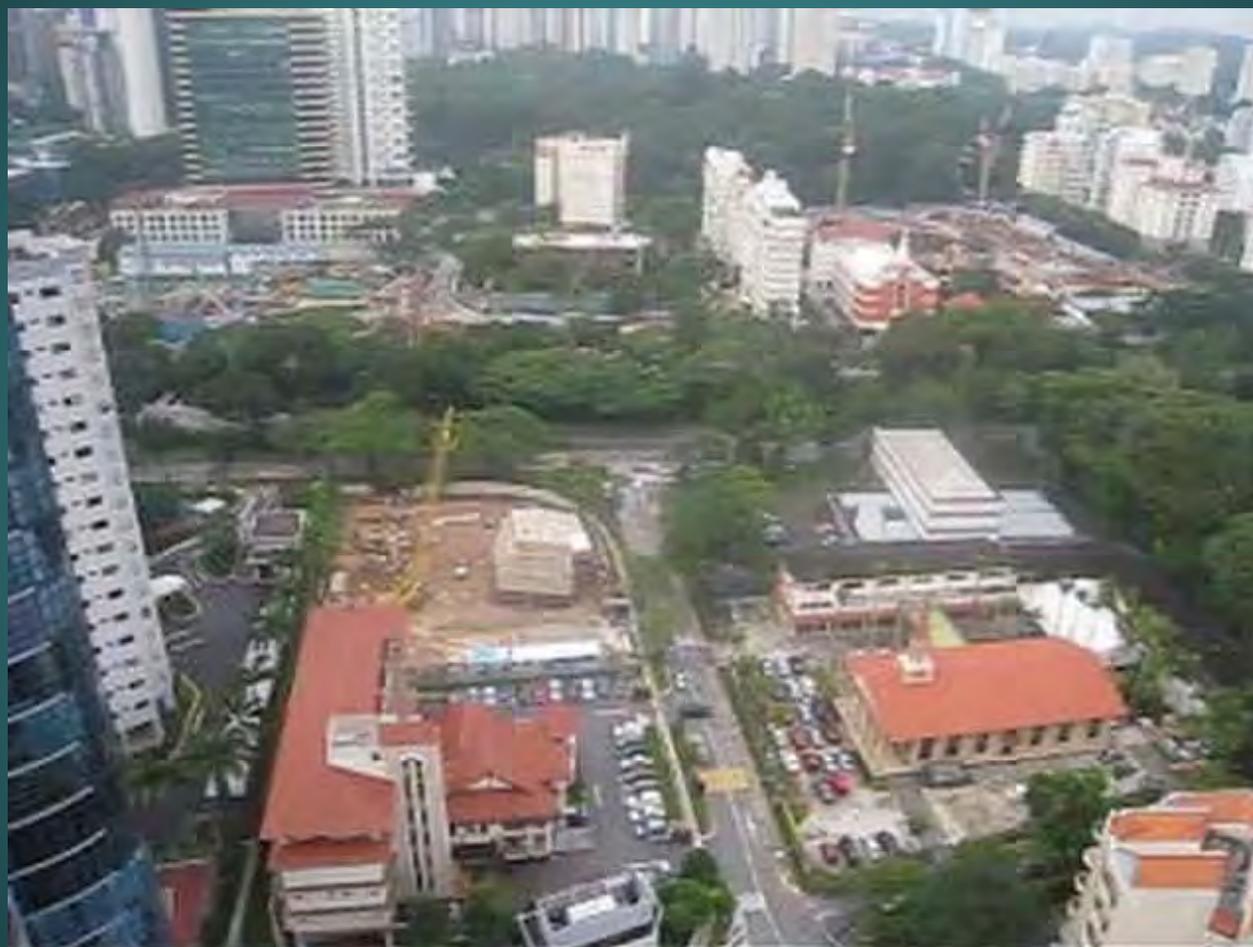
~3000 tonnes of Kentledge in Singapore

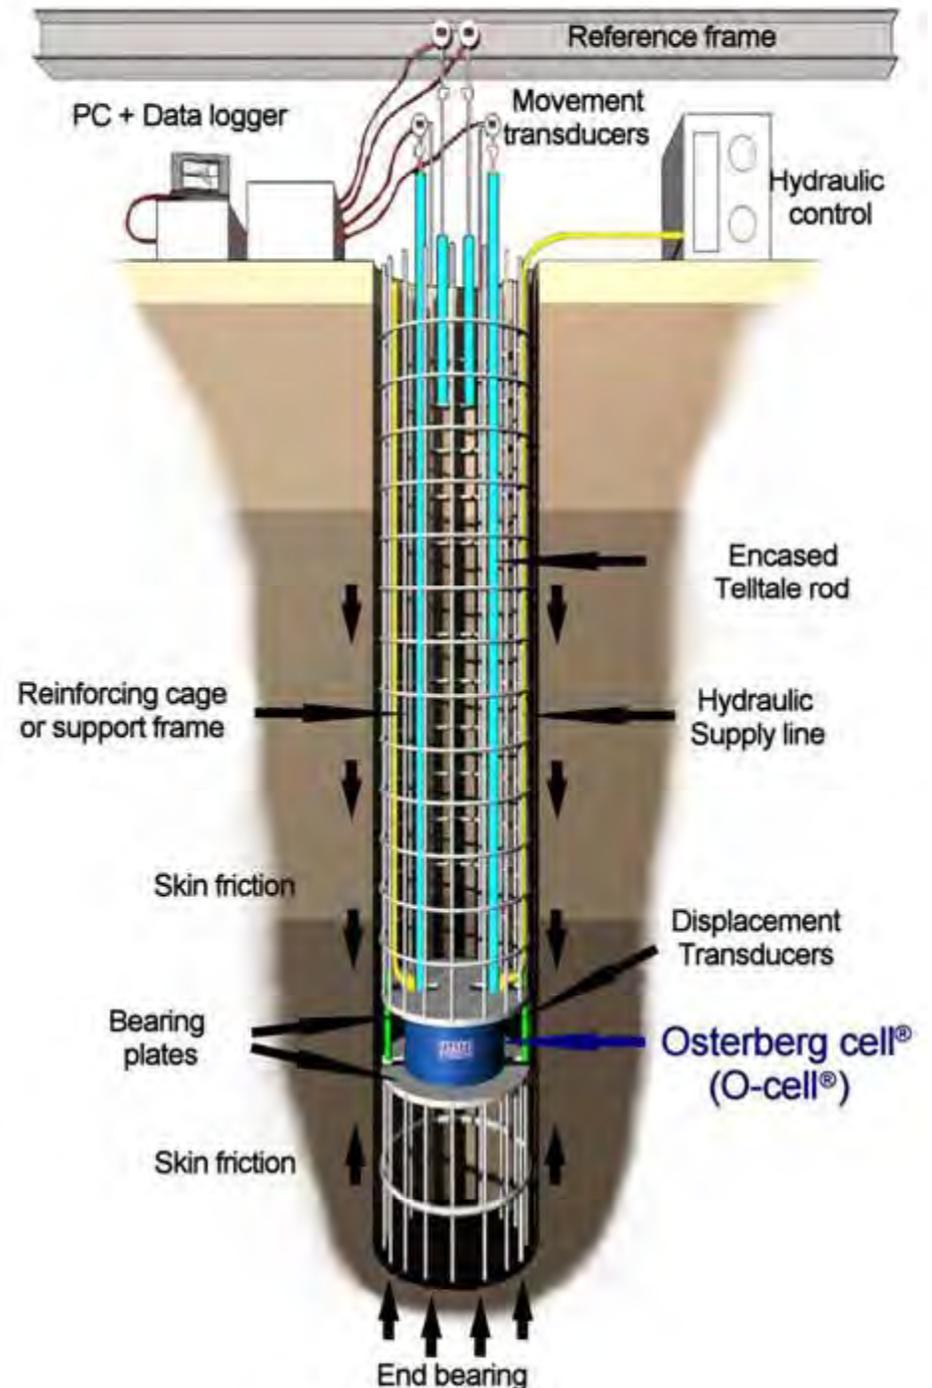
O-cell Instrumentation

- O-cell Expansion Transducers
- O-cell Top Telltales
- Pile Top Deflection
- Pile Bottom Telltales
- Shaft Strain Gauges
- Embedded Shaft Compression Transducers

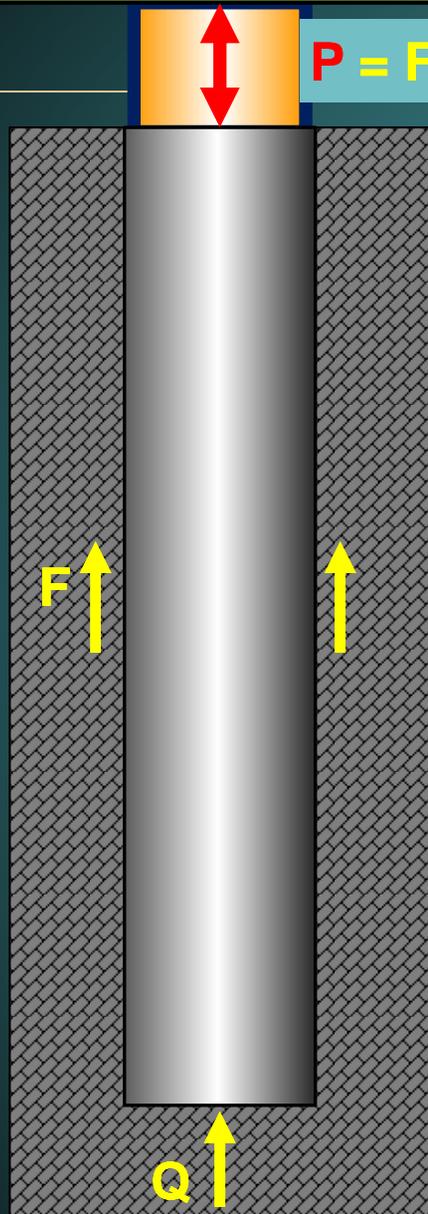
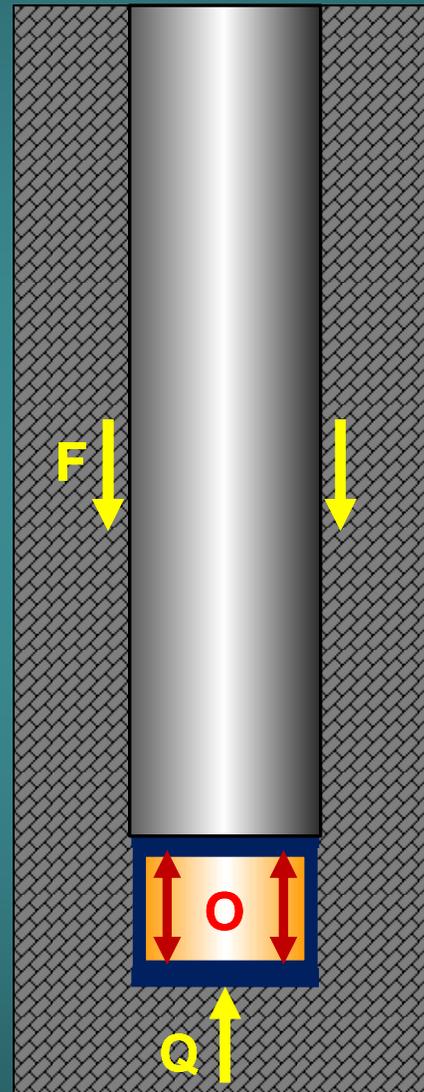
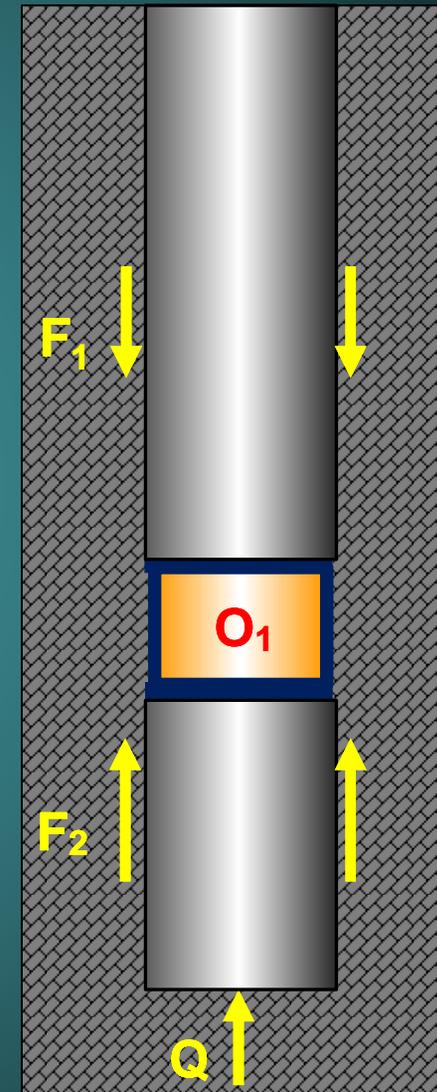
Reaction System

Osterberg Cell Test

Top-Down Test

$O = F = Q = P/2$

$O_1 = F_1 = (F_2 + Q)$

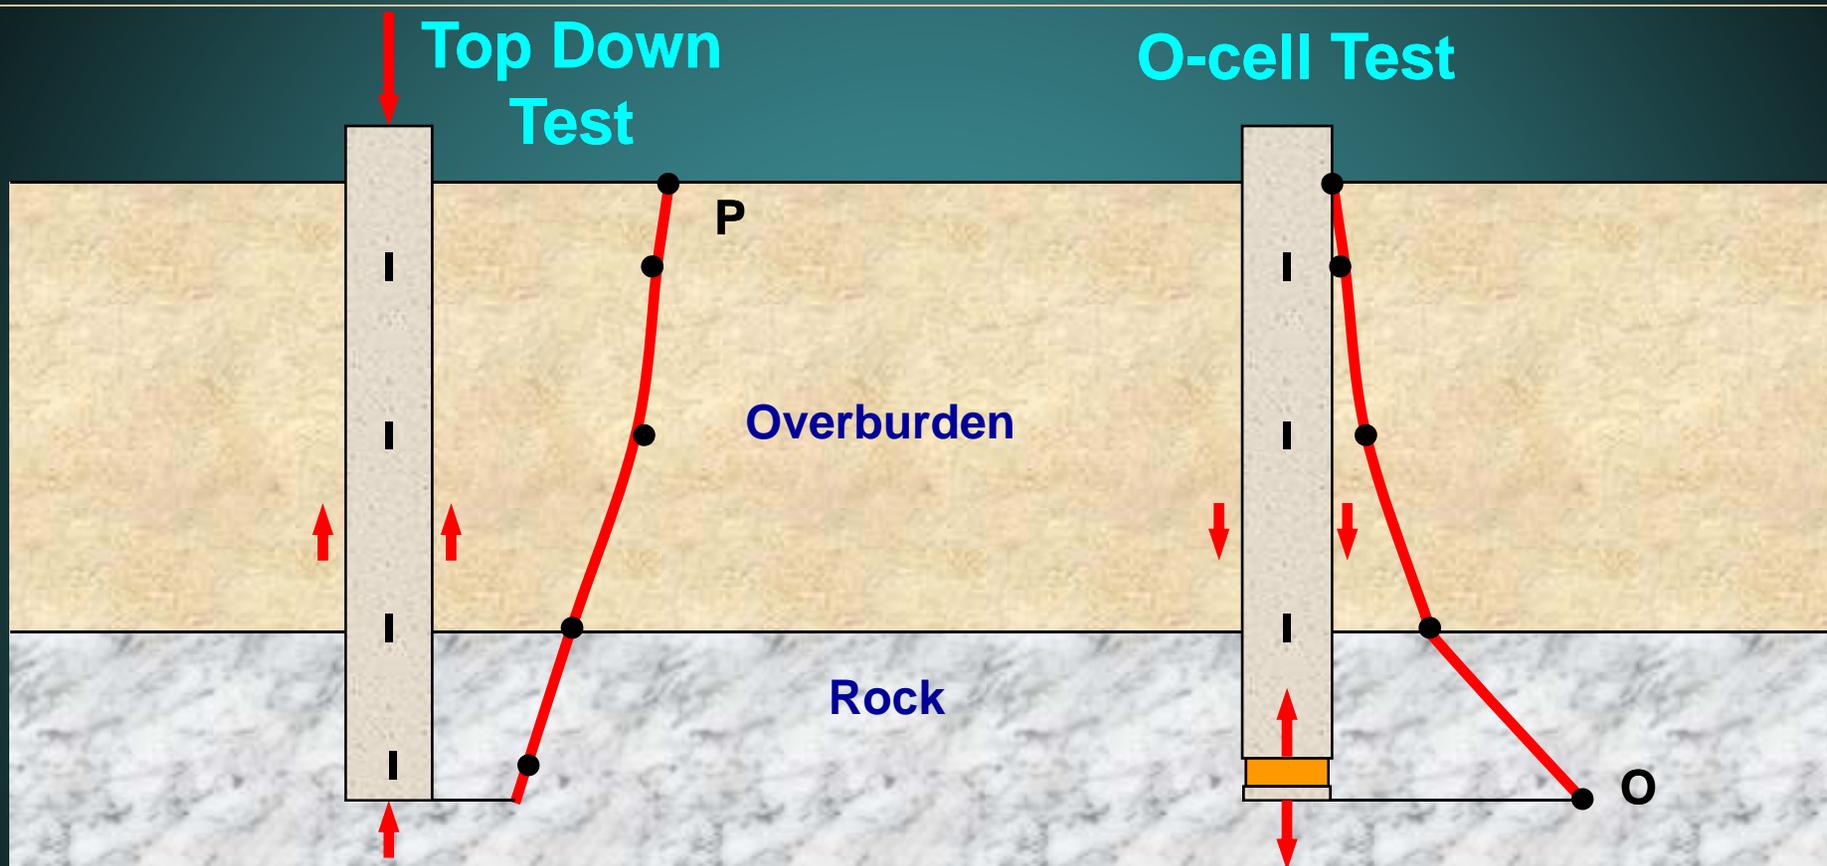
O-cell Separates Bearing from Side Shear

- Uncertain Distribution
- Poor Rock Mobilization
- May Need Model Shaft

- Less Distribution Uncertainty
- Full Load into Rock Socket
- Can Test Full Scale

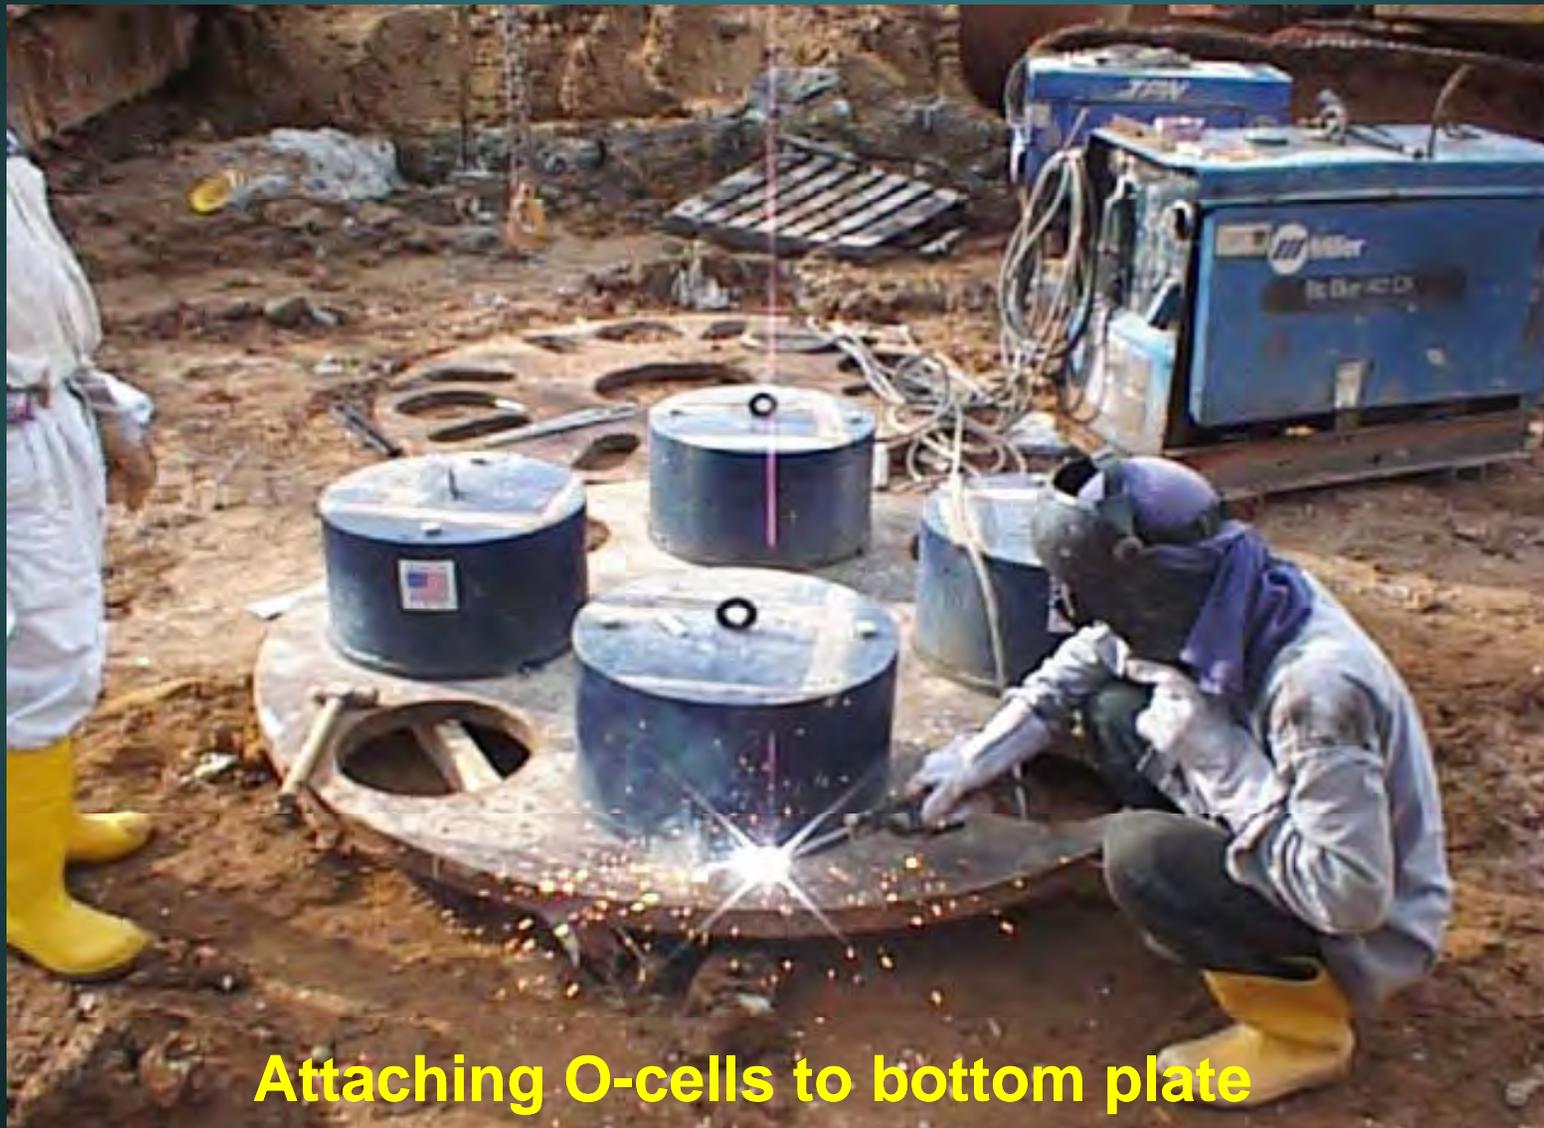
Multiple O-cell Assemblies

Attaching O-cells to bottom plate

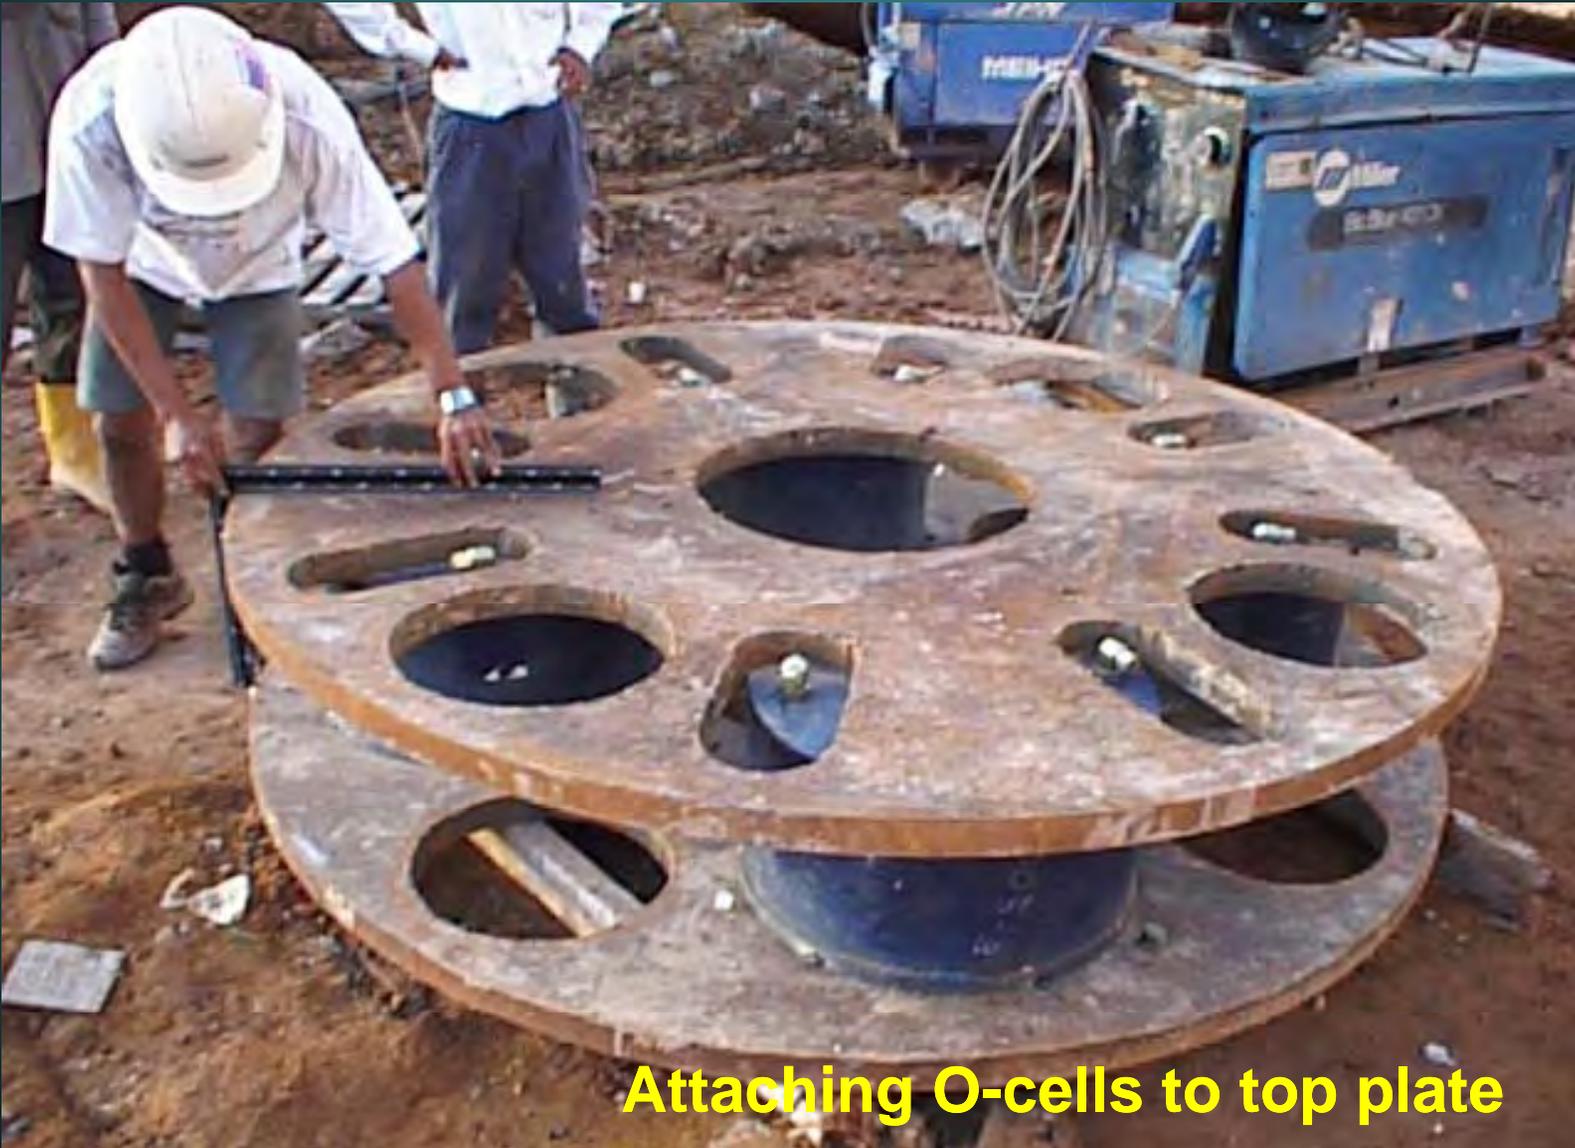
Multiple O-cell Assemblies

Attaching O-cells to top plate

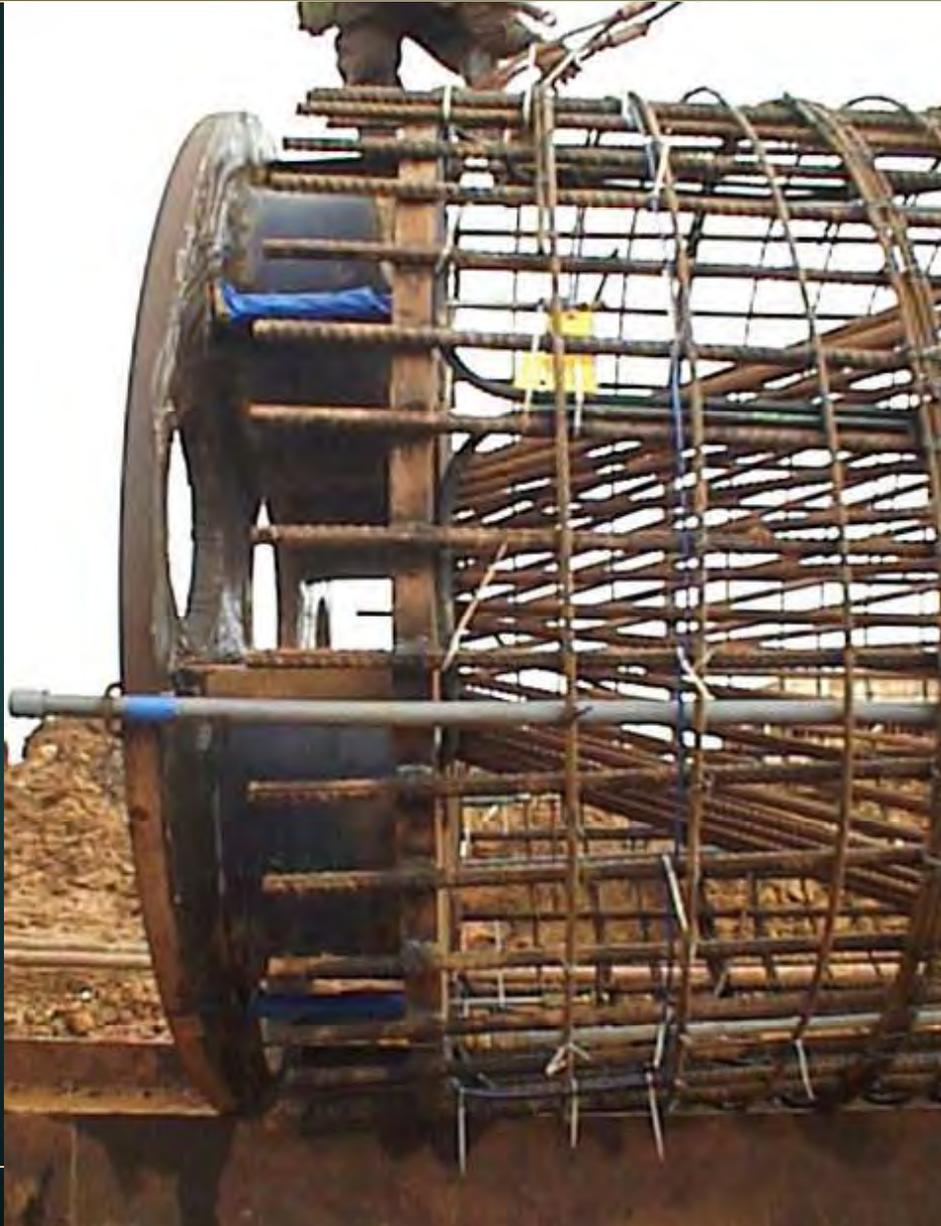
Single O-cell Plate Assembly

← Cone-shaped tremie guide

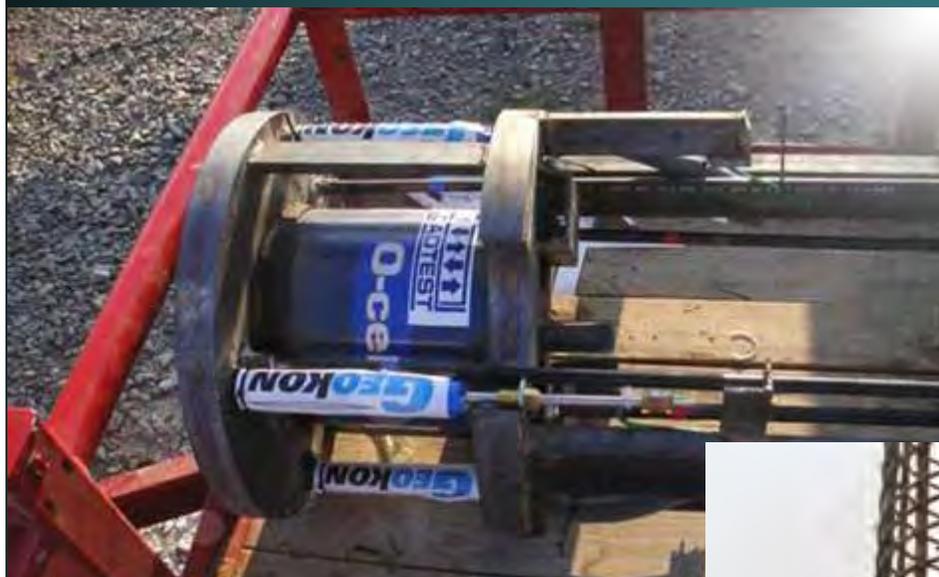
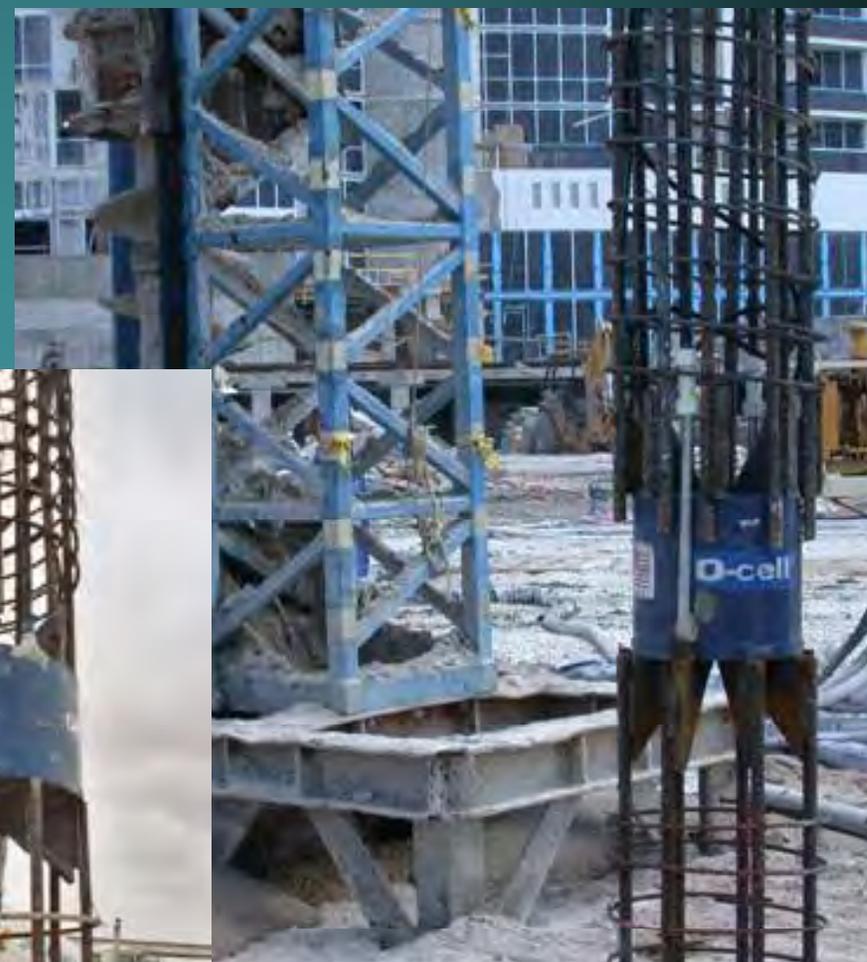
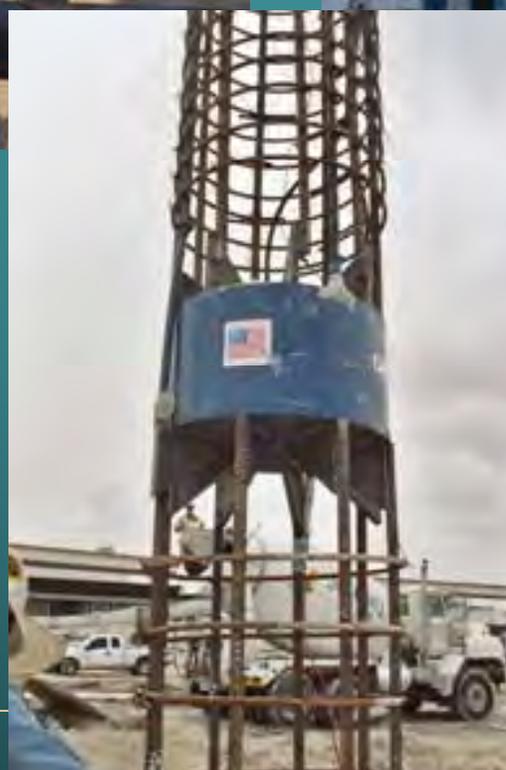
O-cells in CFA piles

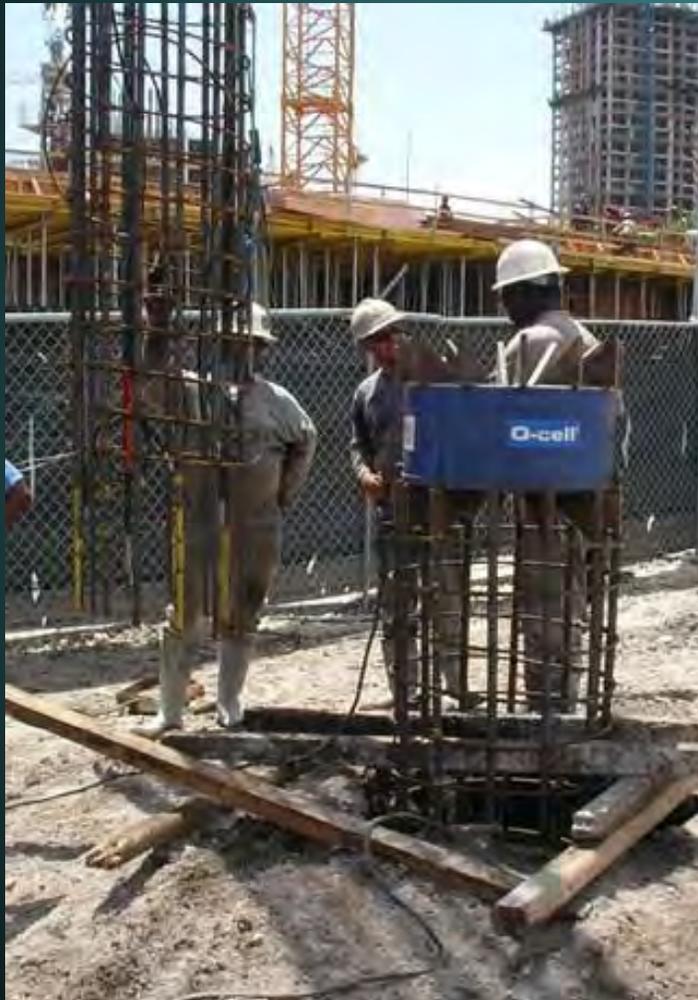
O-cells in CFA piles

Maximum size/loads tested to date

Pile Diameter [mm]	600	750	900	900
Pile Length [m]	38	40	35	36
O-cell Diameter [mm]	405	540	660	2x540
Mobilized Load [MN]	17.5	32	32	46

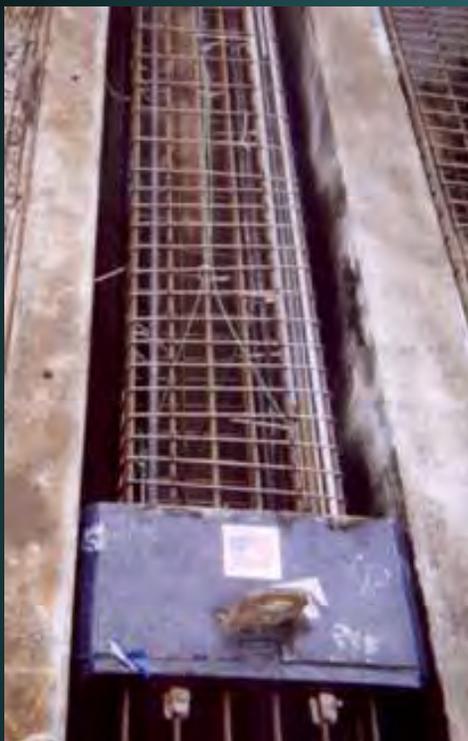
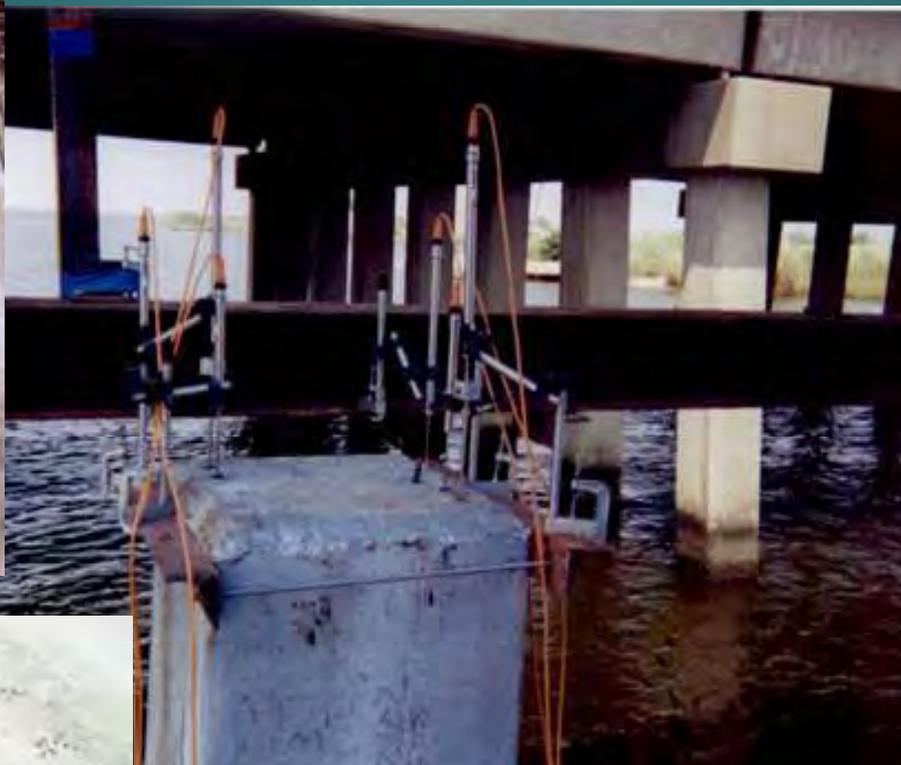
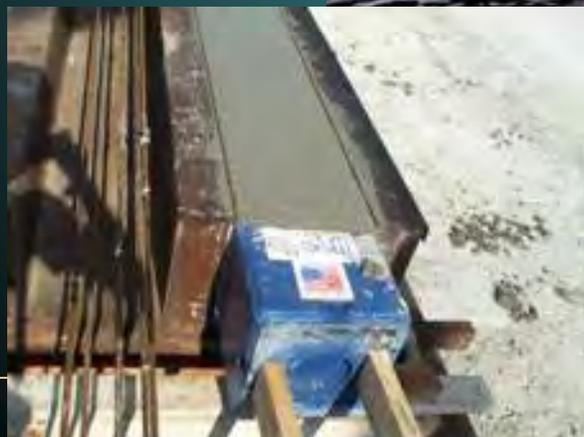
O-cells in Precast Piles

**Sizes tested
to date**

**Pile Section
[mm]
300 mm
450 mm
600mm
750 mm**
