29th Annual
Geotechnical Seminar

GEO-Omaha 2012

February 17, 2012
Scott Conference Center
Omaha, Nebraska

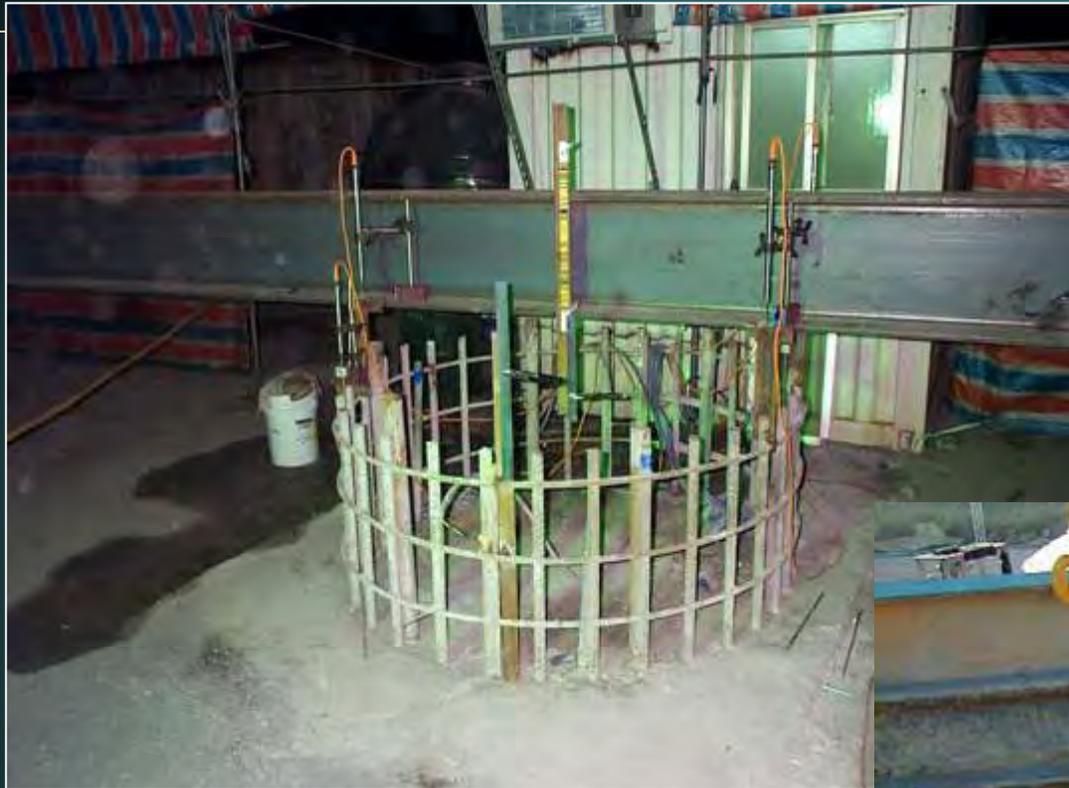
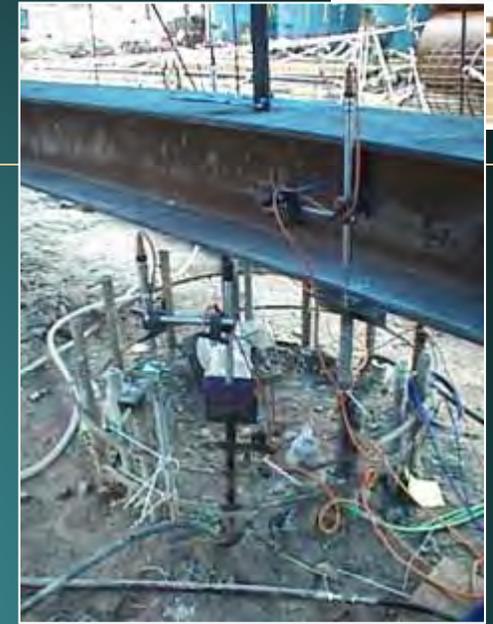
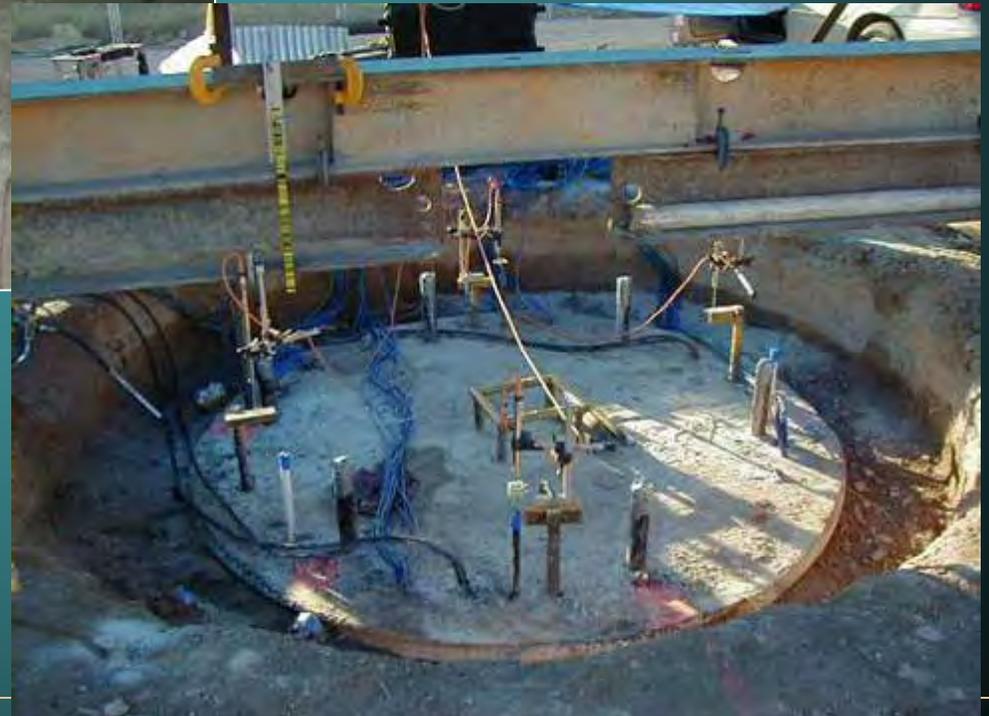
Test Setups

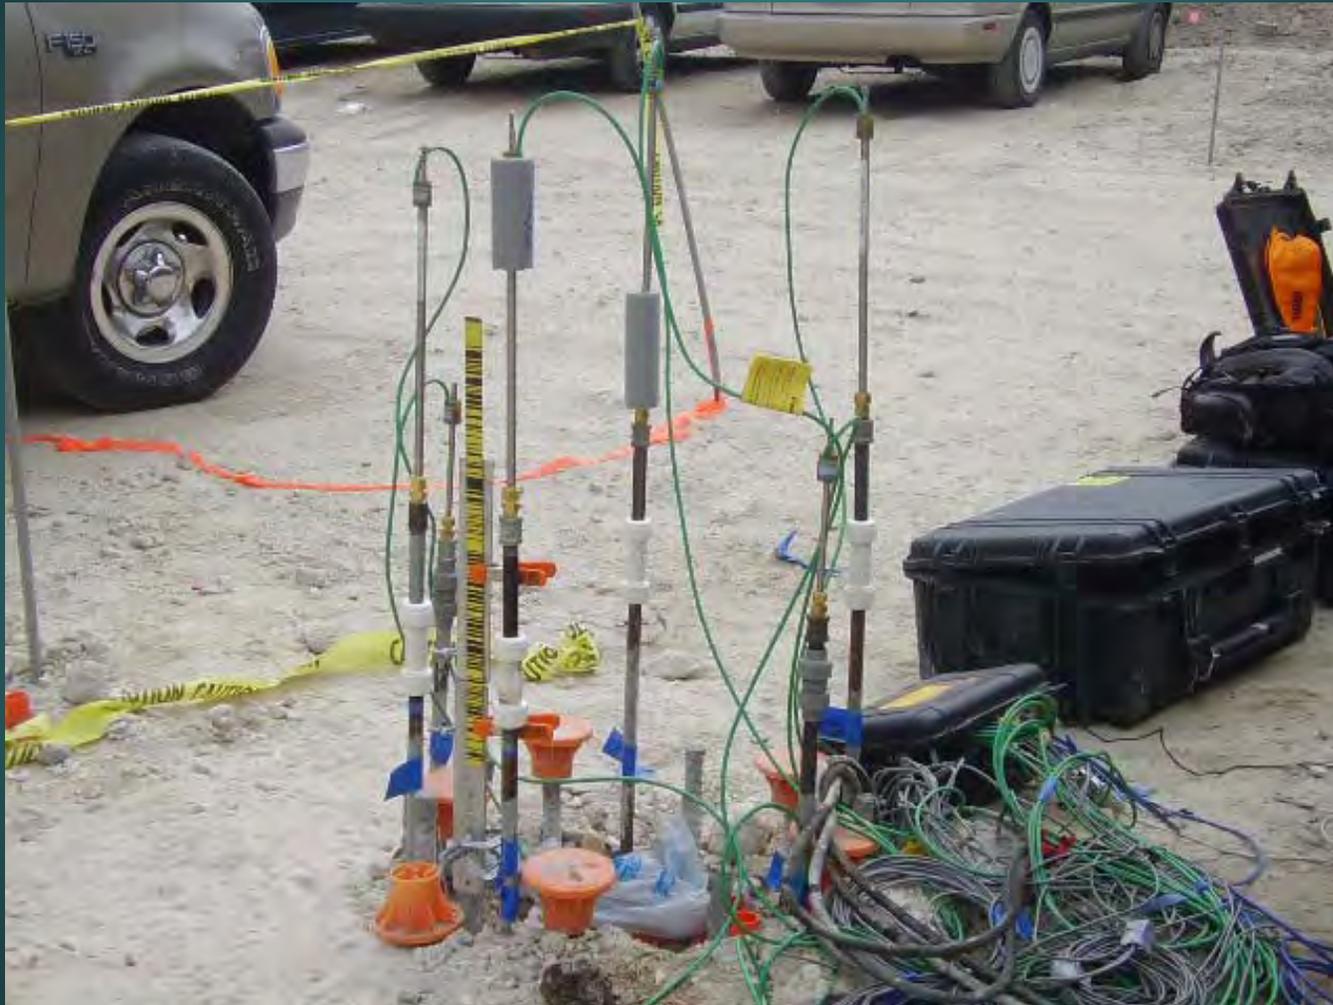
Modern O-cell - No Reference Beams

**The contractor can demobilize, saving time and money
Accuracy actually improved (Sinnreich, Simpson, DFI Journal, 2009).**

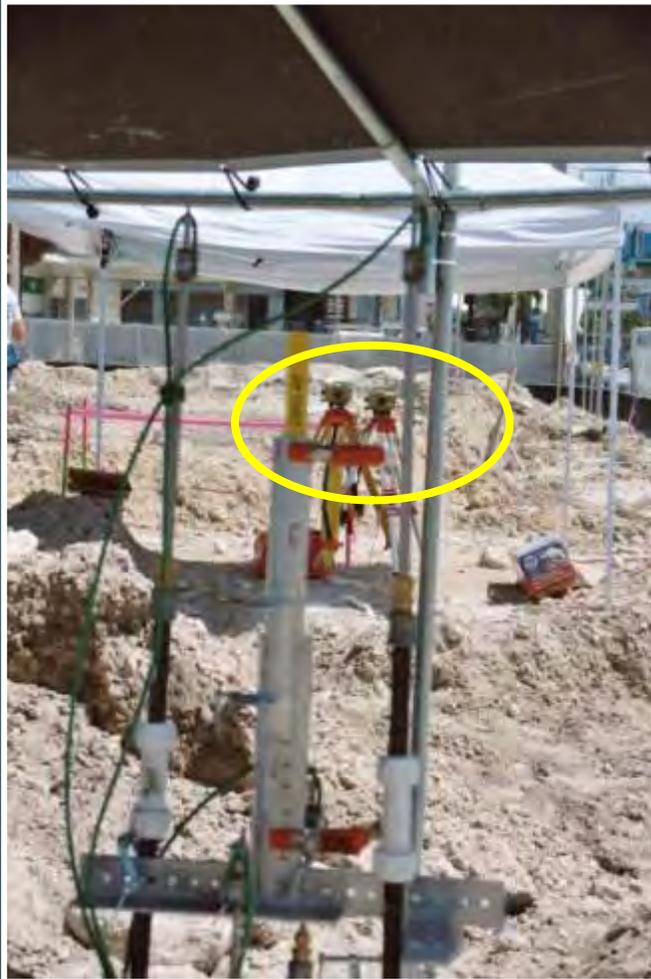
Modern O-cell Test Set up

Leica digital levels monitor top of shaft directly

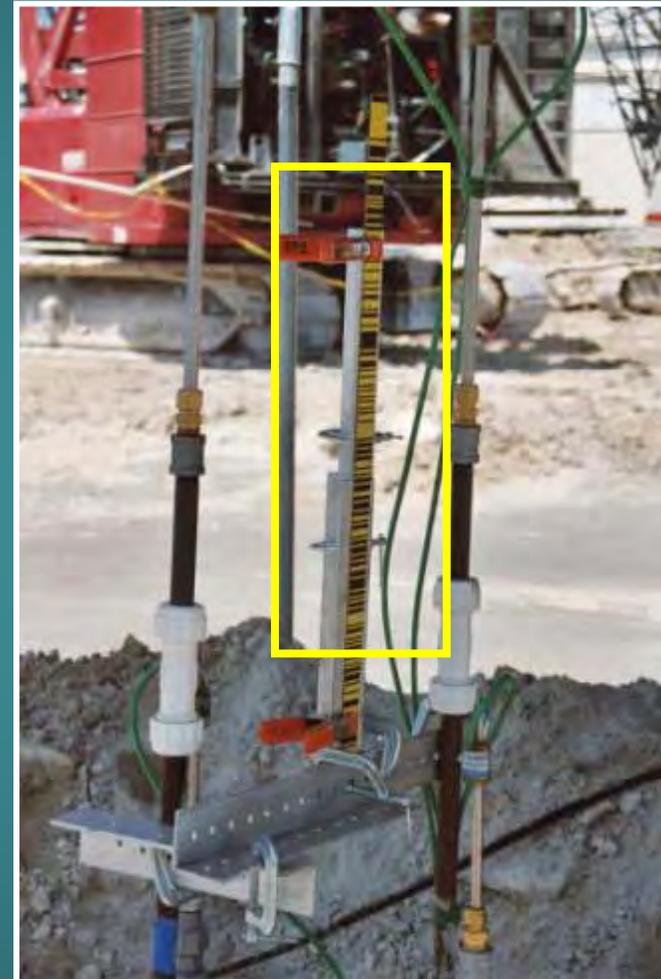
Leica digital levels target a staff on the top of shaft

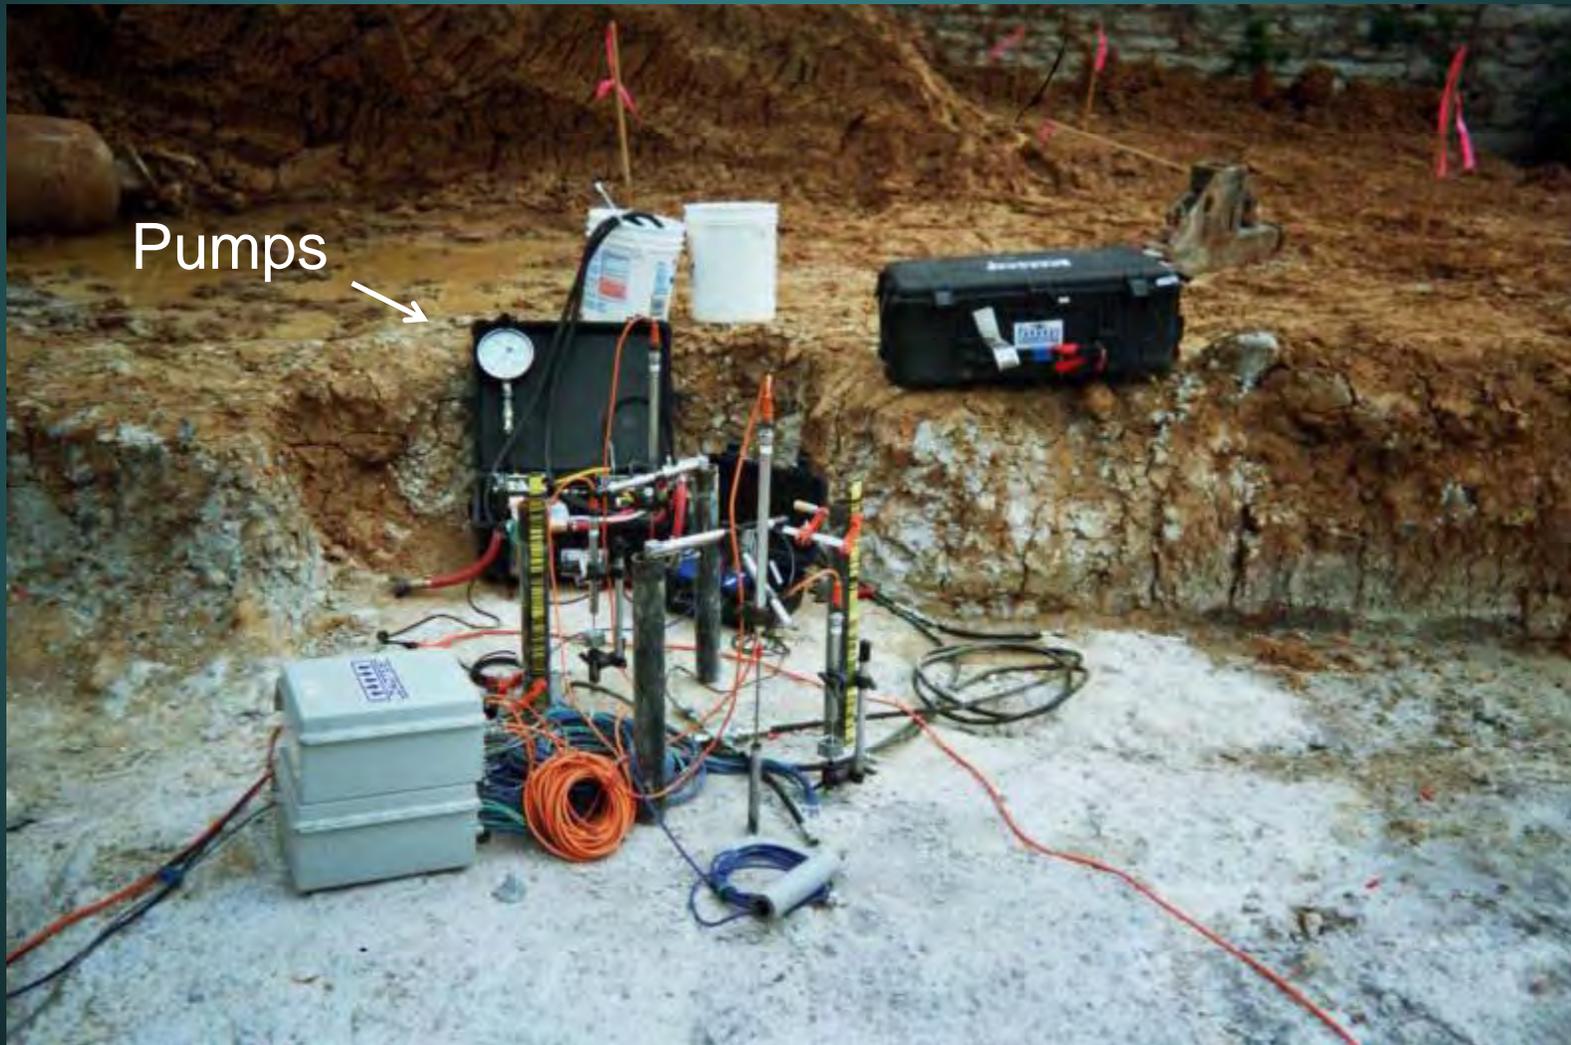
Complete Test Setup

Pumps

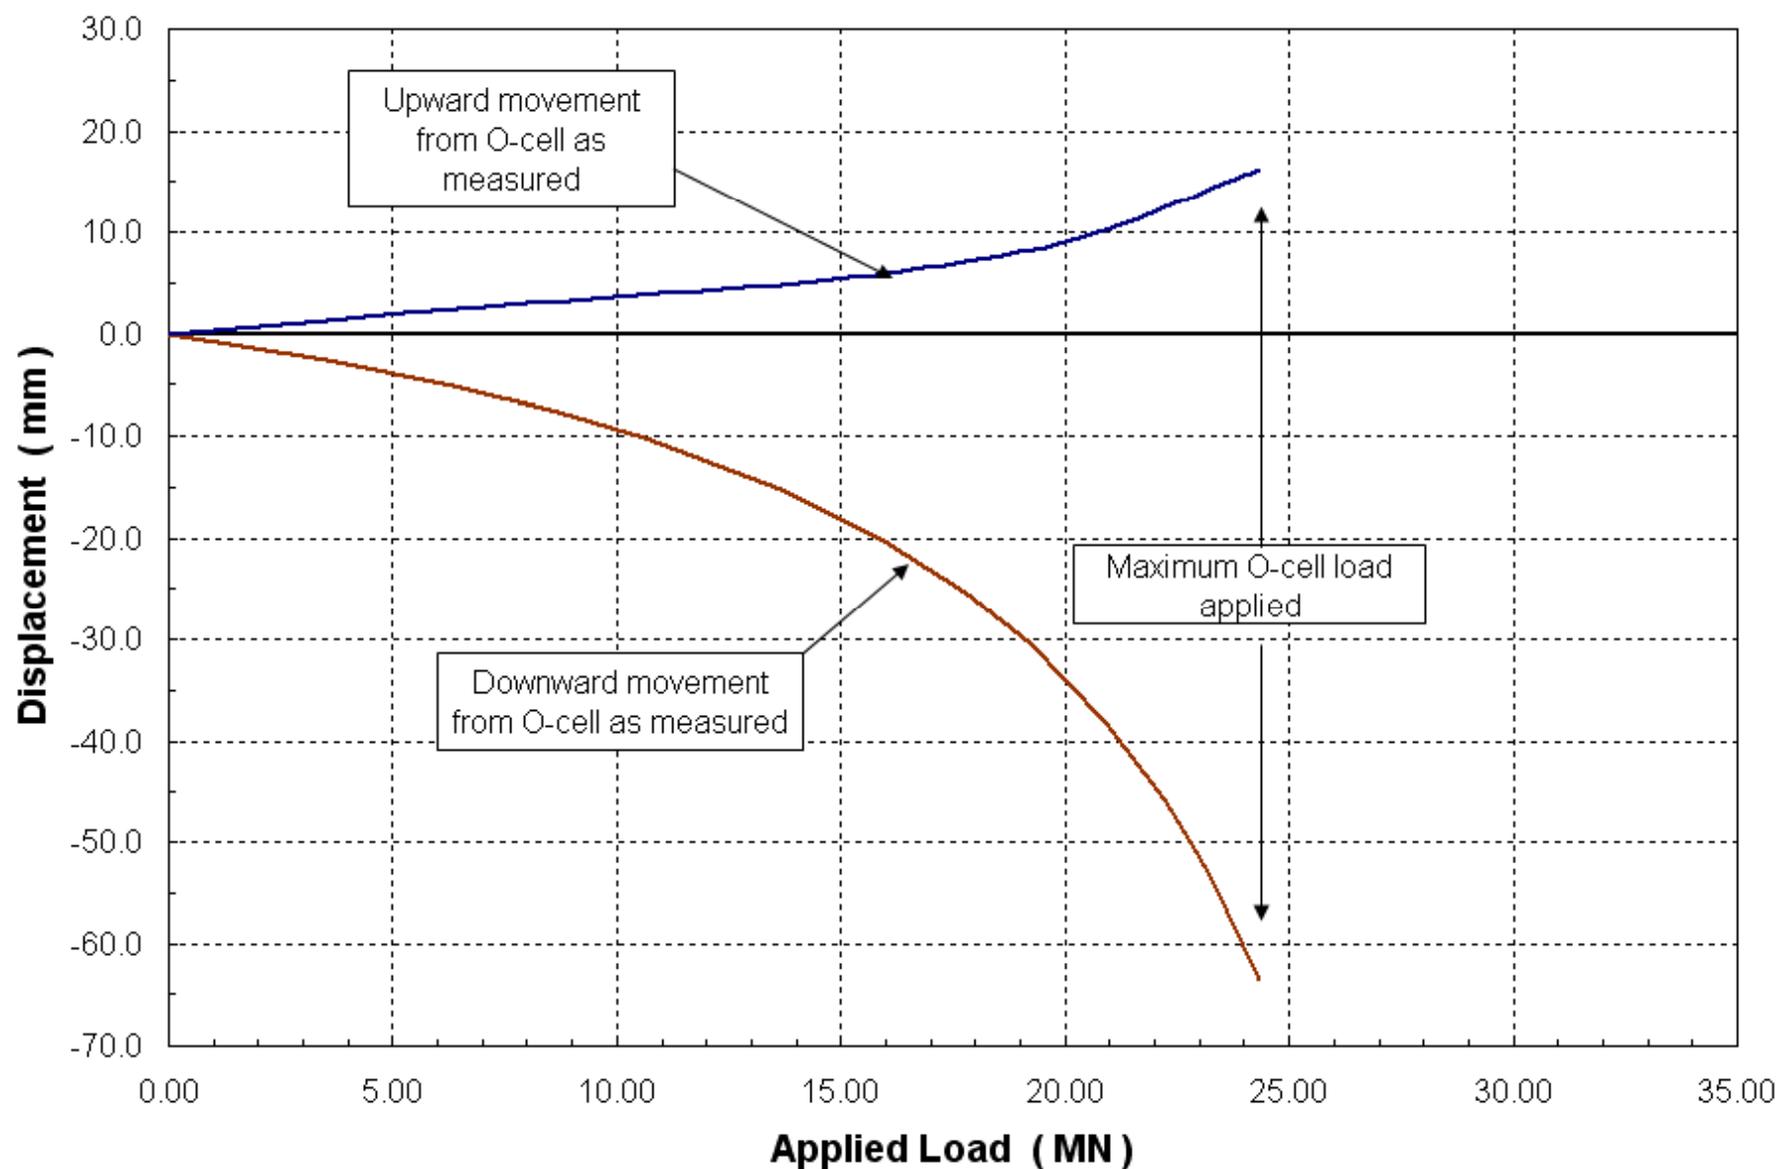
Typical O-cell Test Result

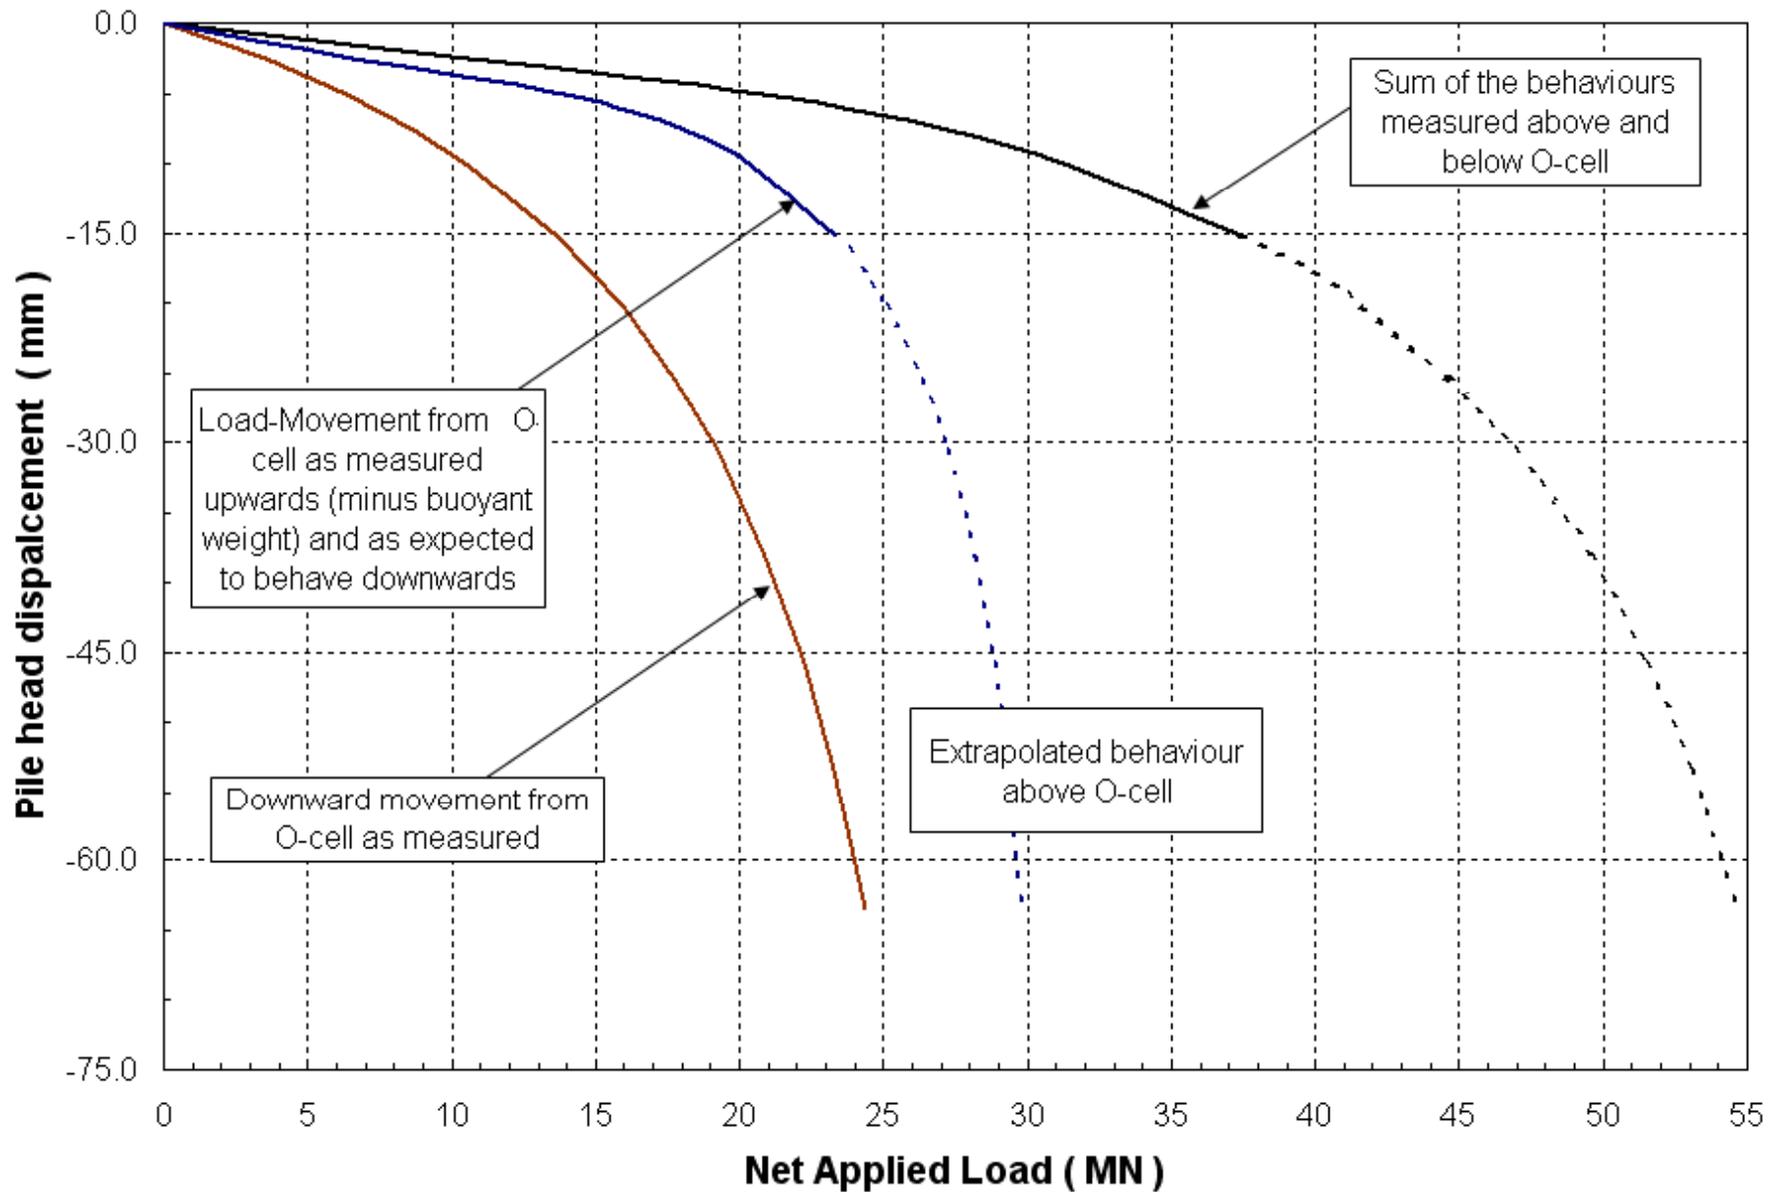
Equivalent Top-Load Curve

- **Shaft preselected**
- **Maximum load limited by weaker of end bearing or side shear (use multi-level)**
- **Top of pile not structurally tested**
- **Must construct equivalent top load movement curve**
 - use the sum of measured behavior
 - use the sum of modeled behavior
 - use from finite element, t-z approach

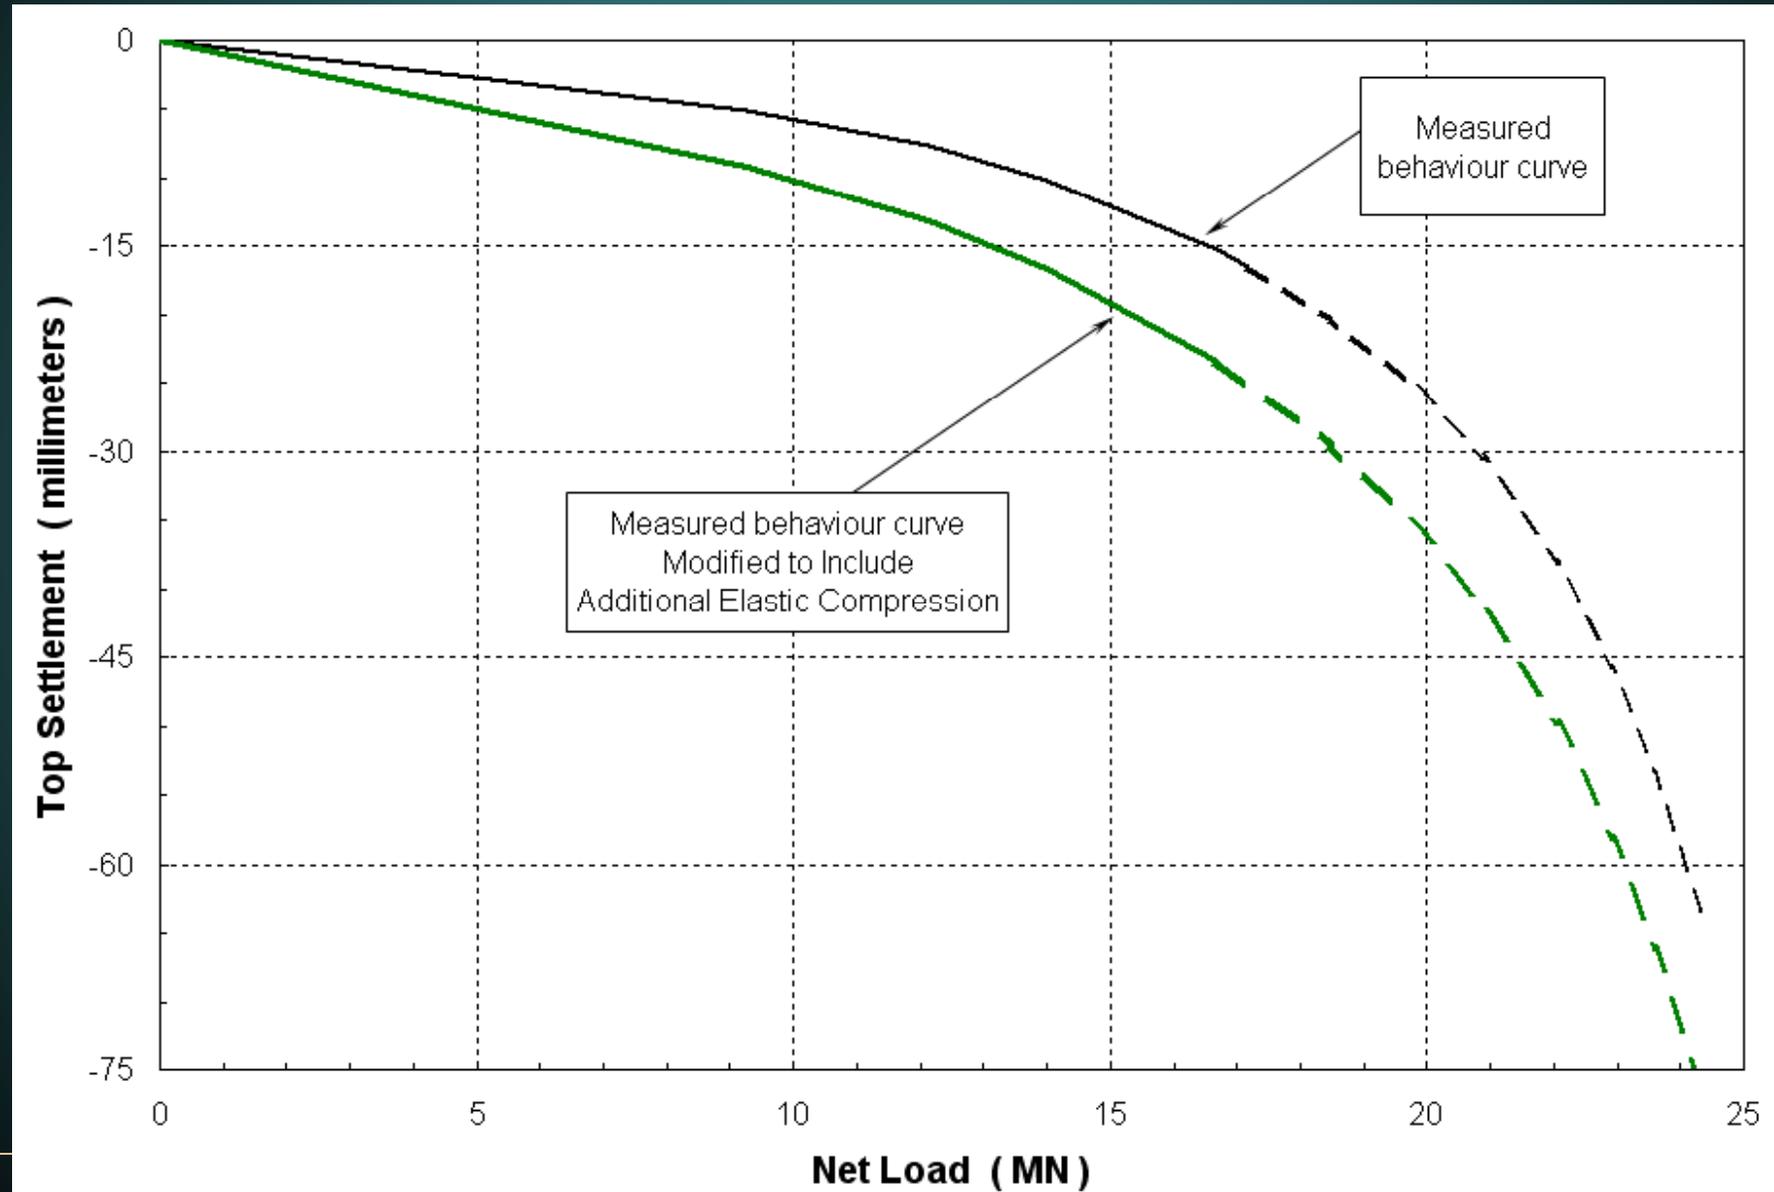
Equiv. Top-Load + Elastic Shortening

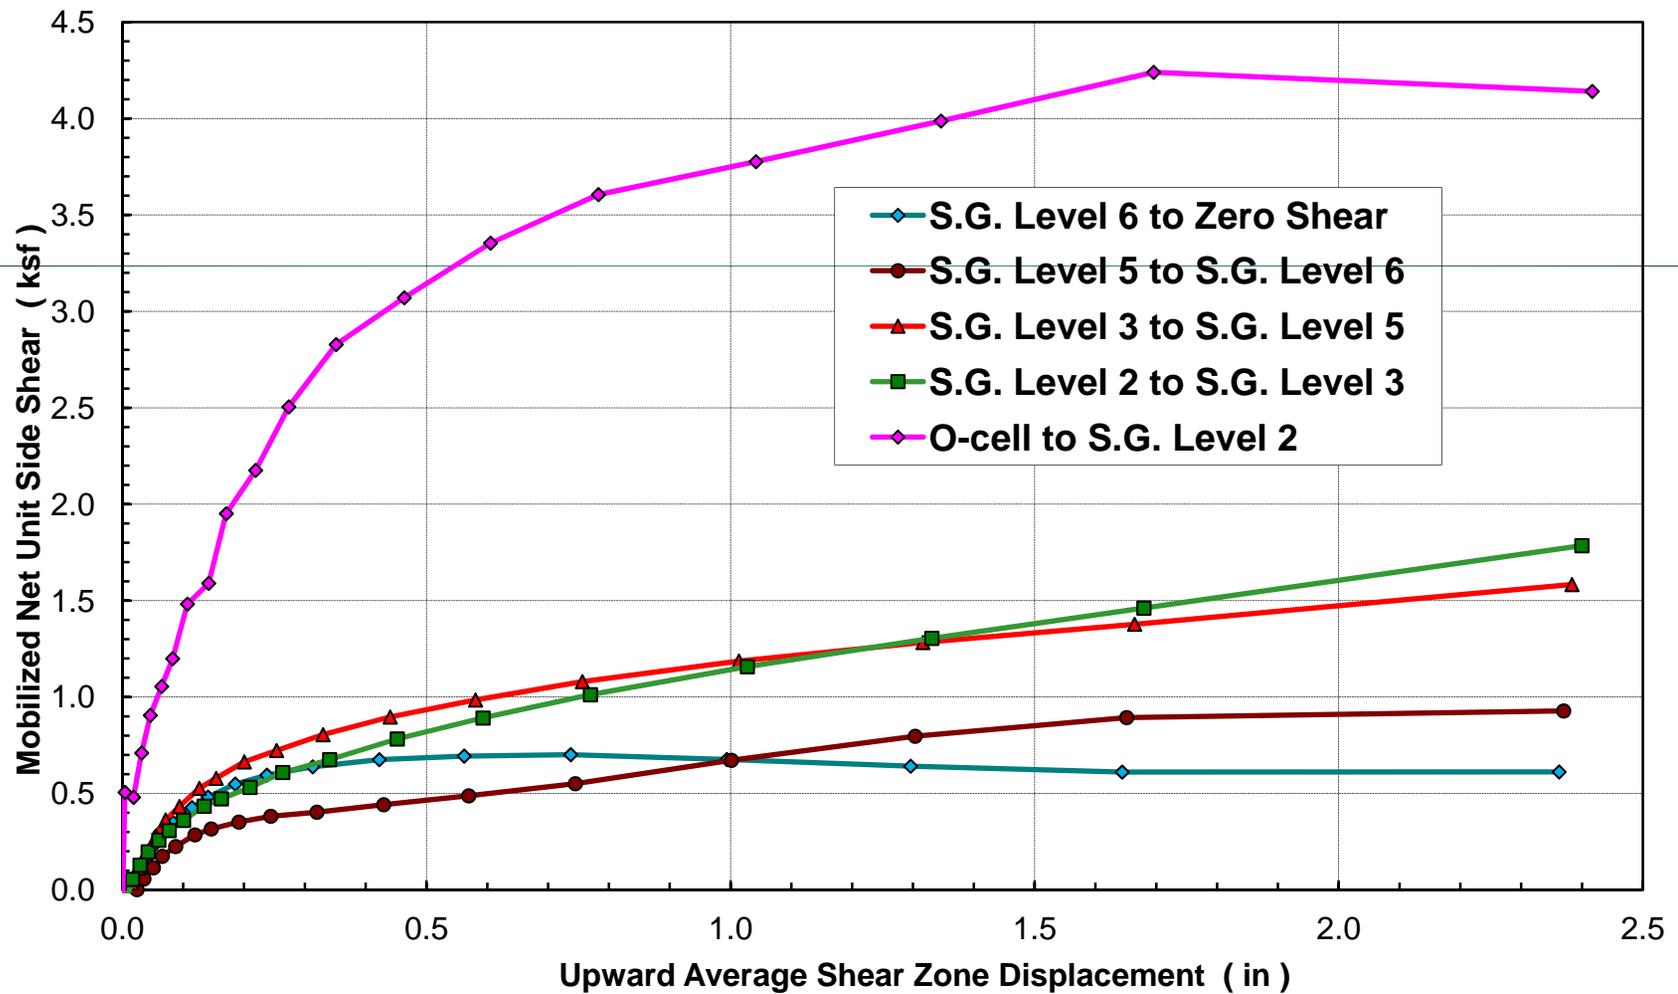
Side Shear from Strain Gauges

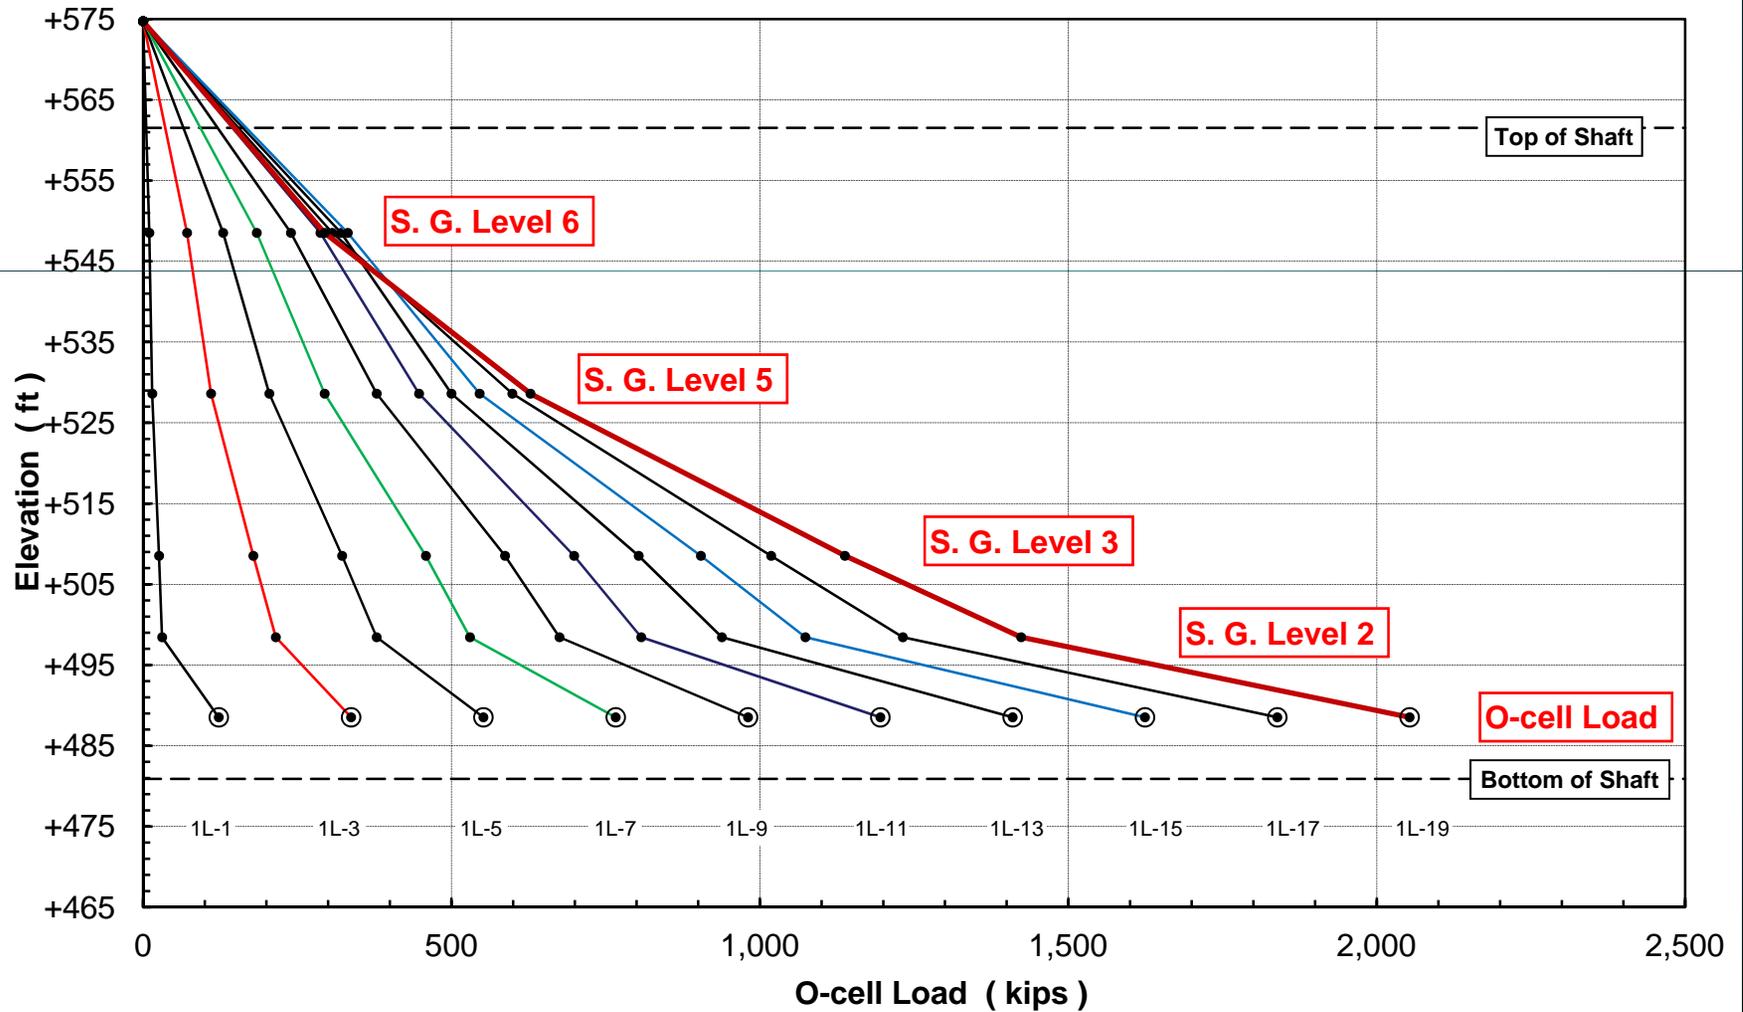
Load Transfer Diagram

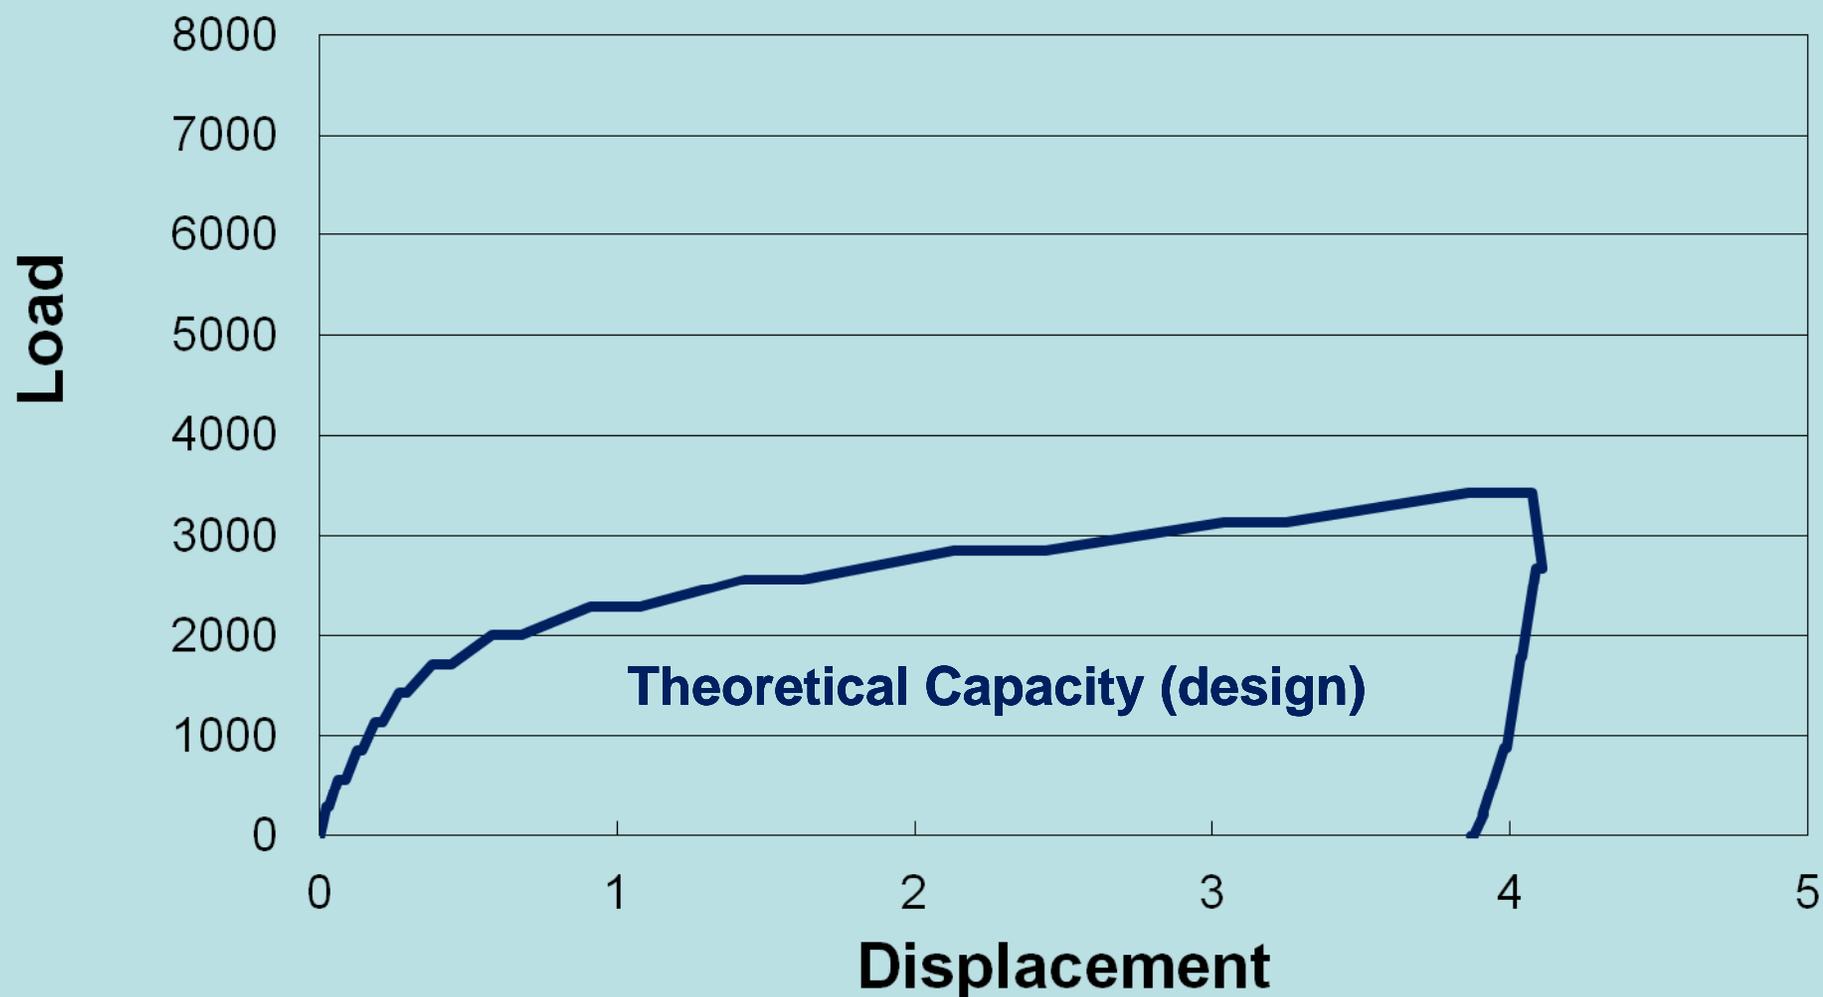
Design Capacity Estimate

- Cost of Foundation Design Cost \$4 Million
- \$40,000 in engineering and testing included
- \$200,000 load test program proposed
- Simplified foundation (uniform site and depth)
 - $N = 100$ shafts
 - Length = 100 feet deep, $R = \phi R_N$
 - Unit Cost = \$400 per foot
 - Total Cost = \$4 million
- $\phi = 0.55$ before load test, $\phi = 0.70$ after load test
- After load test, R increases by 27% ($\phi = 0.55 \rightarrow 0.70$)

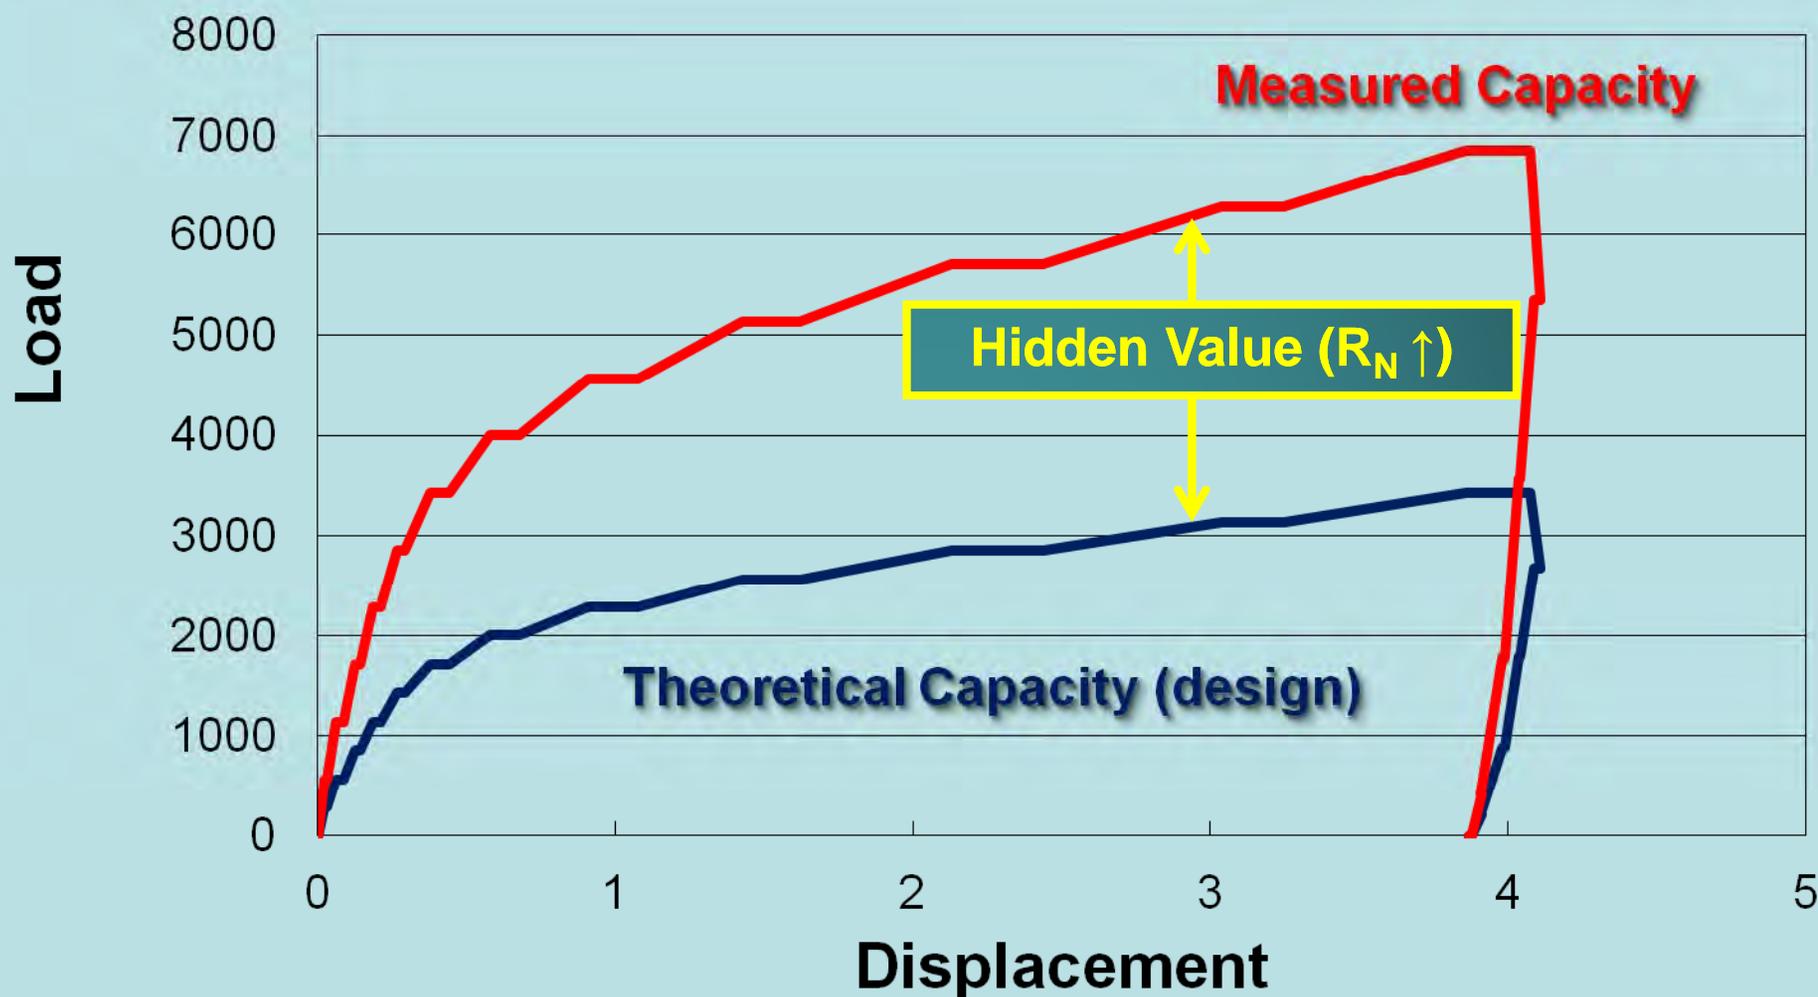
Advantage of Load Testing

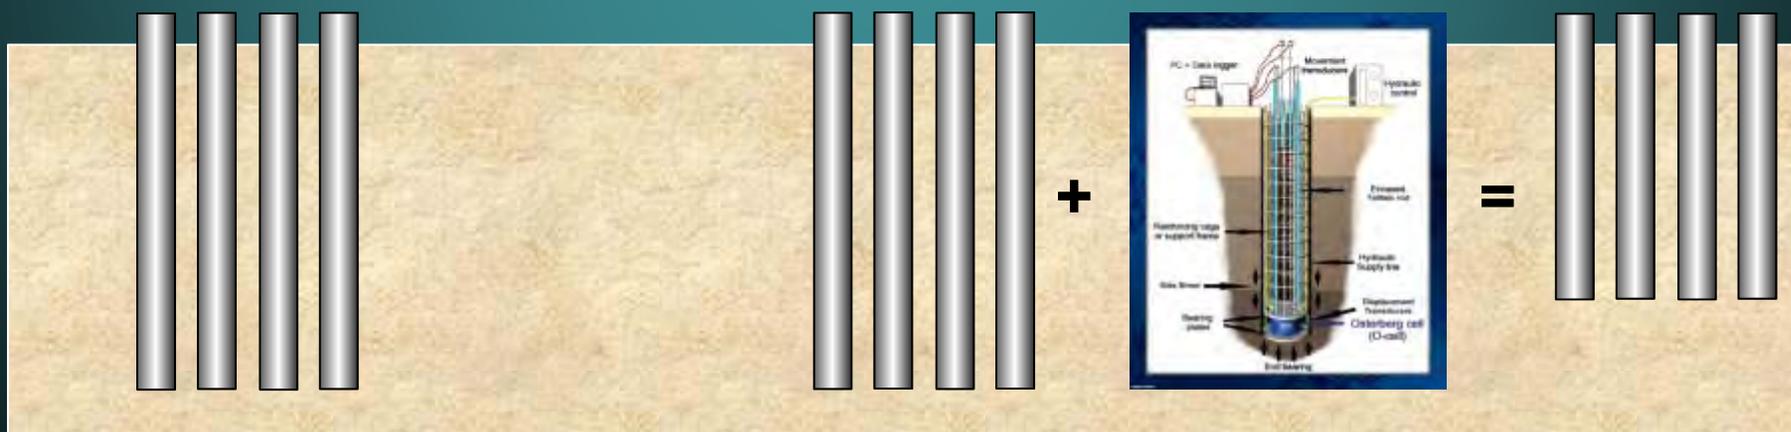
Foundation System 2

Includes Basic Engineering, Site Investigation and O-cell Testing

LRFD, $\phi = 0.60$
Actual Ultimate
Cost = \$2,640,000

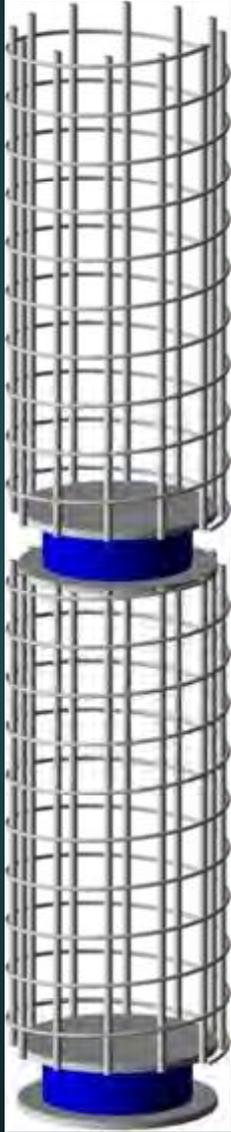
Multilevel testing

**Test is performed in stages
to fully mobilize capacity**

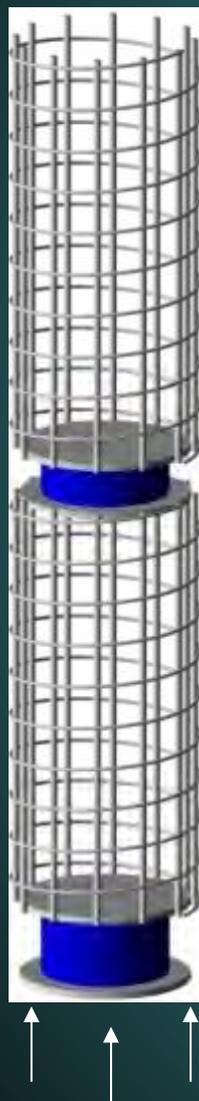
Multilevel testing Stage 1

Mobilize End Bearing

Middle cell closed

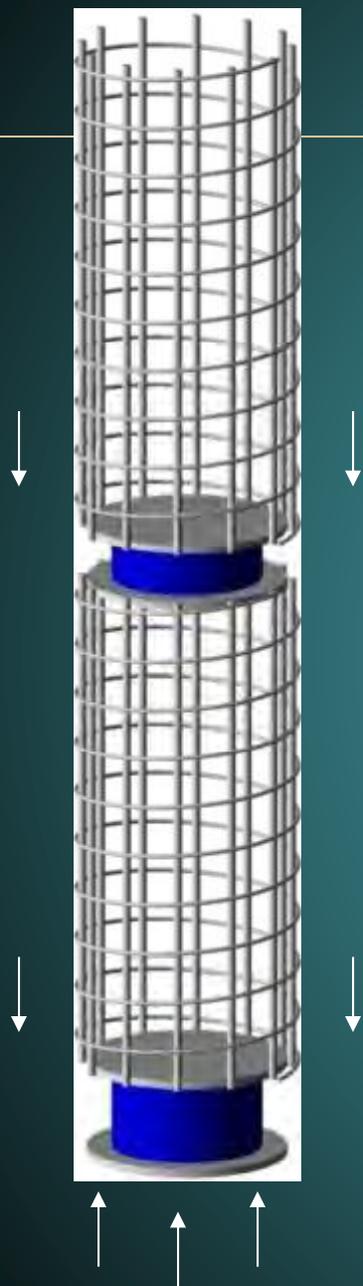
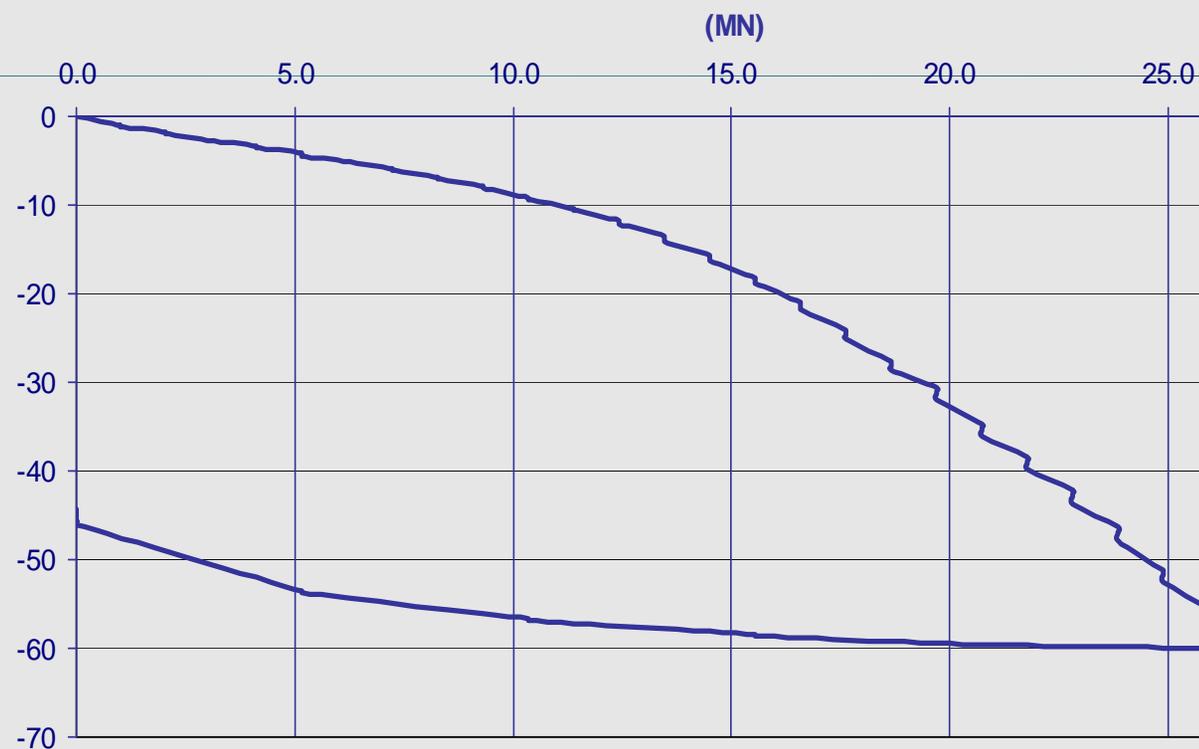
Multilevel testing Stage 1

Downward movement below bottom O-Cell

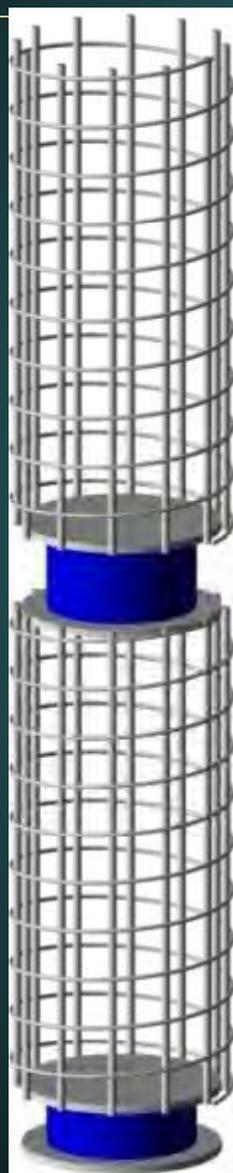
Multilevel testing Stage 2

**Mobilize Side Shear
Between O-cells**

Middle cell pressurized
