29th Annual
Geotechnical Seminar

GEO-Omaha 2012

February 17, 2012
Scott Conference Center
Omaha, Nebraska

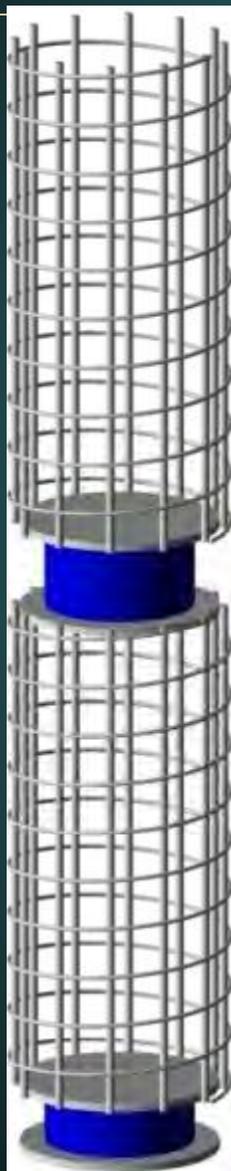
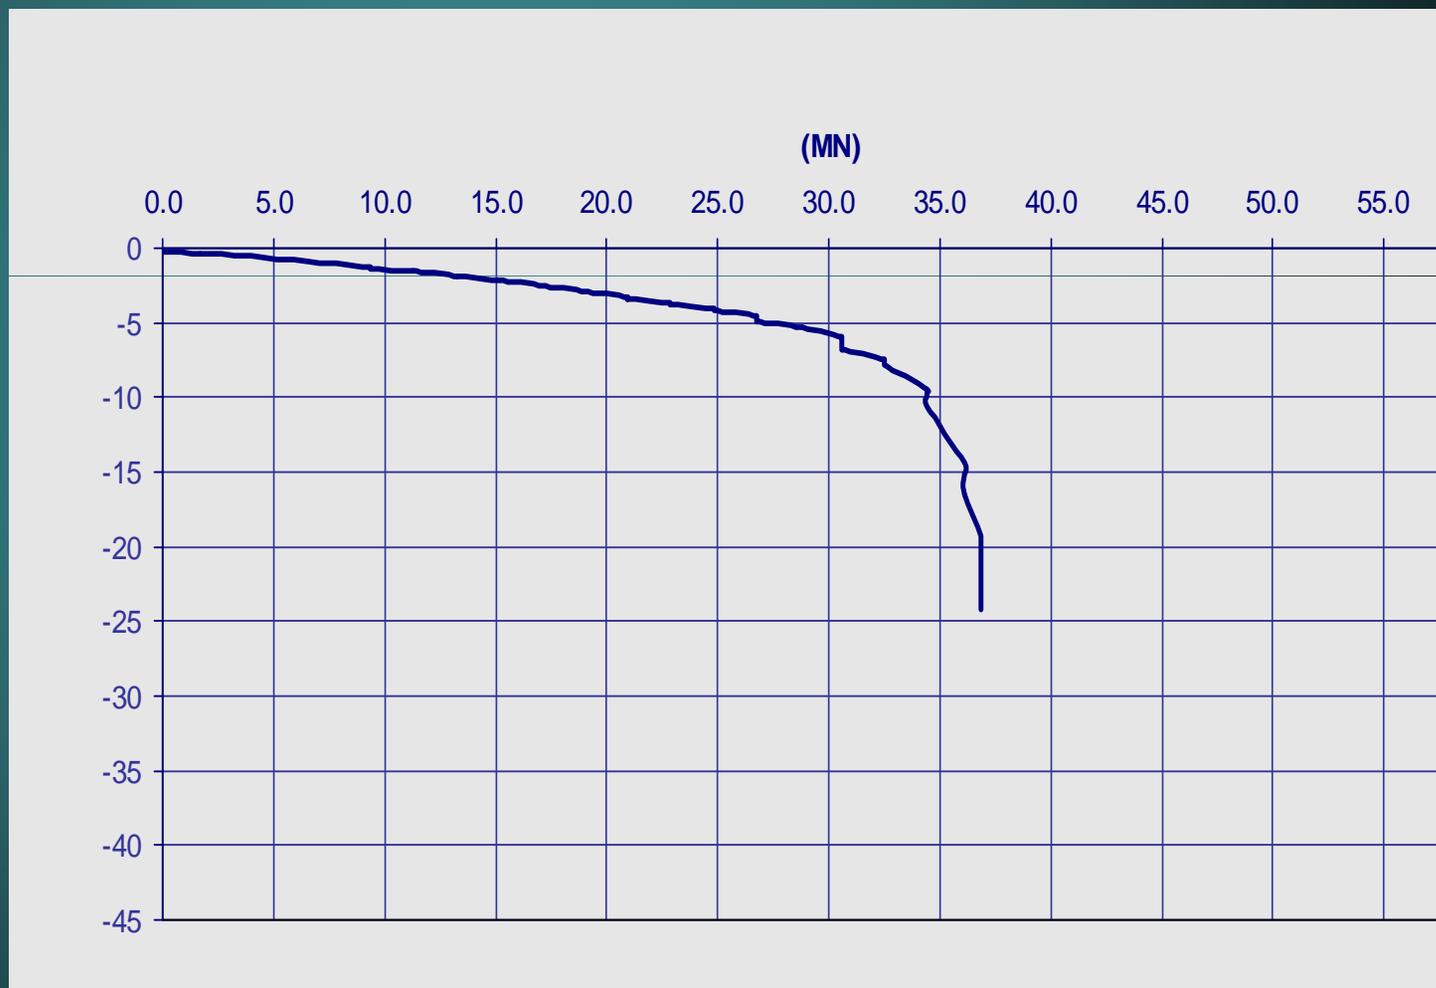
Multilevel testing Stage 2

Downward movement below middle O-Cell

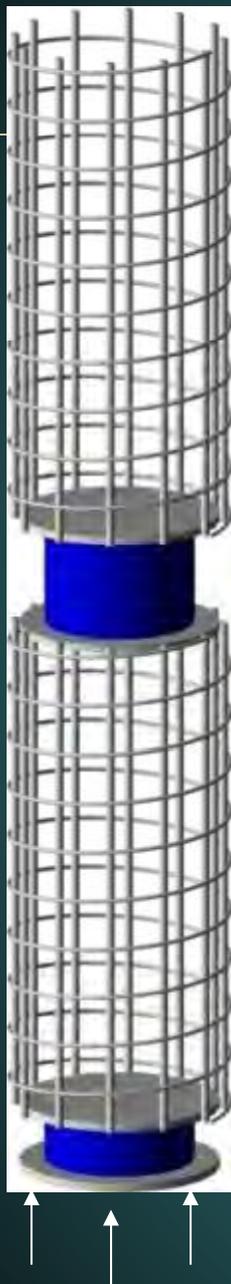
Multilevel testing Stage 3

**Mobilize Side Shear
Above Middle O-cell**

Middle cell pressurized

Lower cell hydraulically closed

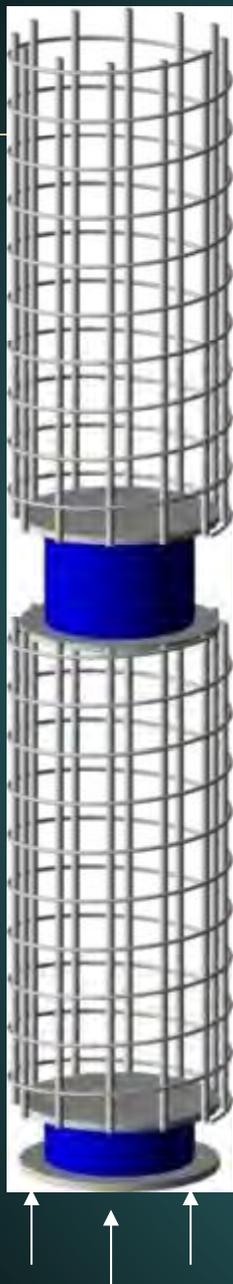
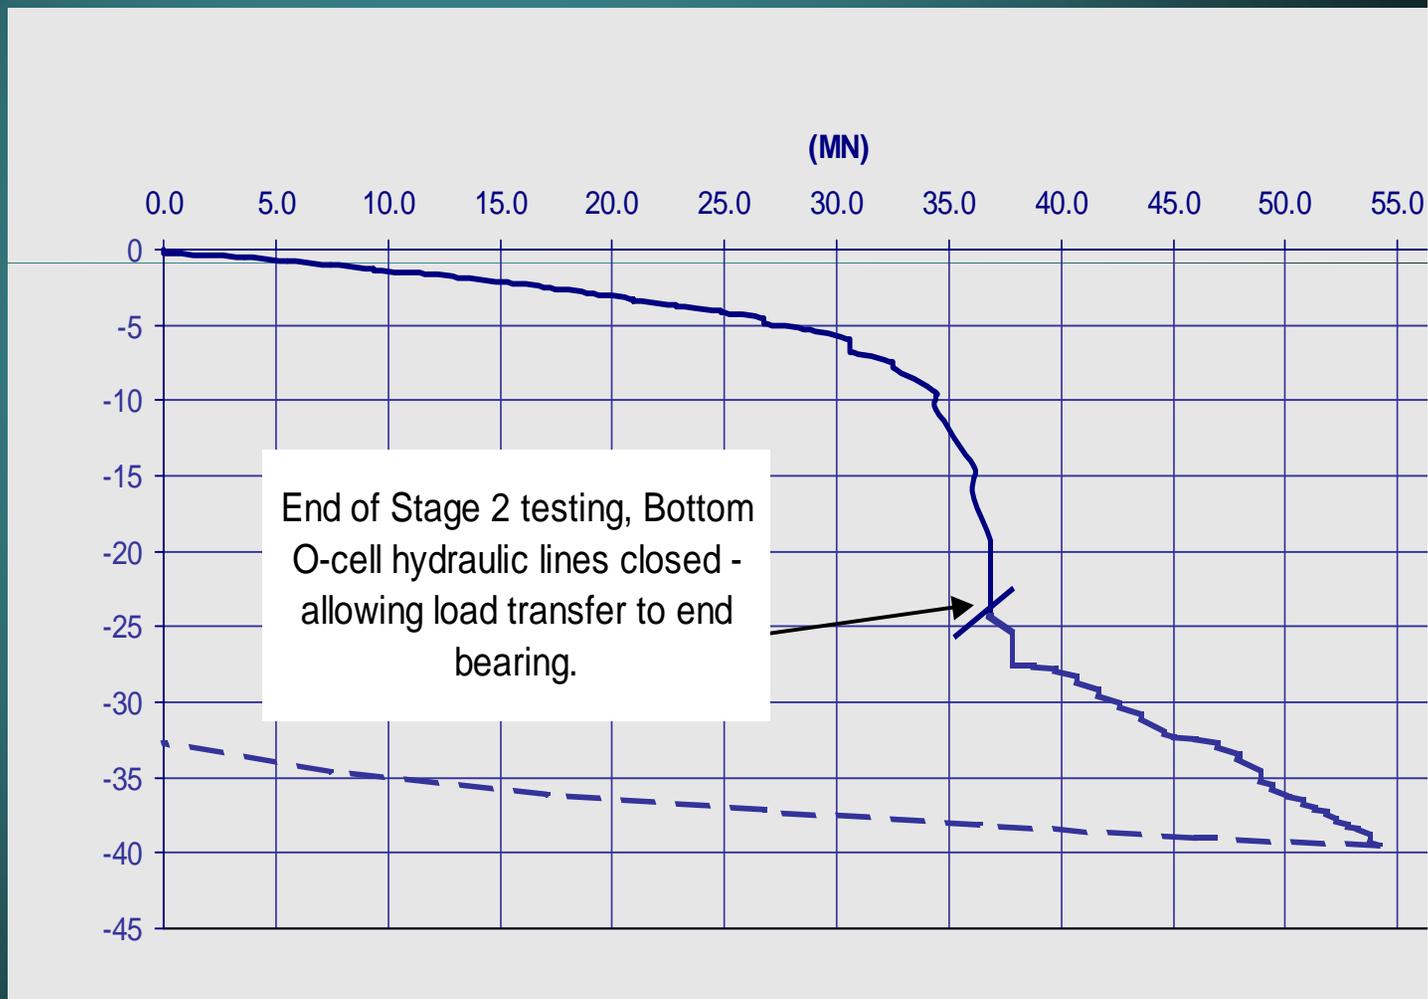
Multilevel testing Stage 3

Downward movement below middle O-Cell

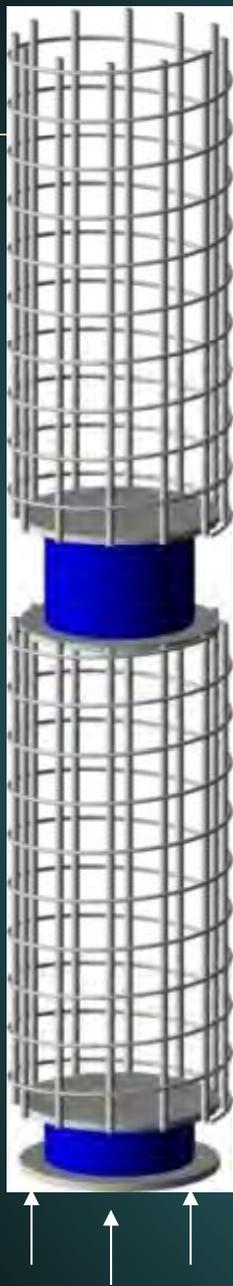
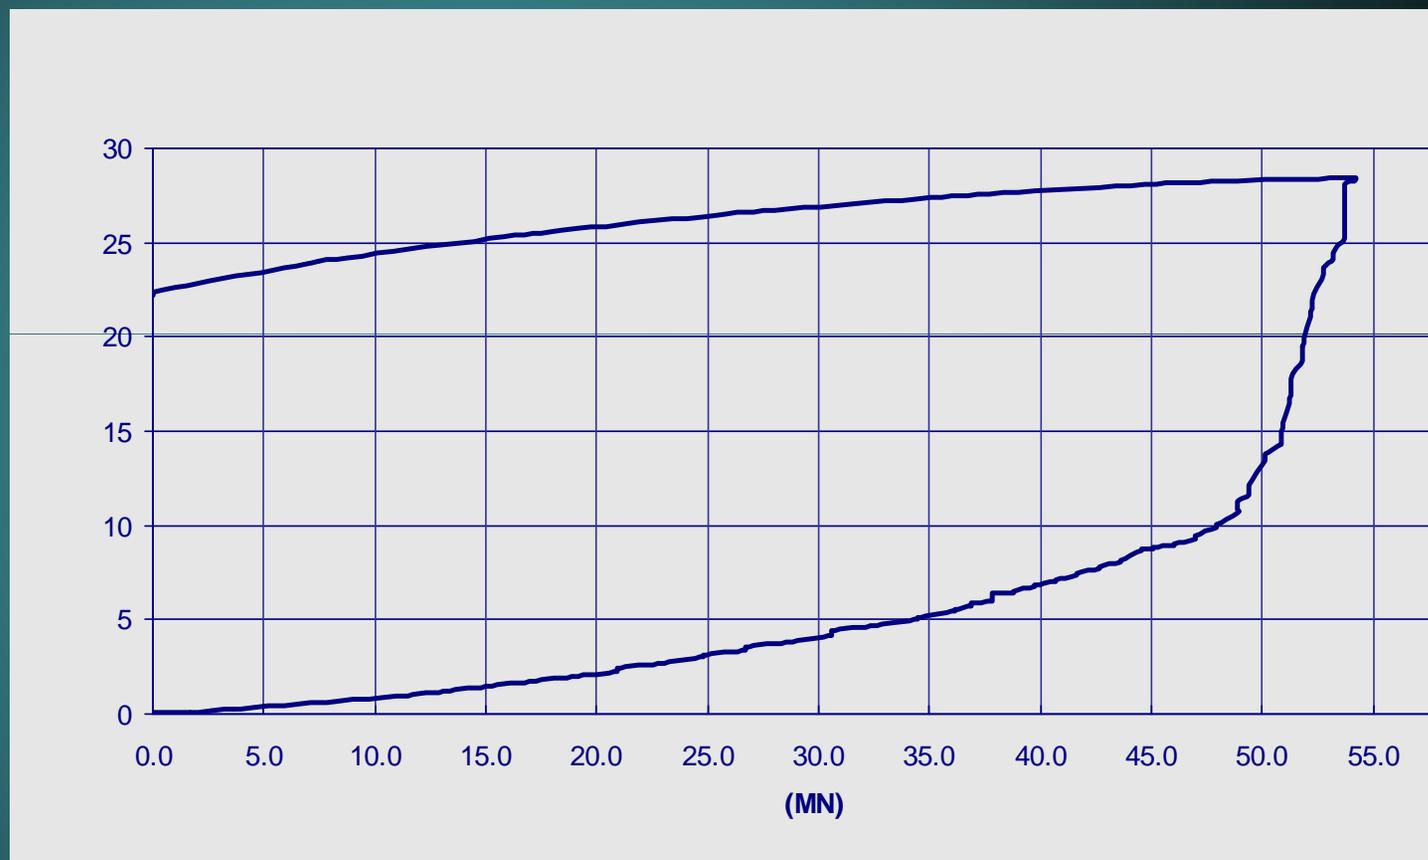
Multilevel testing Stage 3

Upward movement above middle O-Cell

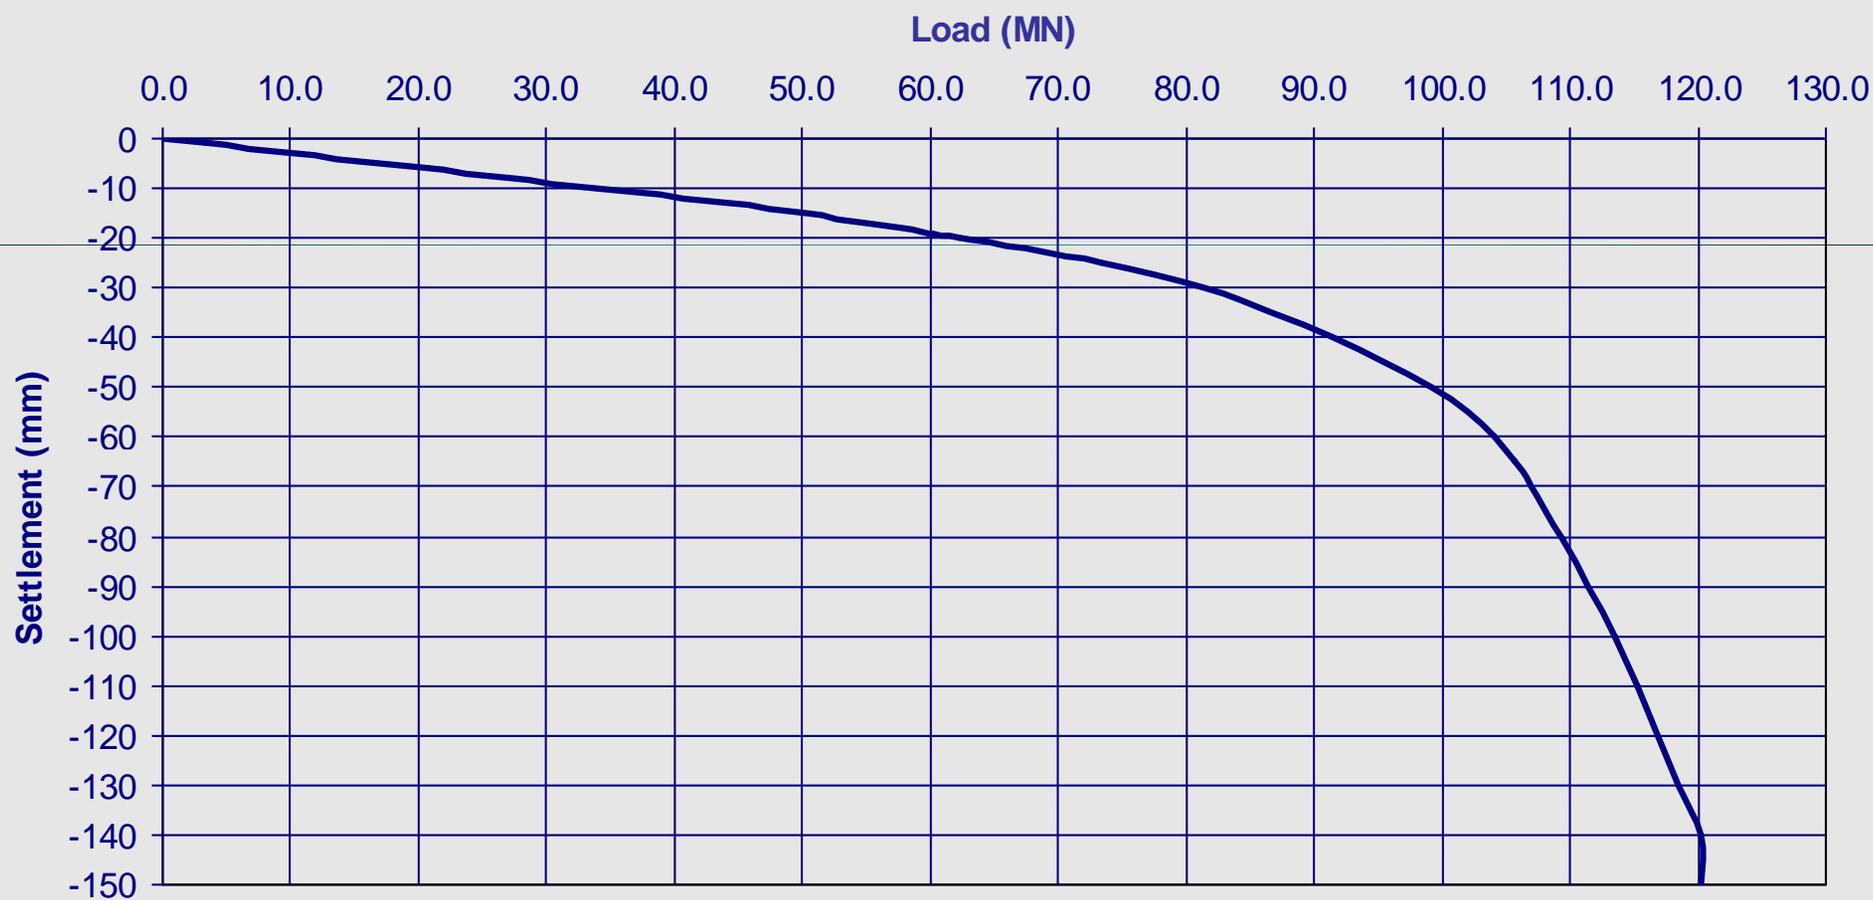
Equivalent top load-settlement curve

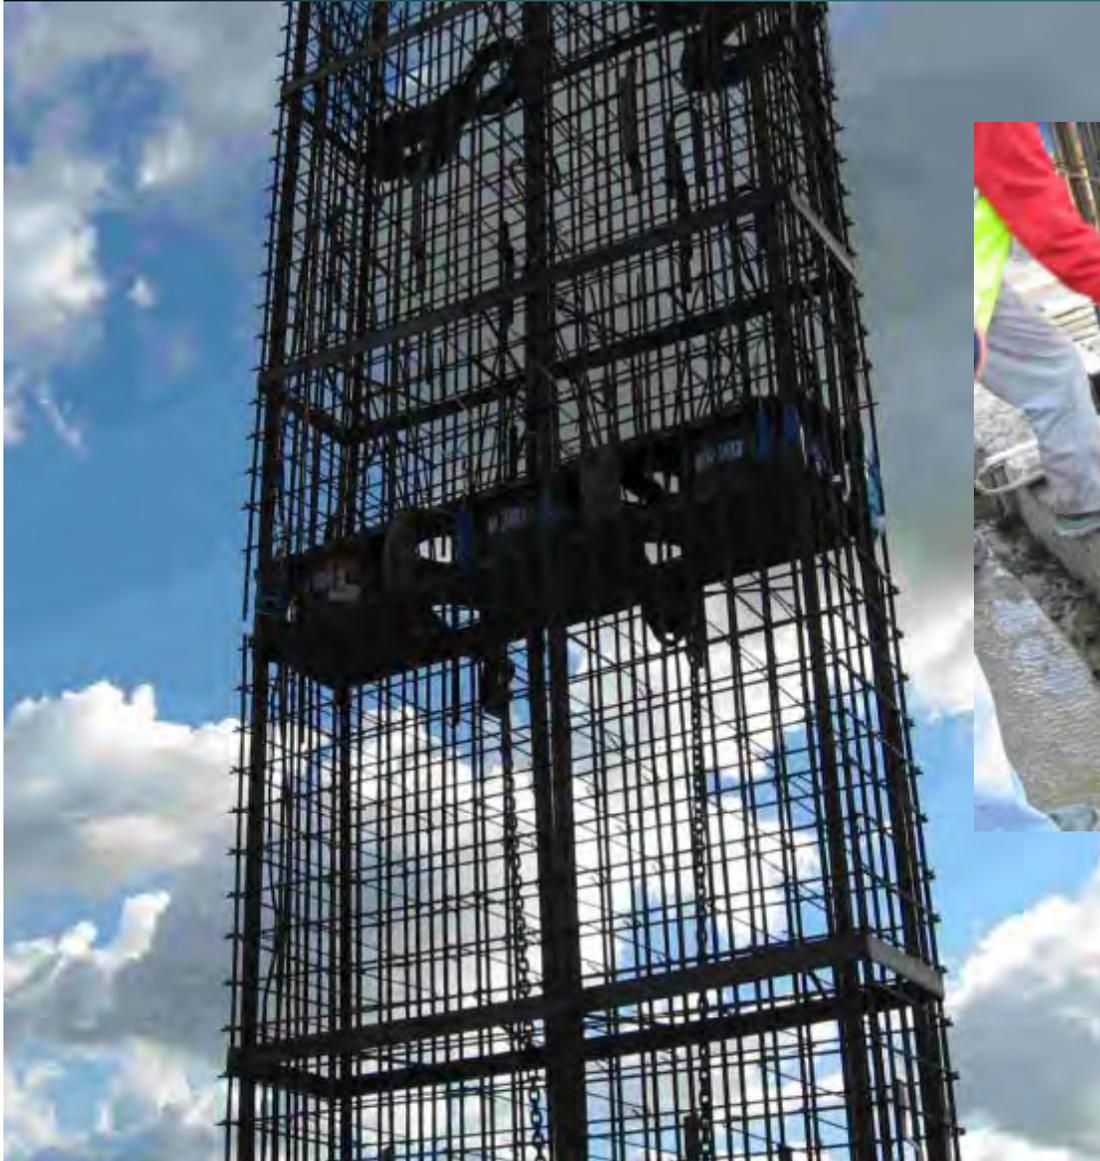
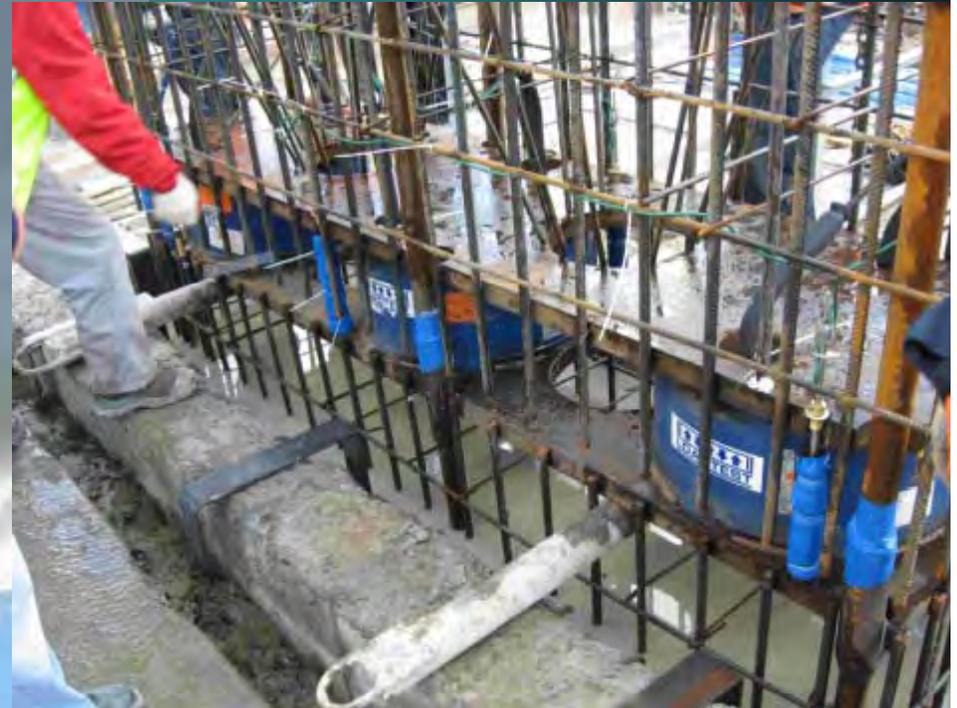
Barrettes - St. Petersburg, Russia

- 60 m deep
- 90 MN capacity

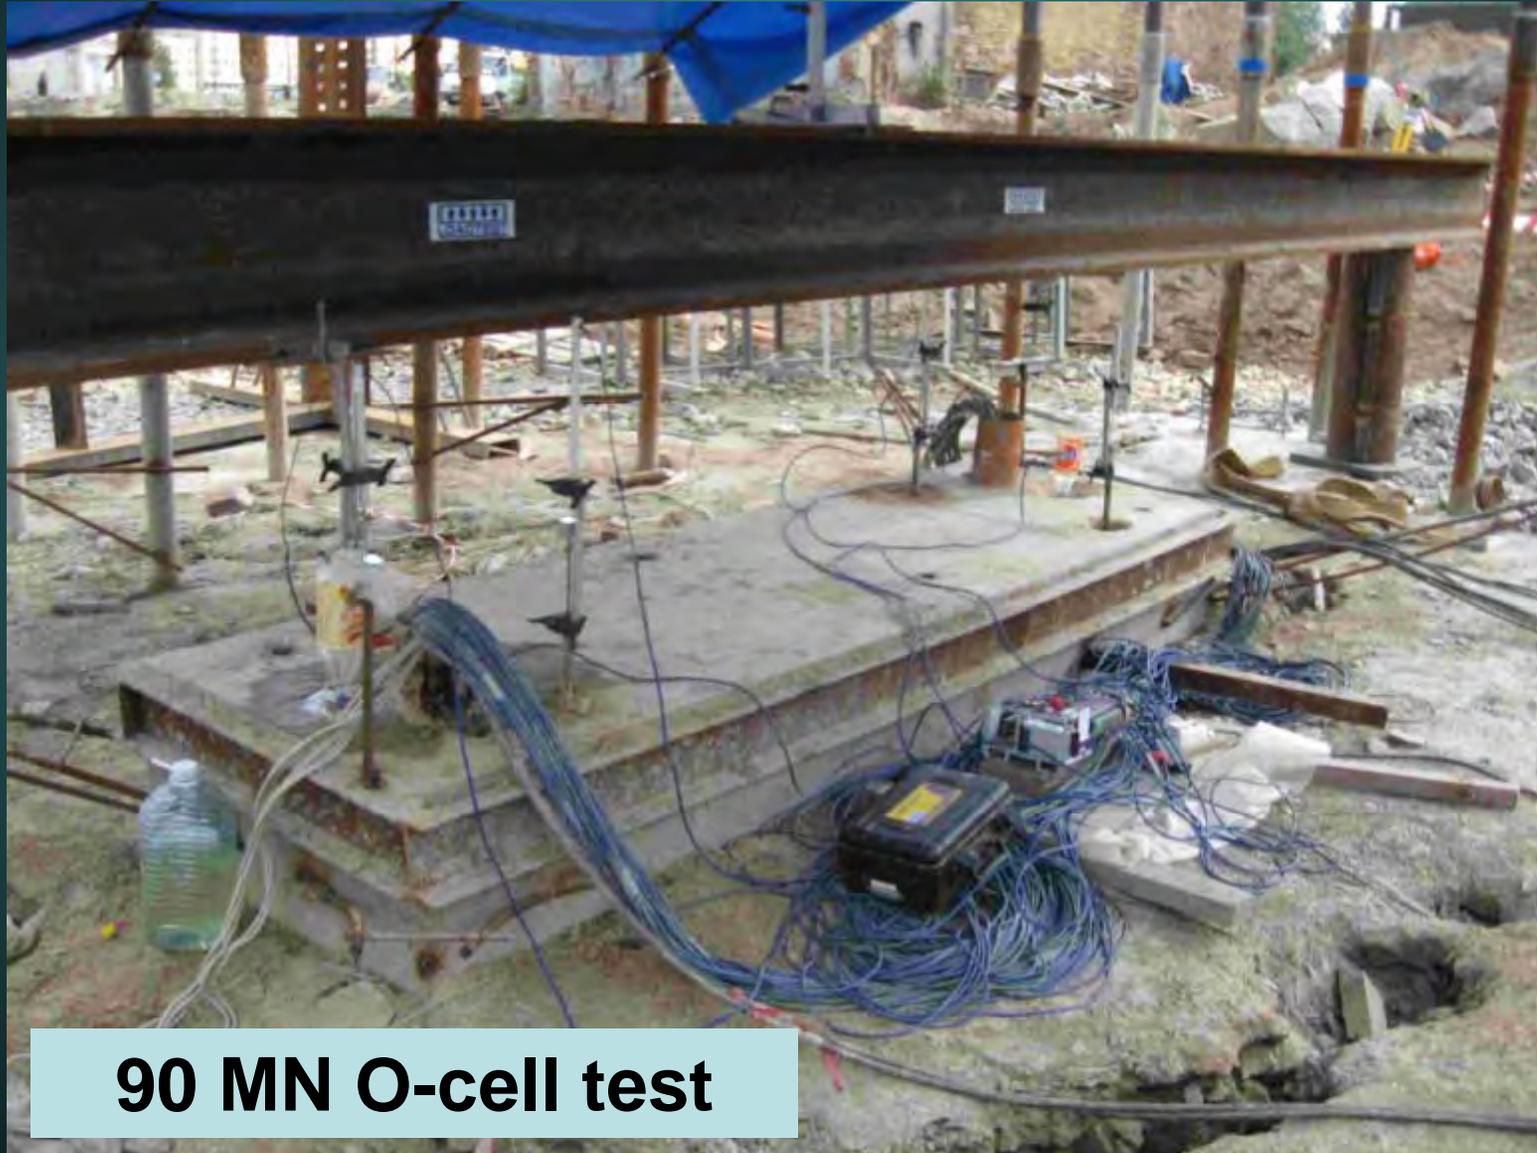
Barrettes - St. Petersburg, Russia

90 MN O-cell test

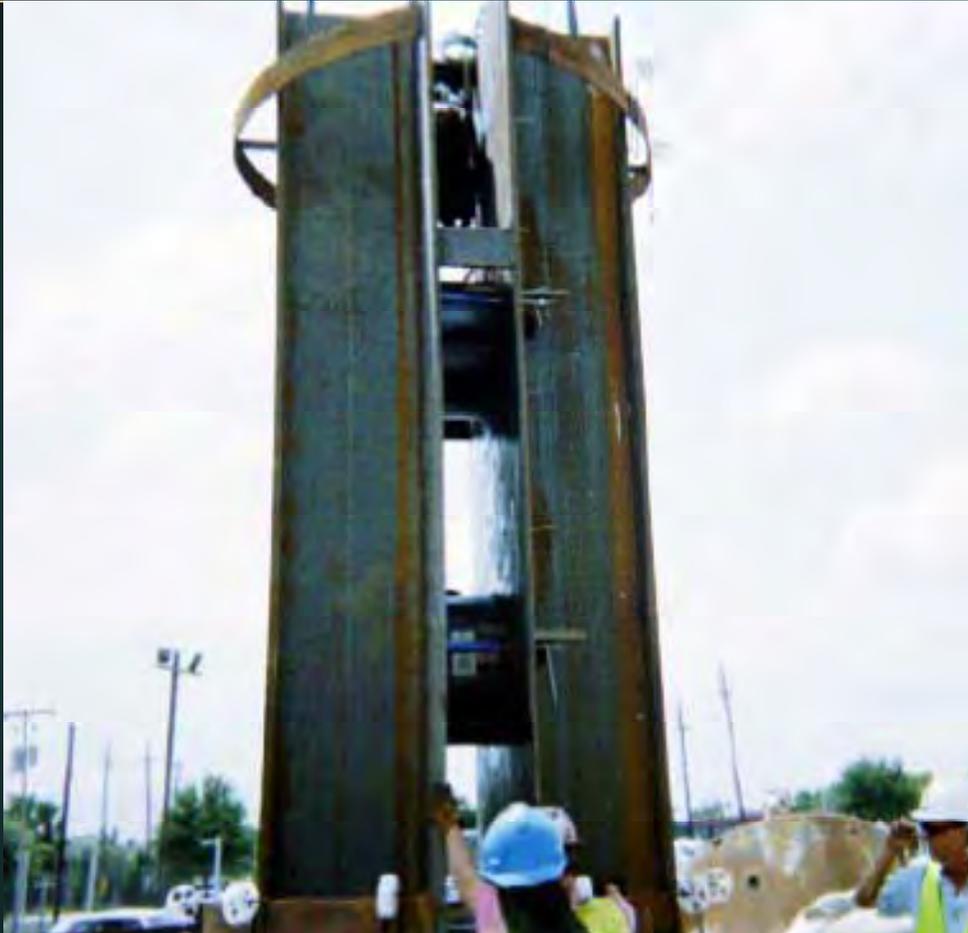
O-cell Split Lateral Test

Two 16 MN (3600 kip) O-cells test lateral stiffness of the Cooper Marl (19-21 m depth) on a 2.4 m (8') pile

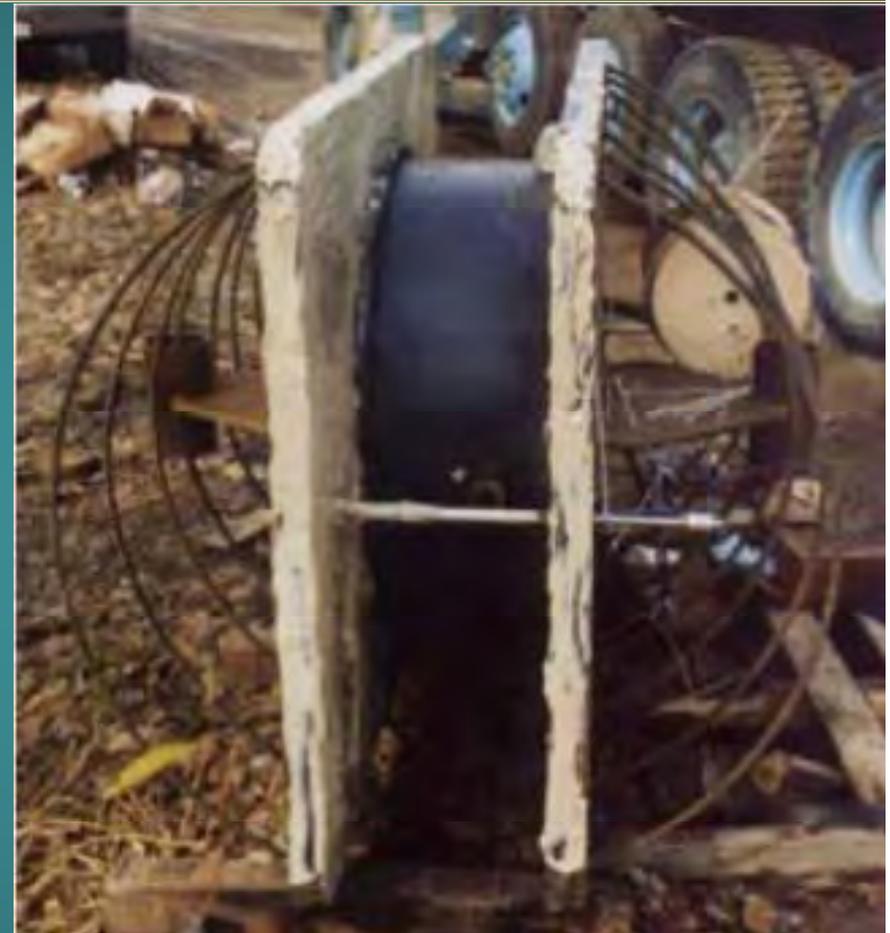
27MN (6000 kip) O-cell used to test a 1.5 m (5') long by 1.2 m (4') diameter rock socket

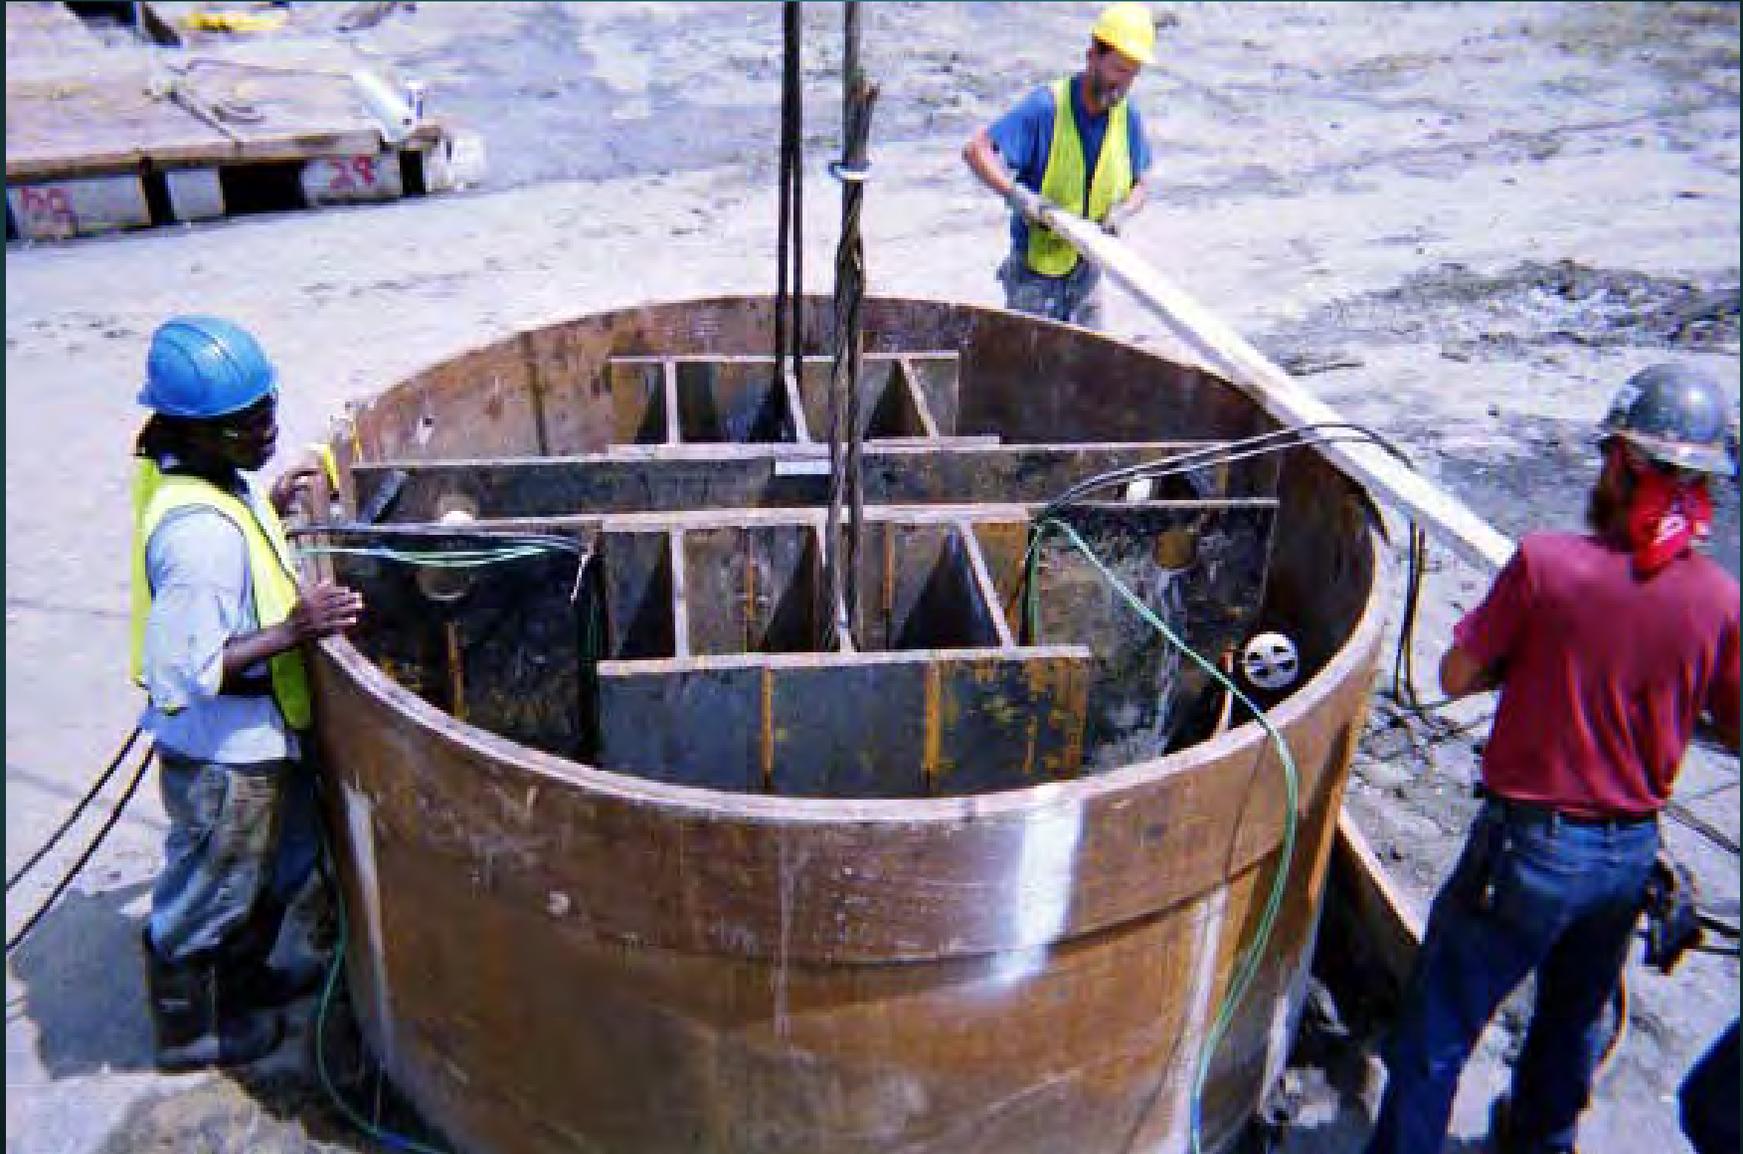
O-cell Split Lateral Test Assembly

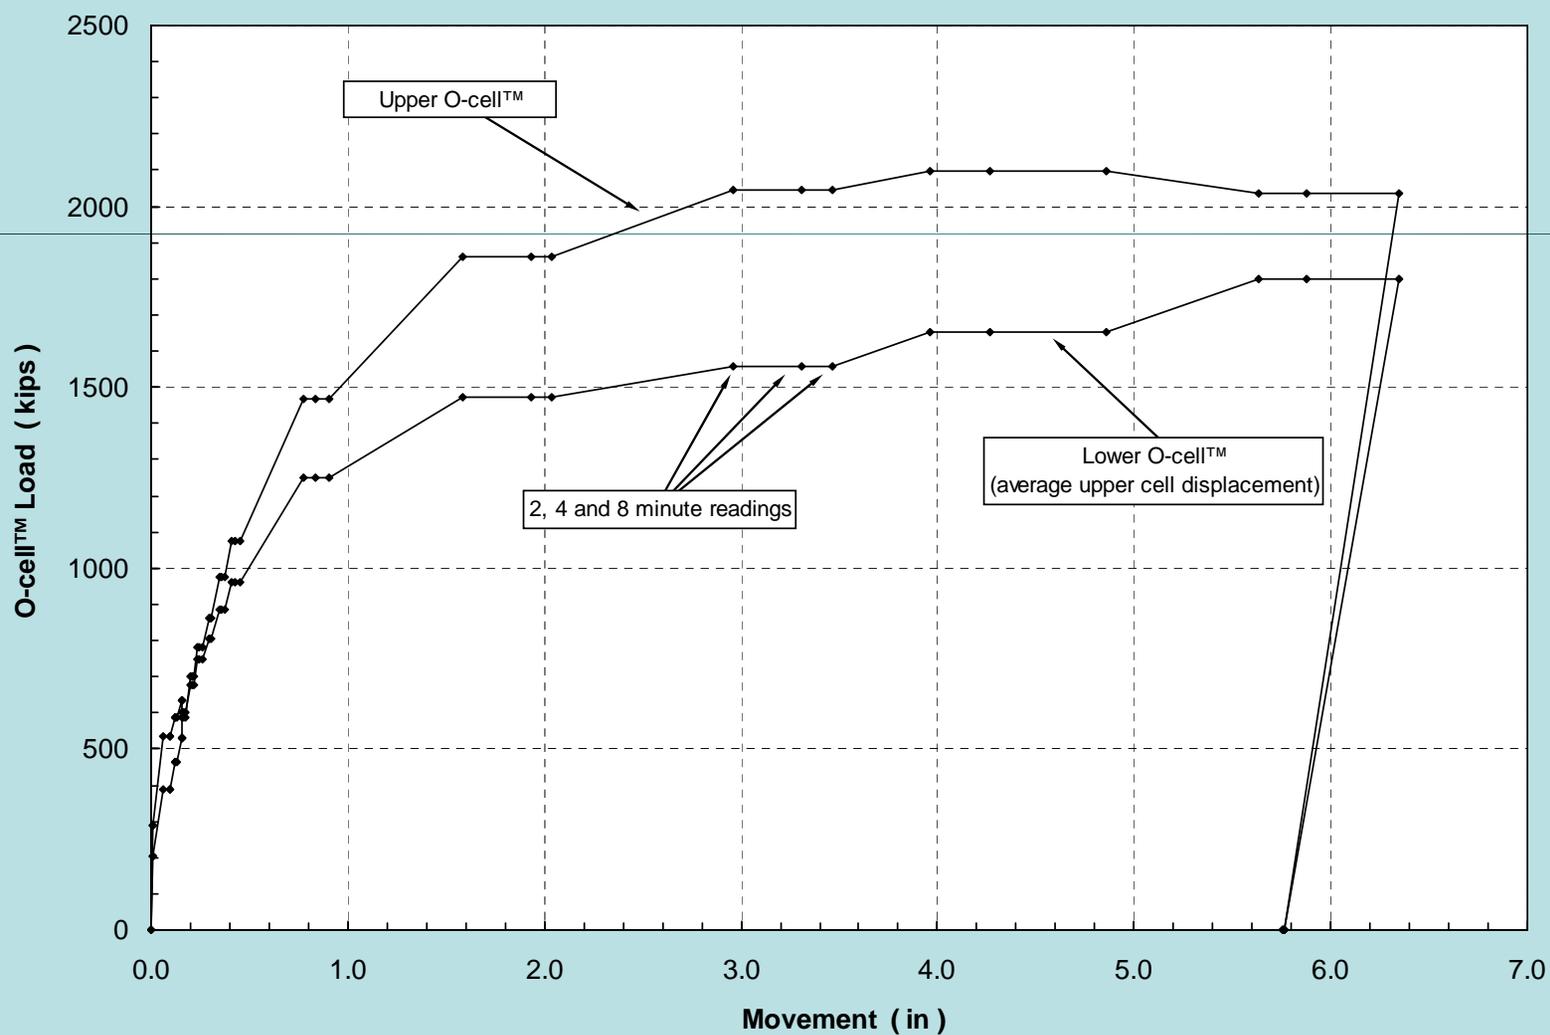
O-cell Split Lateral Test Result

Split Shaft Lateral O-cell™ Load-Movement Curves

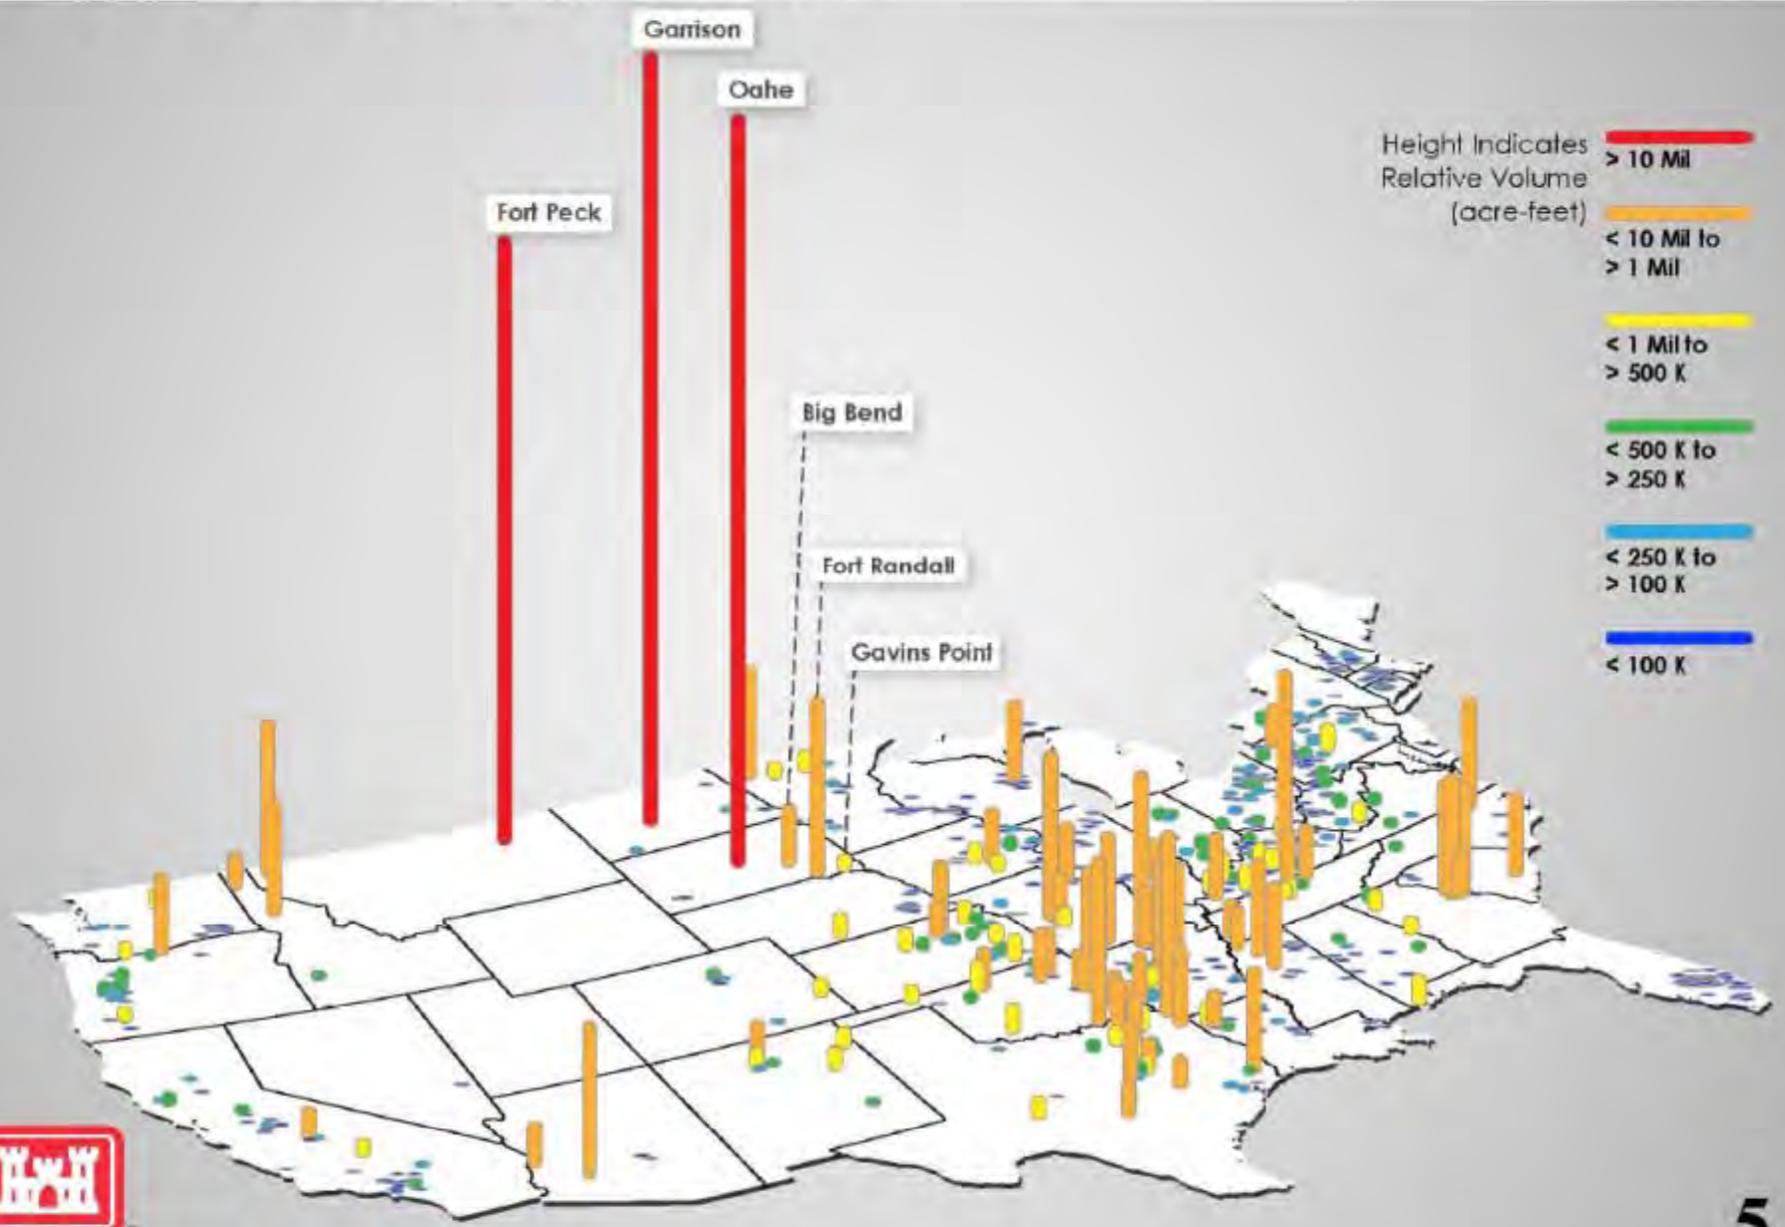
Storage Capacity of Corps Reservoirs

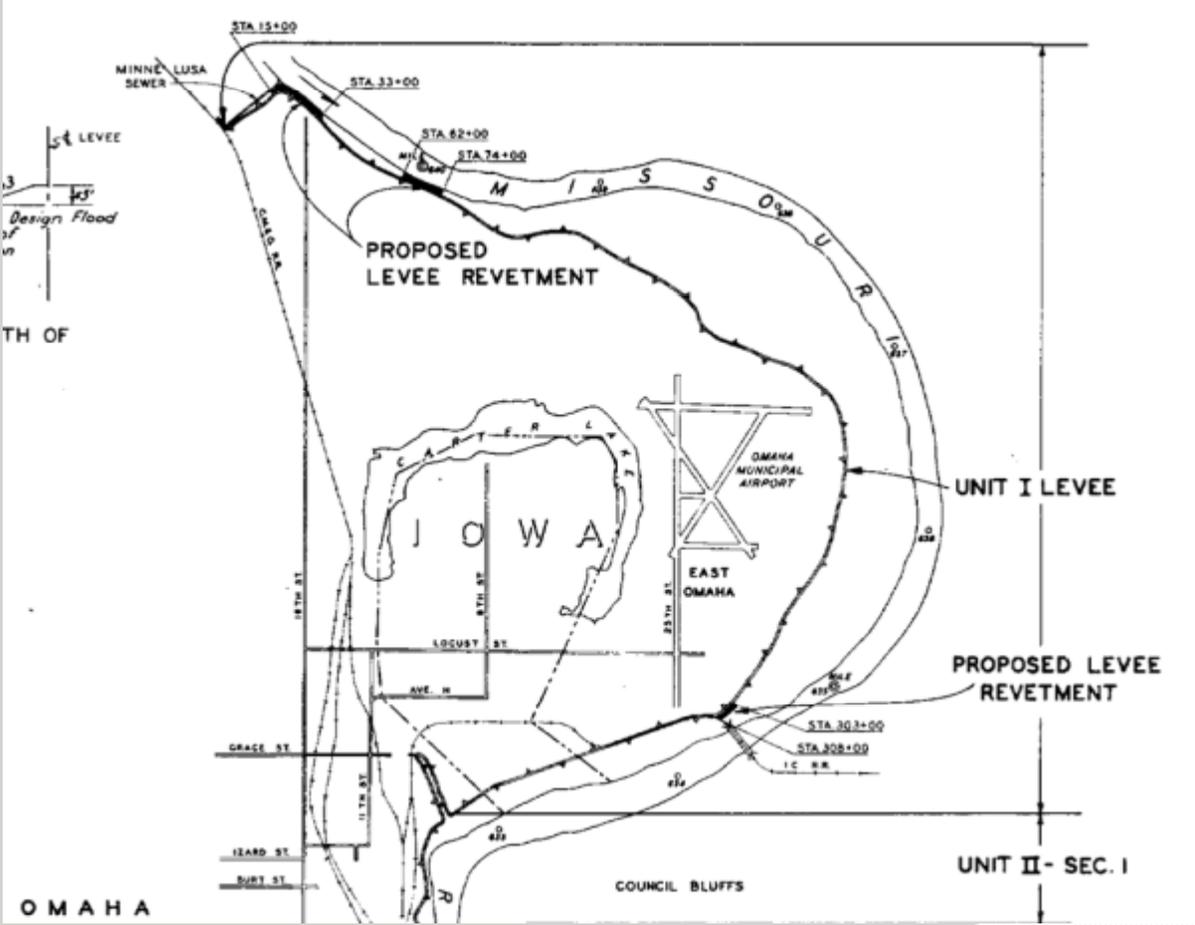
Omaha North Levee 1952

Levee Raise (approx. 1948)

Included installation of relief wells,
collector system

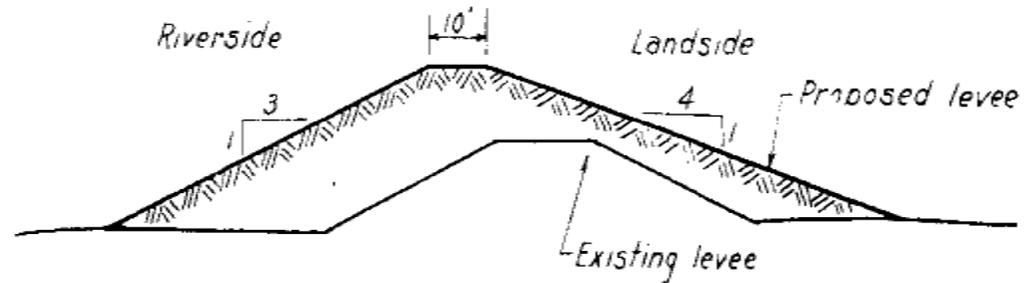
TYPICAL EMBANKMENT SECTION
STA. (0+79) TO STA. 391+83.73

The relative position of the
axes of the new and existing levee
varies.

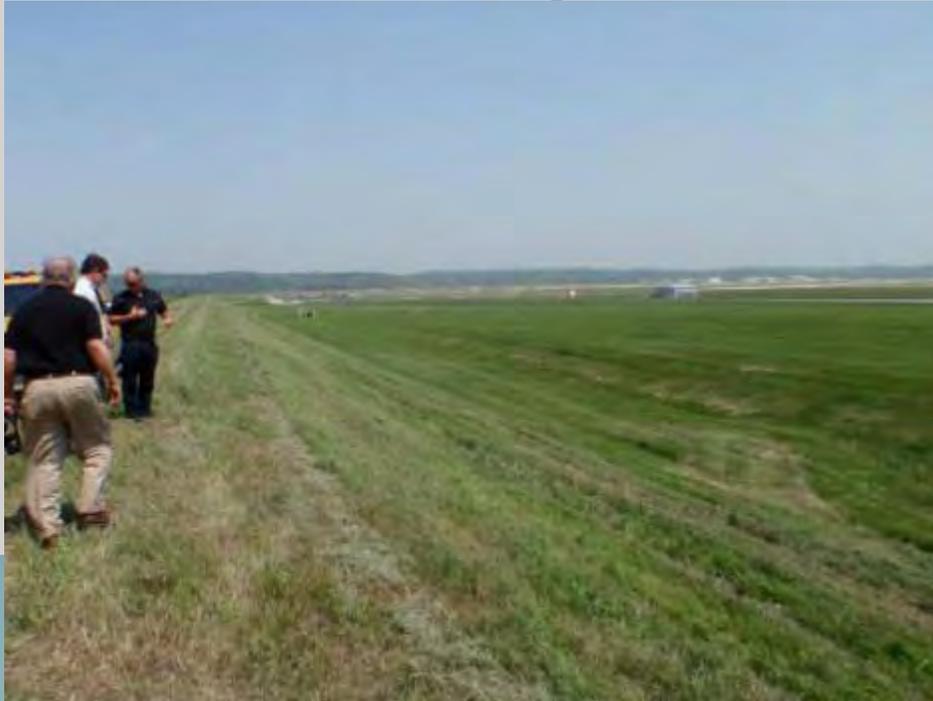
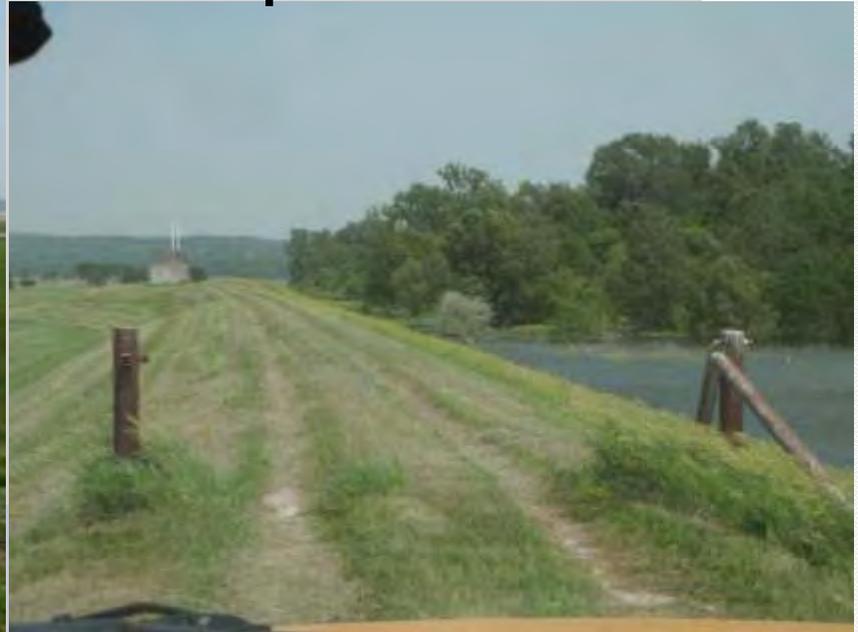
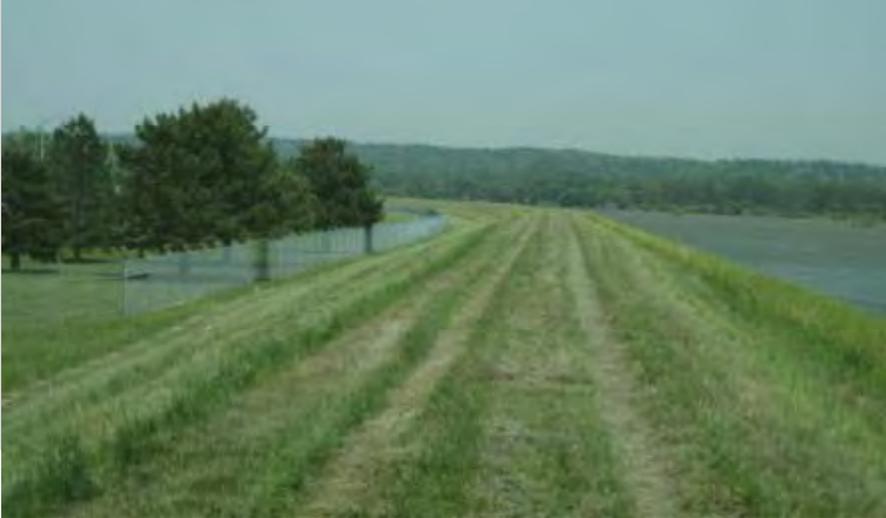
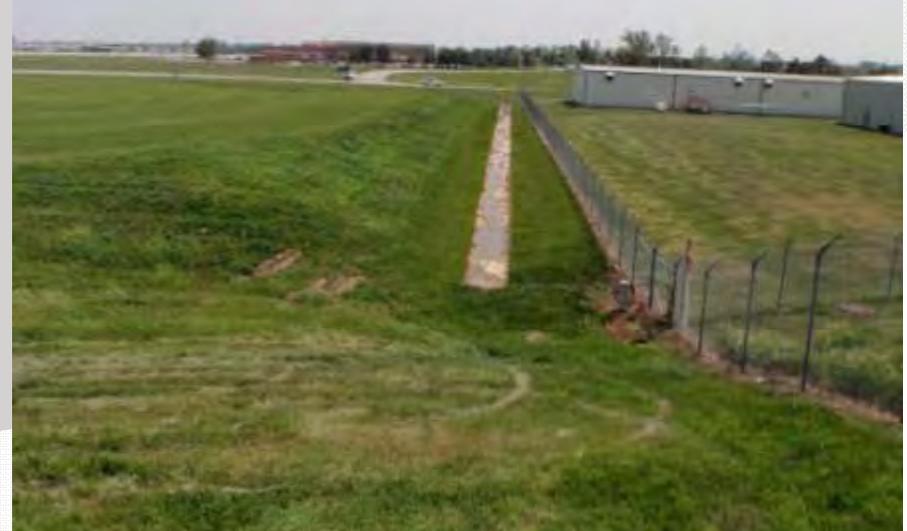
Airport levee

Initial Inspection

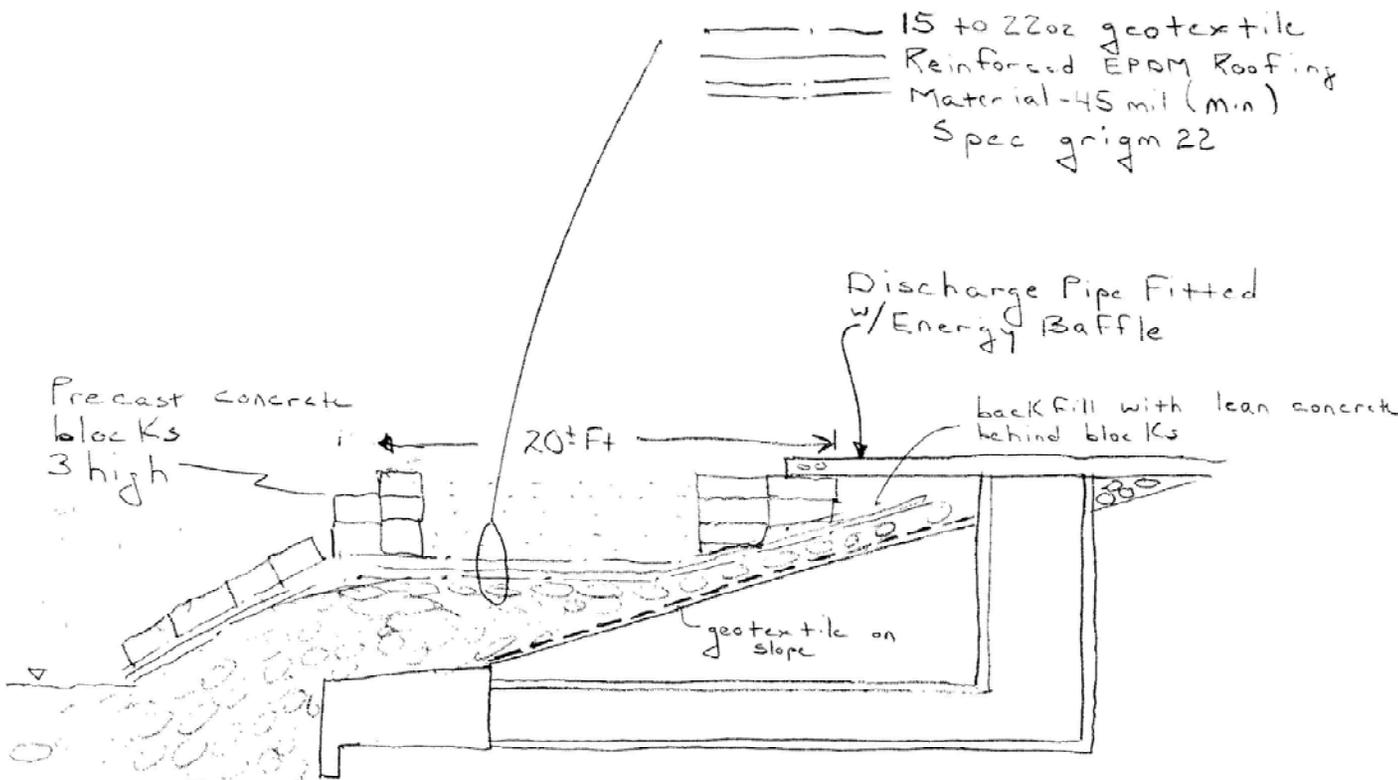
East Pump Station: discharge outlet design

block dimensions = 2x3x6 Ft
