29th Annual
Geotechnical Seminar

GEO-Omaha 2012

February 17, 2012
Scott Conference Center
Omaha, Nebraska

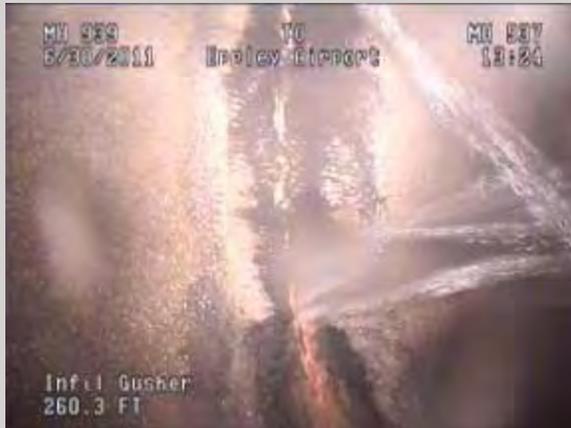
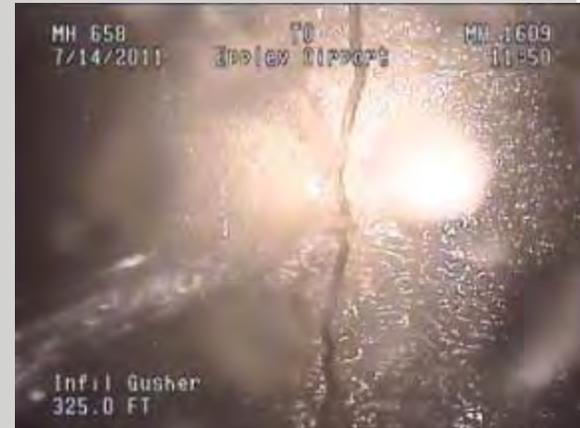
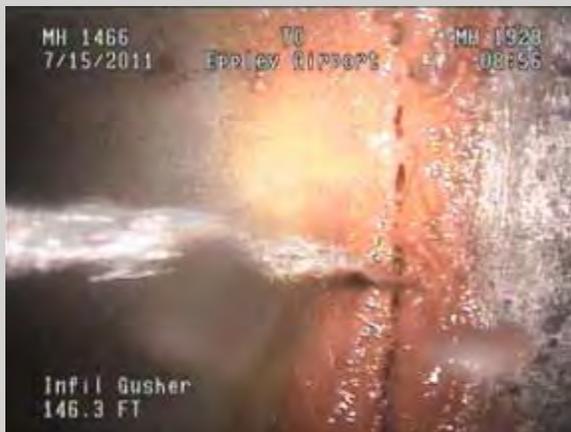
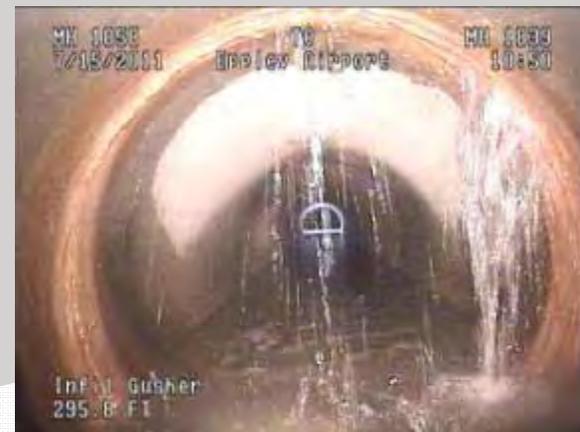
Inspection of Storm Water Pipes with TV Cameras

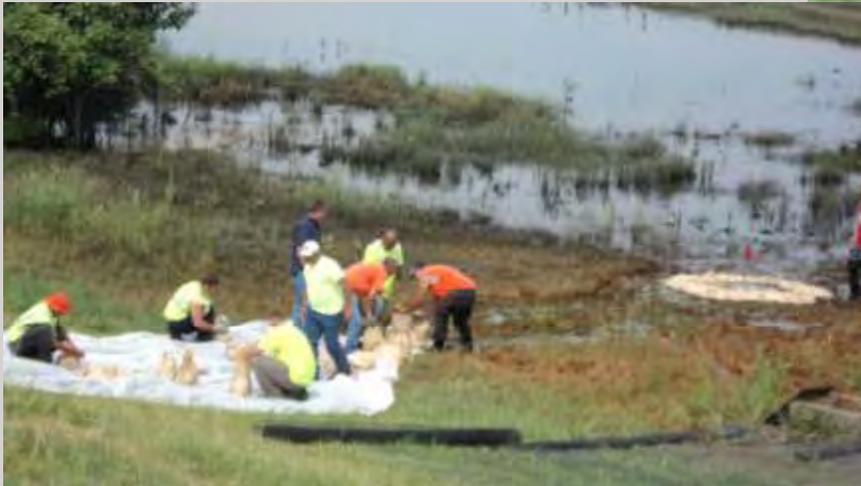
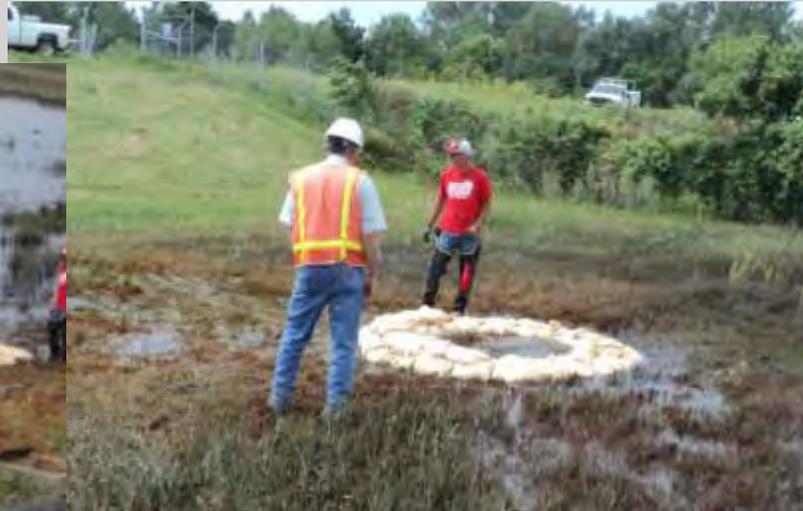
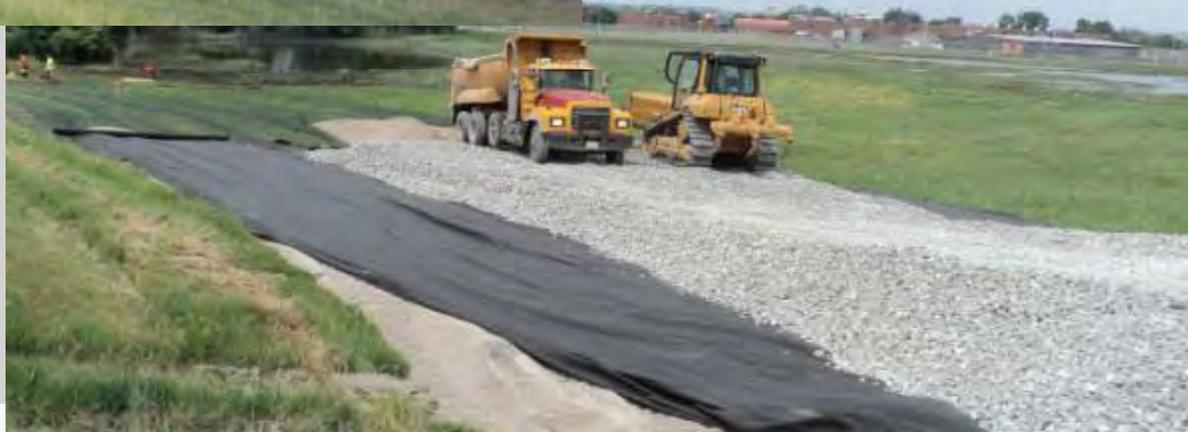
Response to sand boils

Typical “off-the-shelf” design

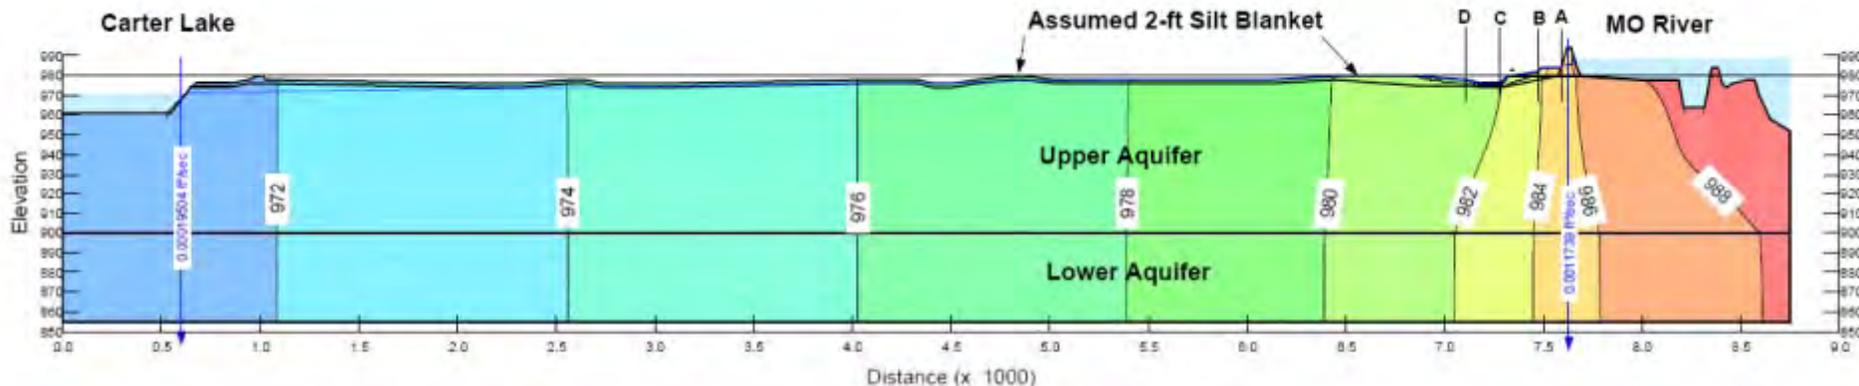
Gradient Calculation

A	B	C	D
Total Head - Top	= 984.0	982.0	976.0	
Total Head - Bottom	= 984.9	983.8	981.8	
Elevation - Top	= 984.0	982.0	976.0	
Elevation - Bottom	= 980.0	977.9	974.0	
Gradient, I	= 0.2	0.4	2.9

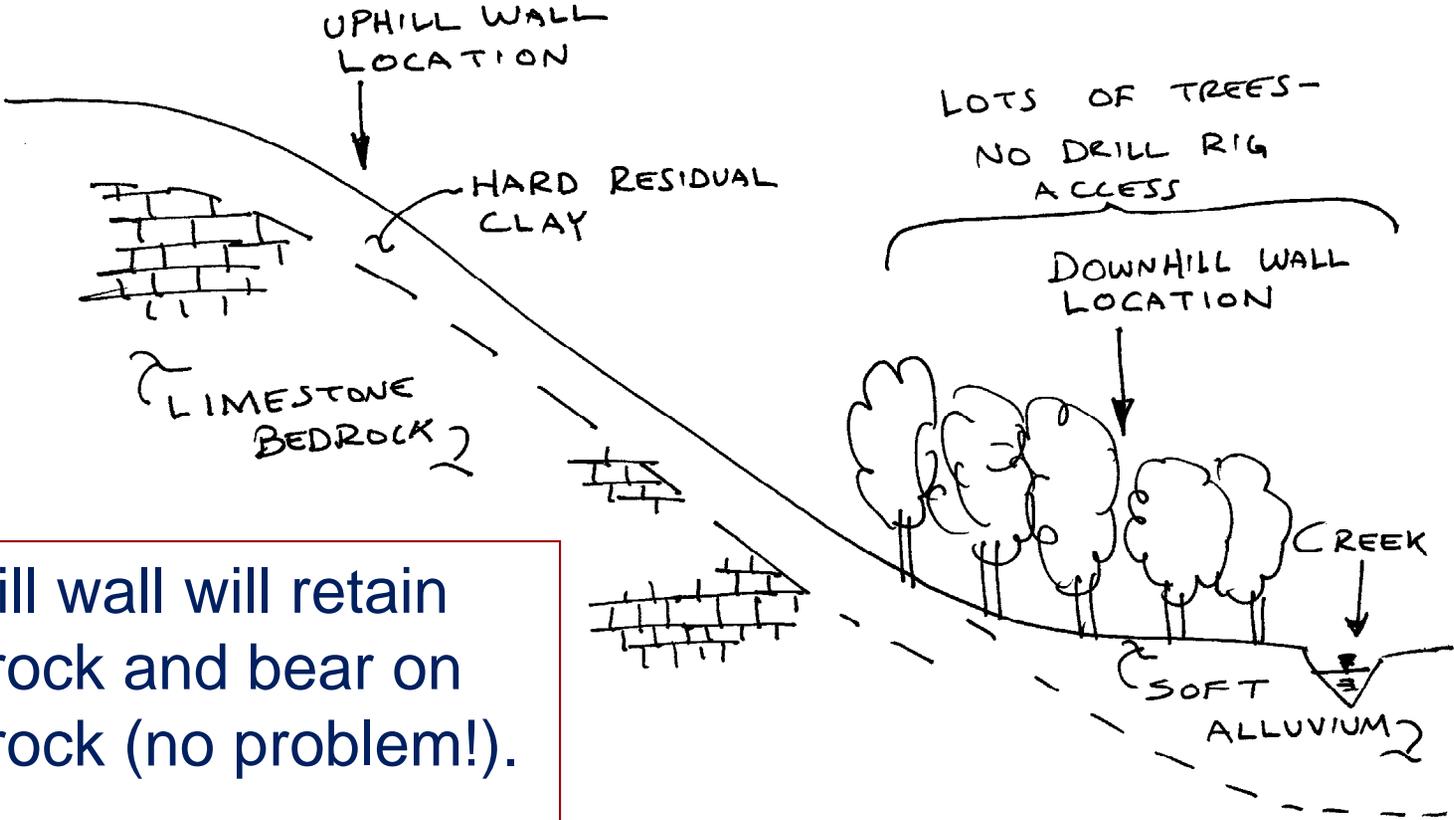
Site and Subsurface Conditions

Uphill wall will retain bedrock and bear on bedrock (no problem!).
Downhill wall = ???

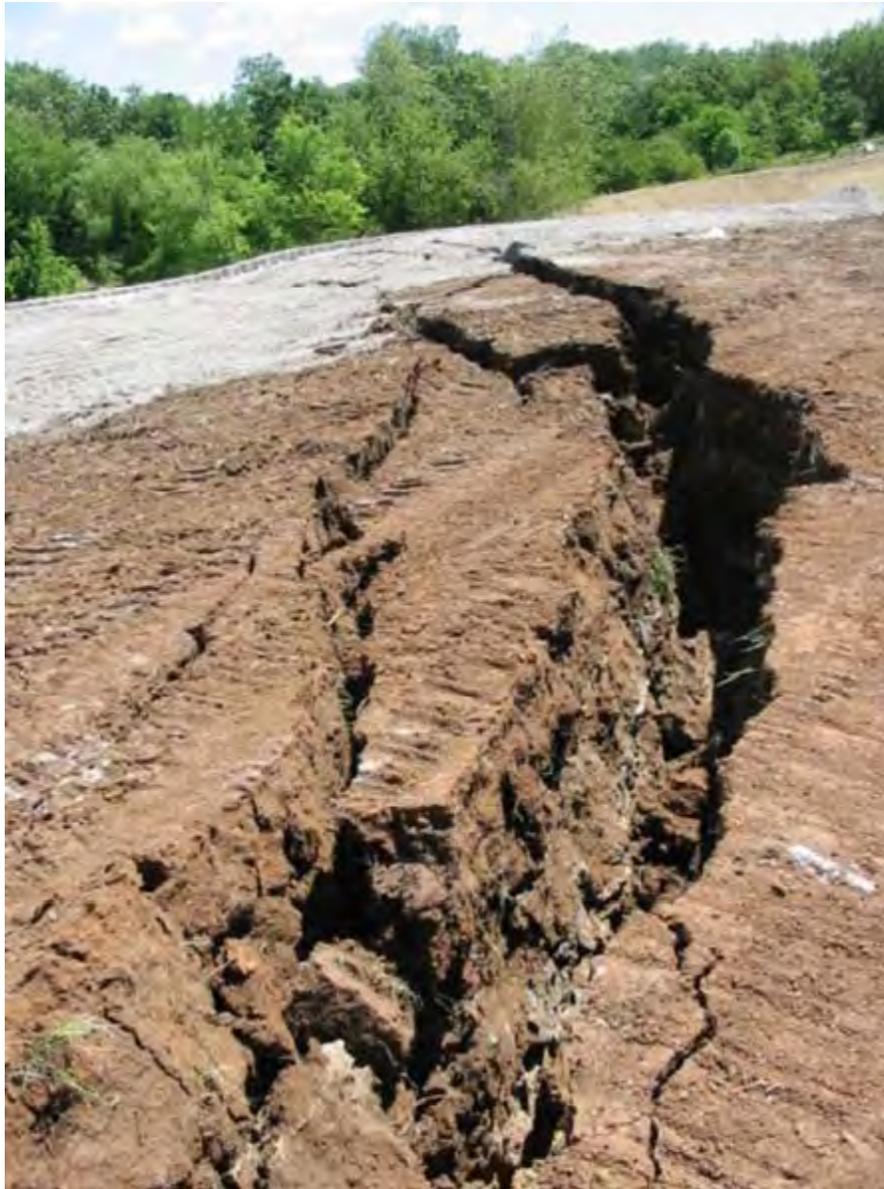
Tension cracks
behind top of wall
Don't fall in!

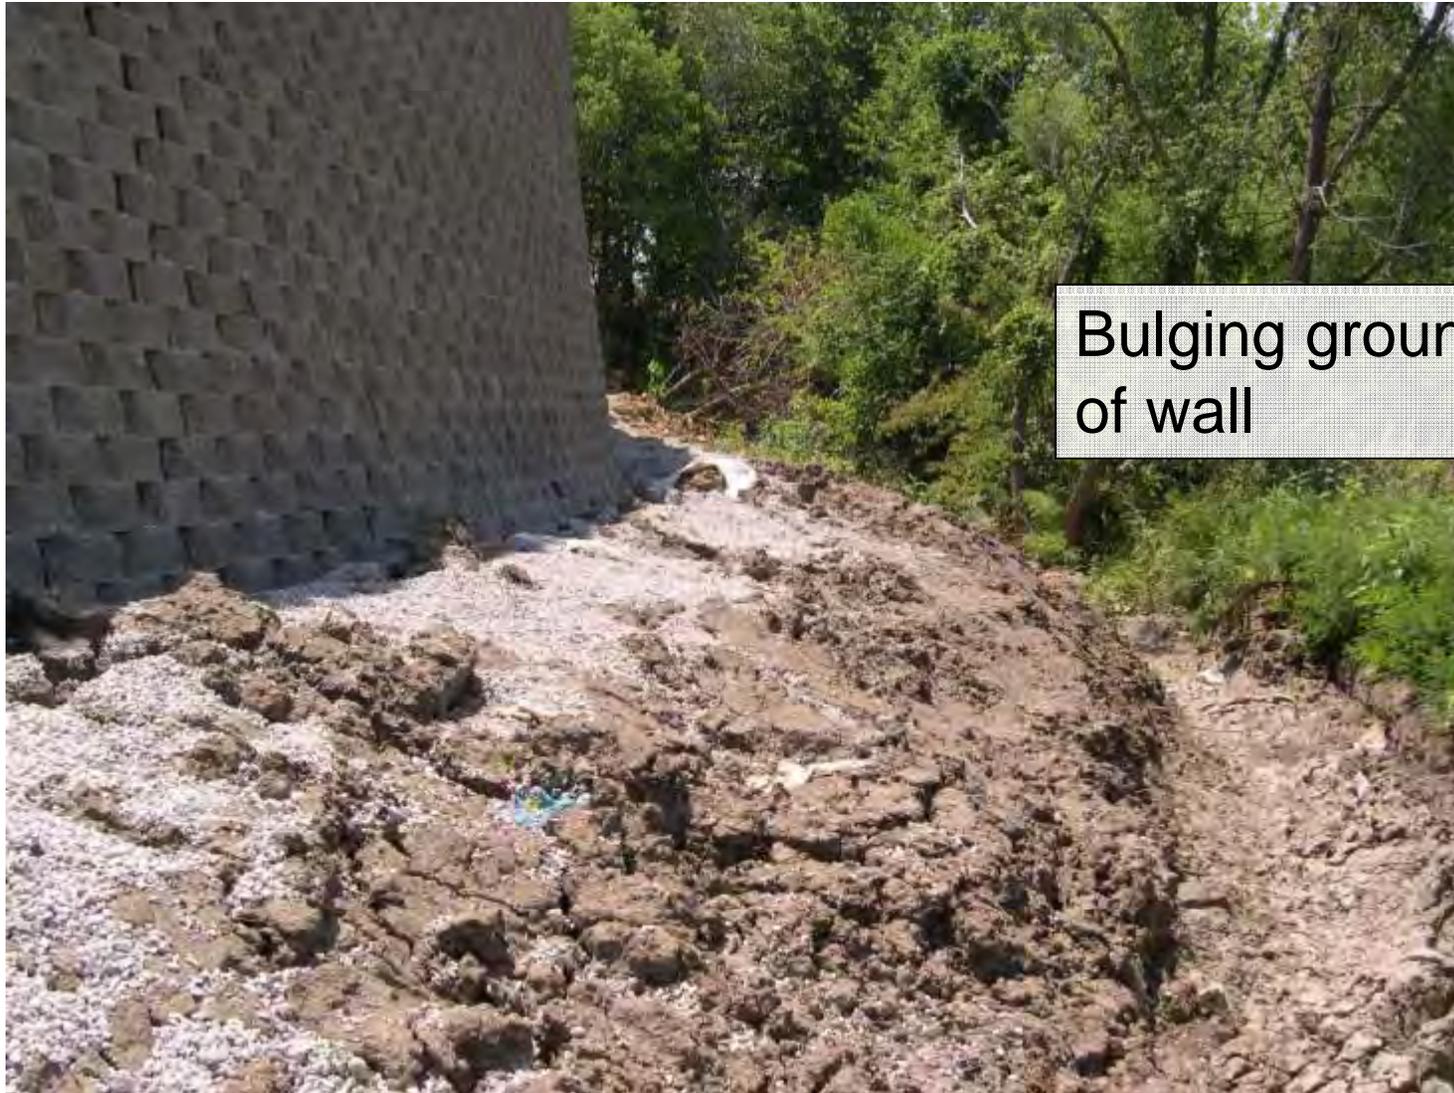
Bulging ground at toe of wall

The wall experienced a **global stability failure**.

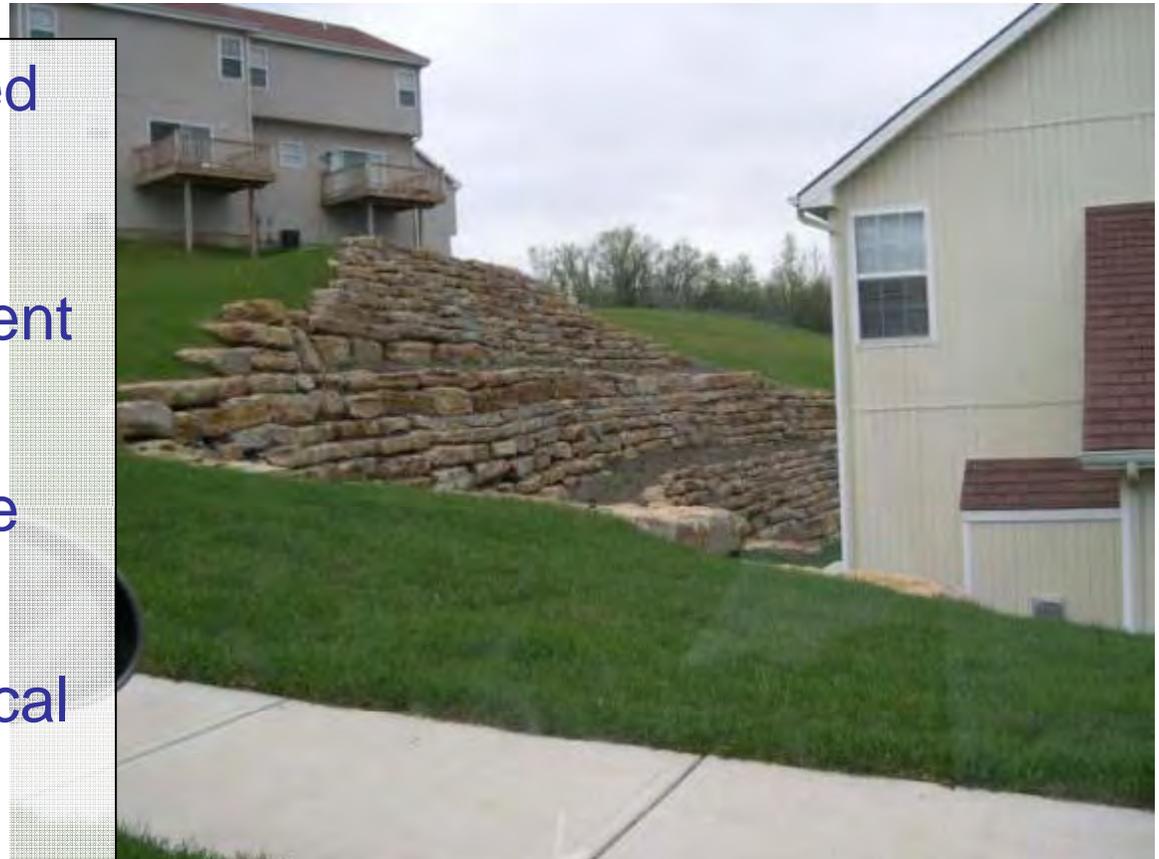
Here's what it looks like now, after it is fixed.

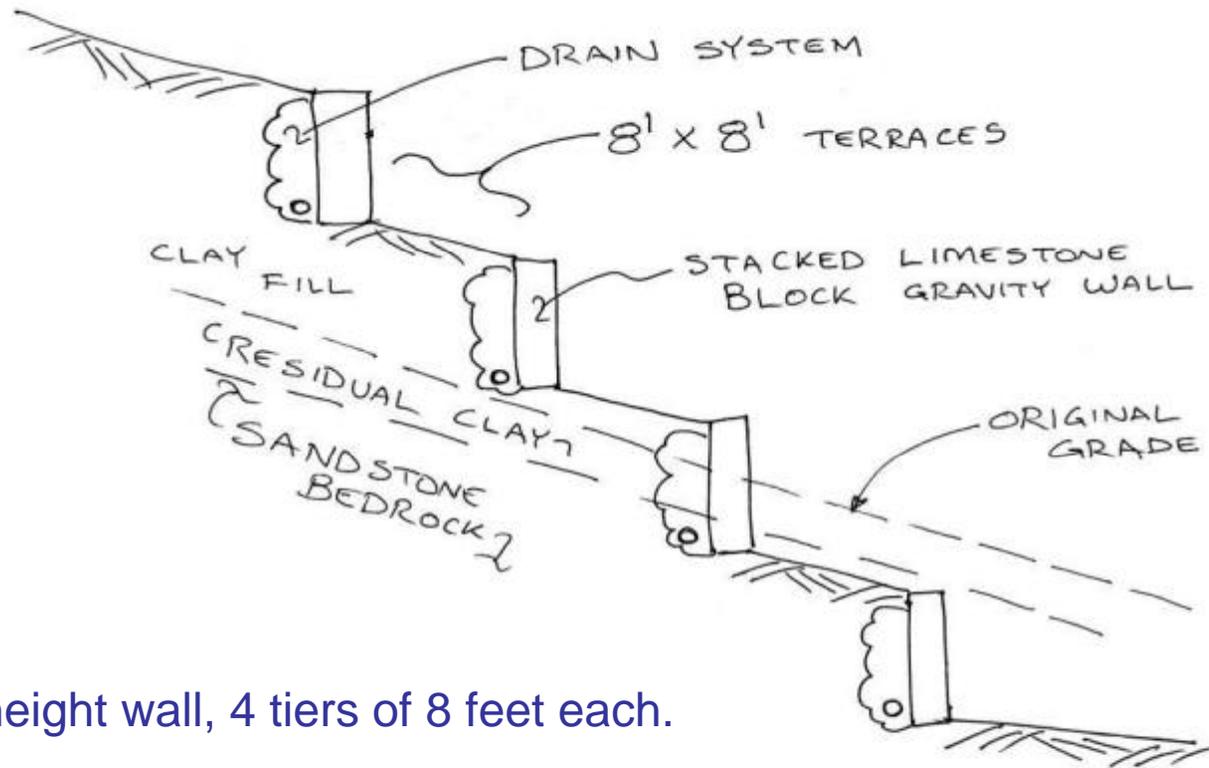
Initial Design

32 feet total height wall, 4 tiers of 8 feet each.

Overall slope would be 1H:1V. Lower 12 feet would be cut into sandstone bedrock.

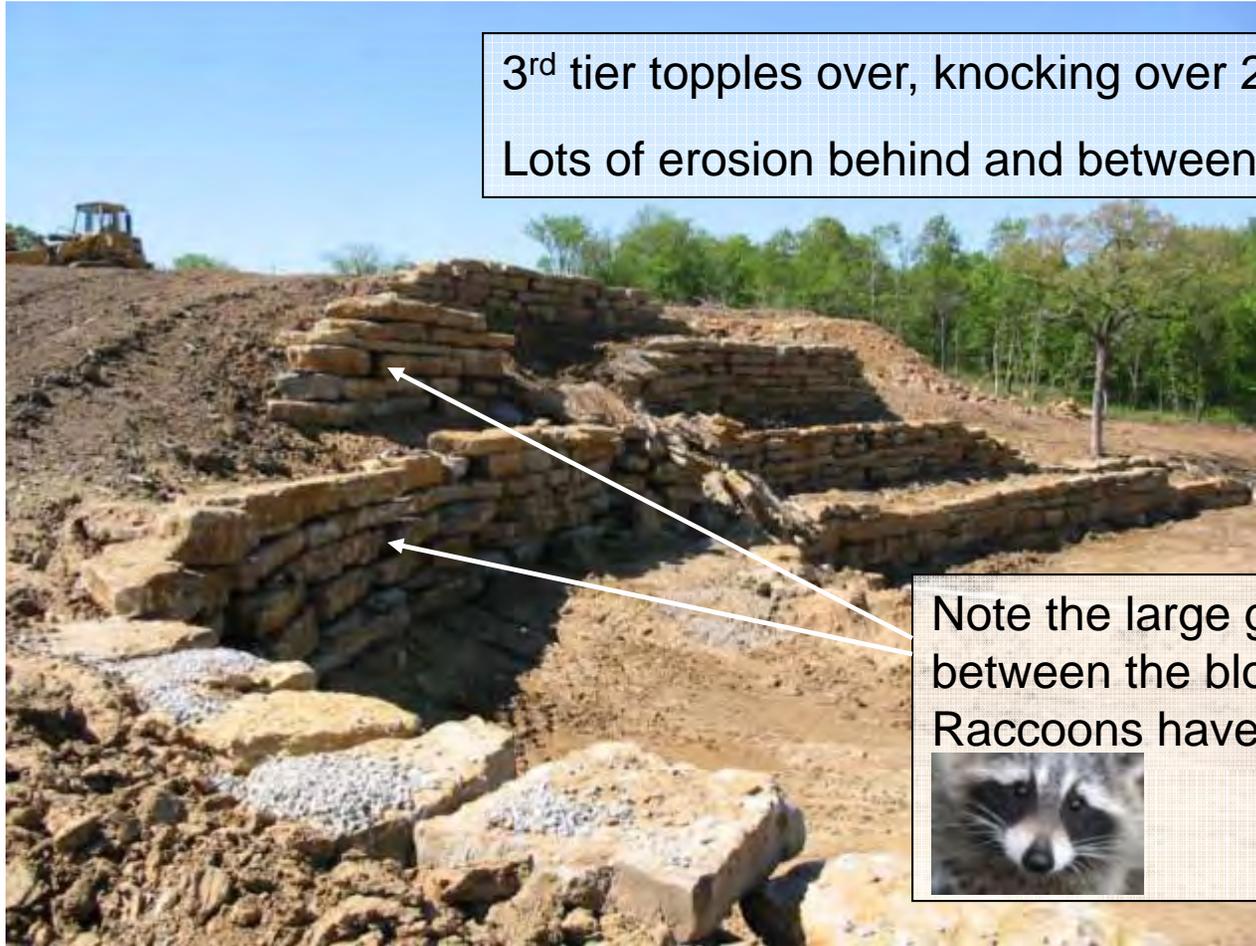
The second time it failed... during a heavy rain

3rd tier topples over, knocking over 2nd tier.
Lots of erosion behind and between blocks.

Note the large gaps
between the blocks.
Raccoons have moved in.

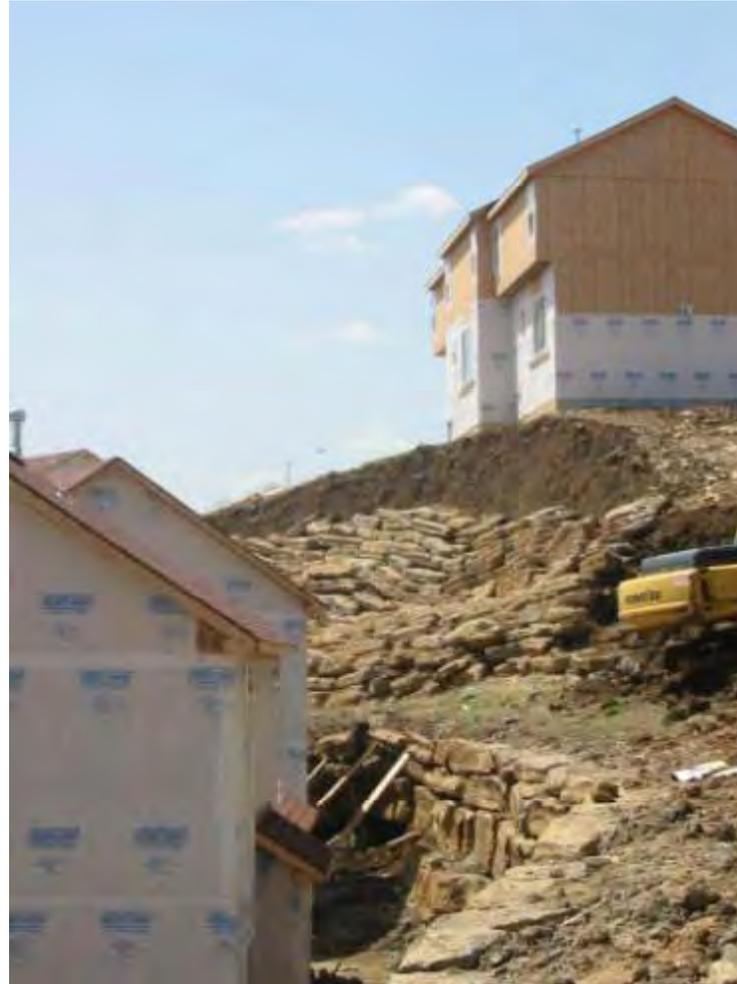
Lower building is
partially crushed

The wall failed due to erosion between blocks and shallow slope failures.

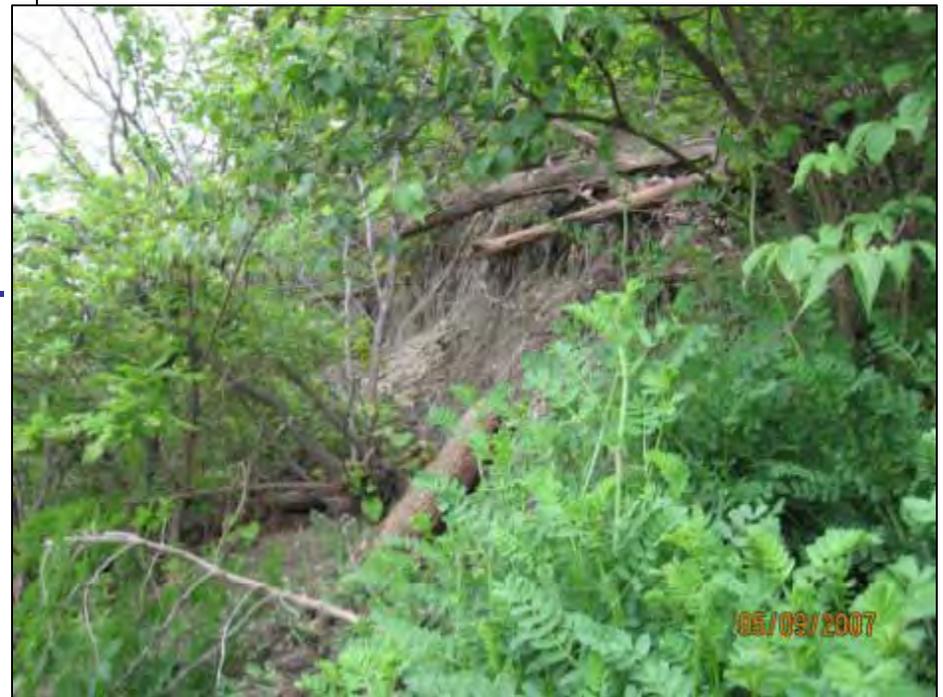
So, we'll need a big retaining wall on the slope to hold up the building pad.

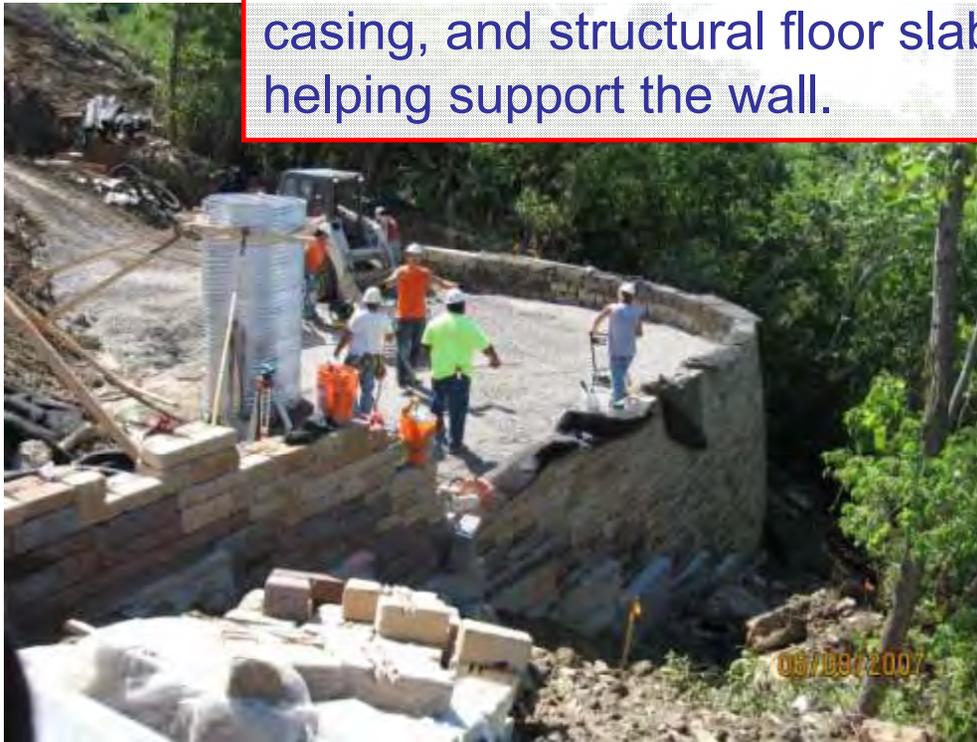
Immediate Concern – Global Stability

Global stability on steep, unstable hill is a major concern. The earthwork and wall construction contractors are nervous about the site. Bearing on massive limestone bedrock at the toe of the wall takes care of this concern. Also, 9 large drilled shafts with grade beams, permanent casing, and structural floor slab are within the wall backfill helping support the wall.

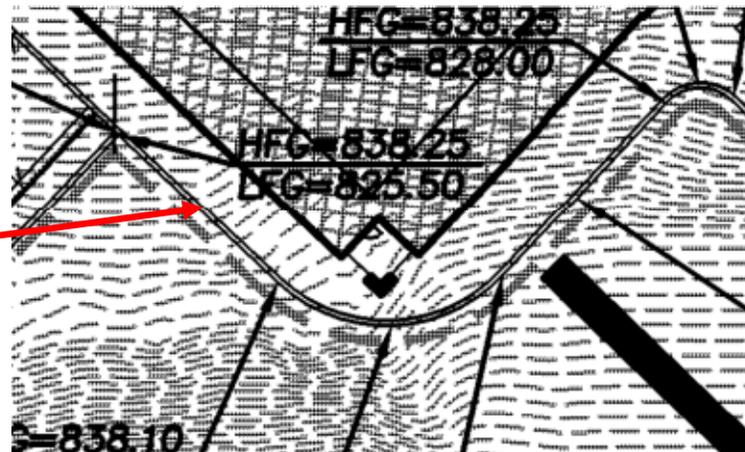
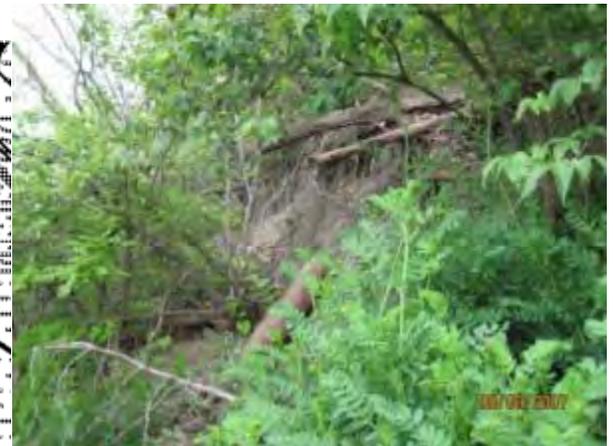
- There were 4 civil engineering / surveying firms working on the project. “A” did the grading plan. “B” designed the wall. “C” did construction surveying for the retaining wall contractor. “D” did construction surveying for the general contractor.
- They had different interpretations of the narrow, solid line on the grading plan that represented the wall’s location. Top of wall? Toe of wall?
- Topographic lines on grading plan were not accurate, no surprise on steep slope with dense vegetation. Various drawings have multiple disclaimers regarding who is responsible for accuracy of topography.

What does this line represent?
Top of wall?
Bottom of wall?
Wall at ground surface?

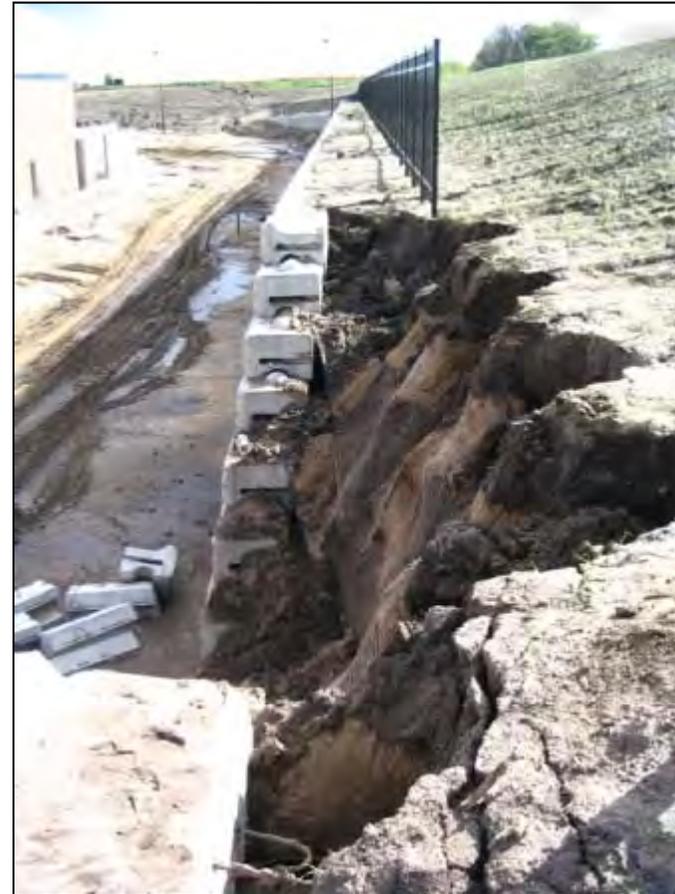
5-inch rain fall a few
weeks after completion
of construction.

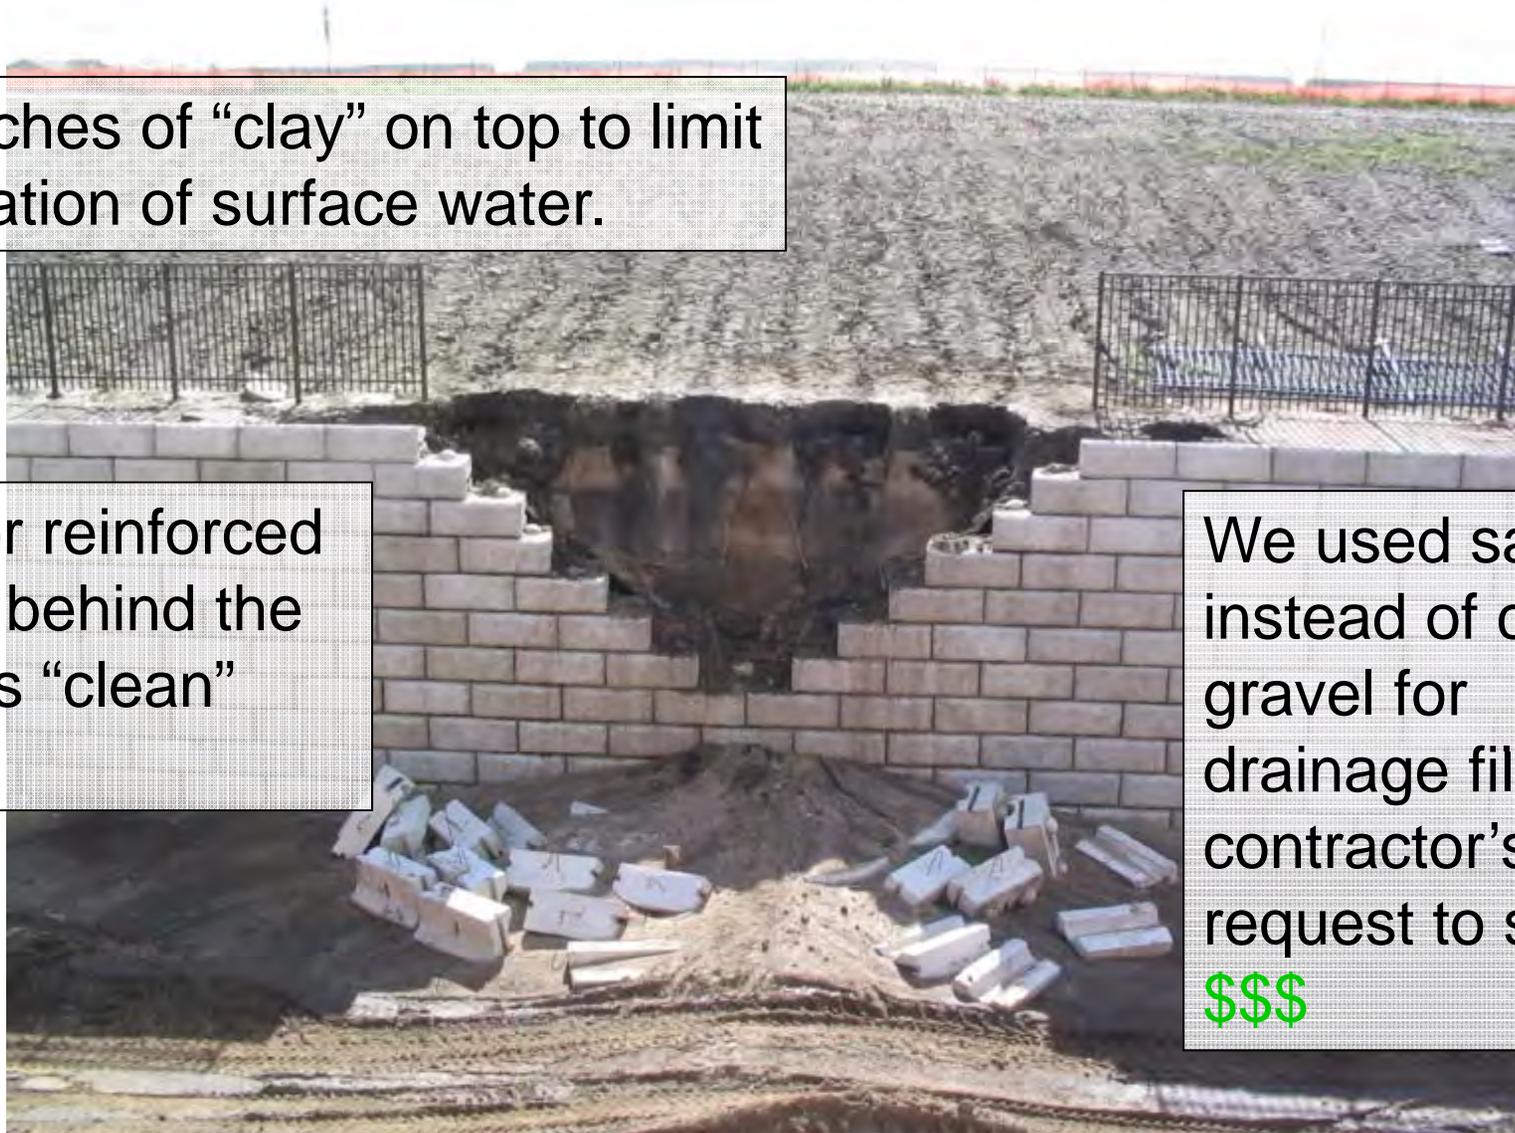
24 inches of “clay” on top to limit infiltration of surface water.

Fill for reinforced zone behind the wall is “clean” sand

We used sand instead of clean gravel for drainage fill at contractor’s request to save \$\$\$

Heavy rain caused hydrostatic pressure which blew out the front face of the wall.

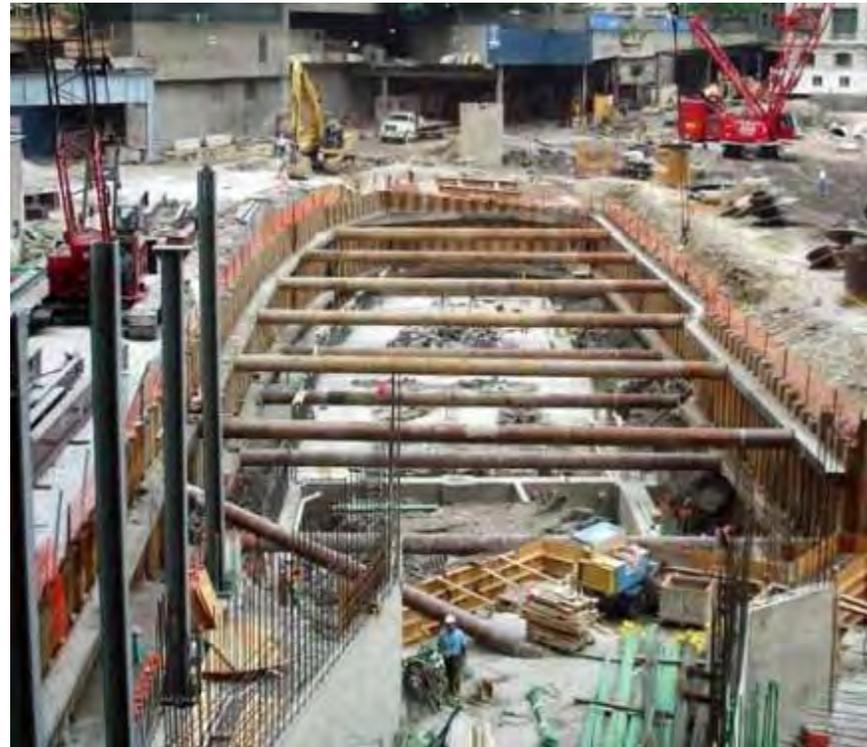
A few weeks later, the engineer who agreed to remove the braces asks, “Am I **getting fired?**”

Surface runoff was directed towards this area. Sheet piles dammed up the water behind the wall. Hydrostatic pressure builds up. Toe (passive resistance) loses strength due to upward seepage gradient

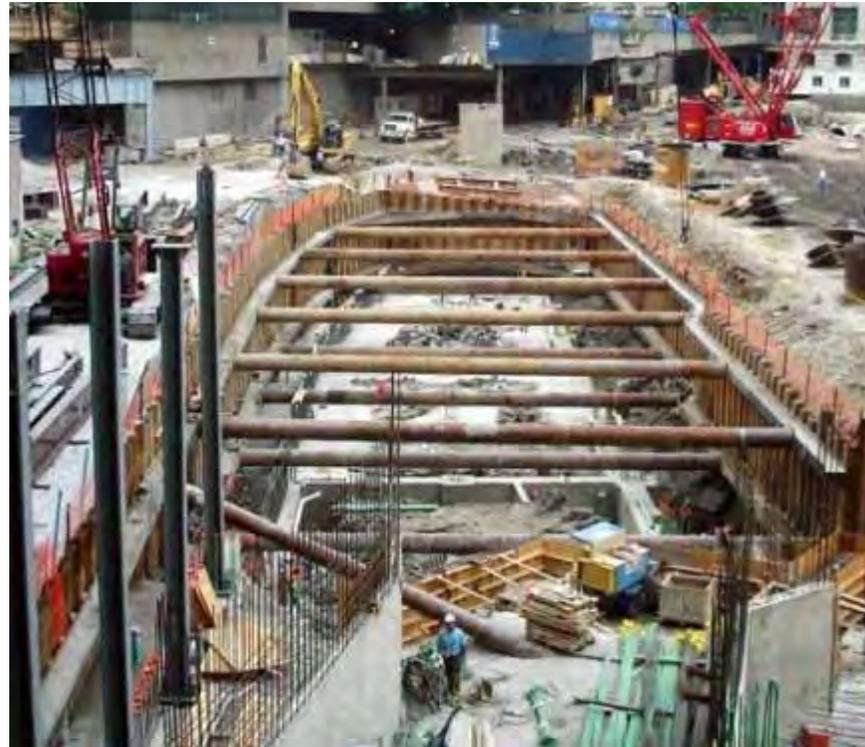
Now the pipes and pumps don't fit in the excavation

It cost \$250,000 to fix it.

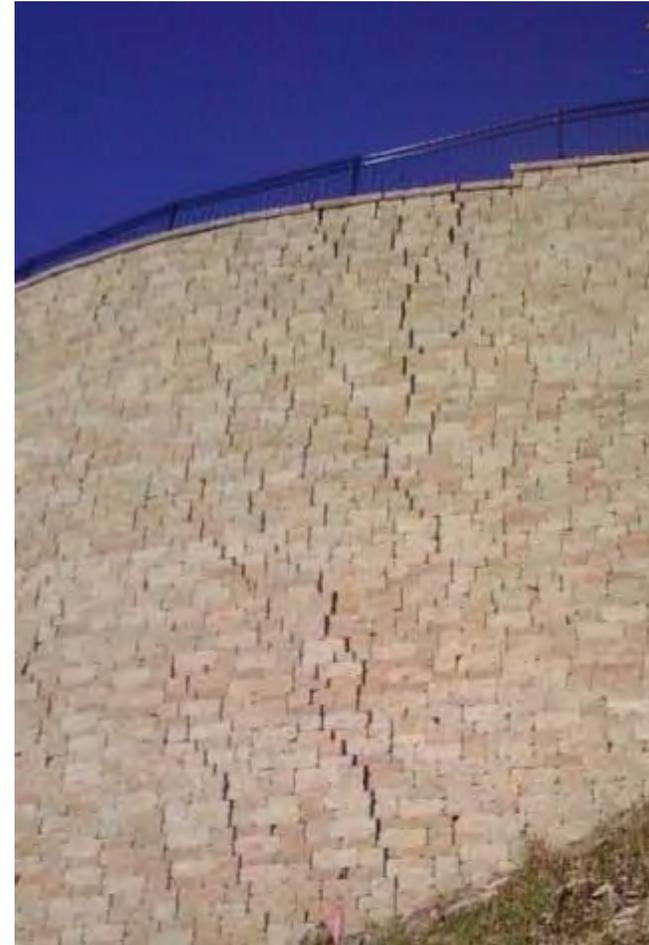
Completely stable for 3 years. Starts sliding horizontally at about 1 inch per month, cracks are visible. No apparent groundwater issues

Fixed with rock anchors, and without attorneys, before it collapsed.

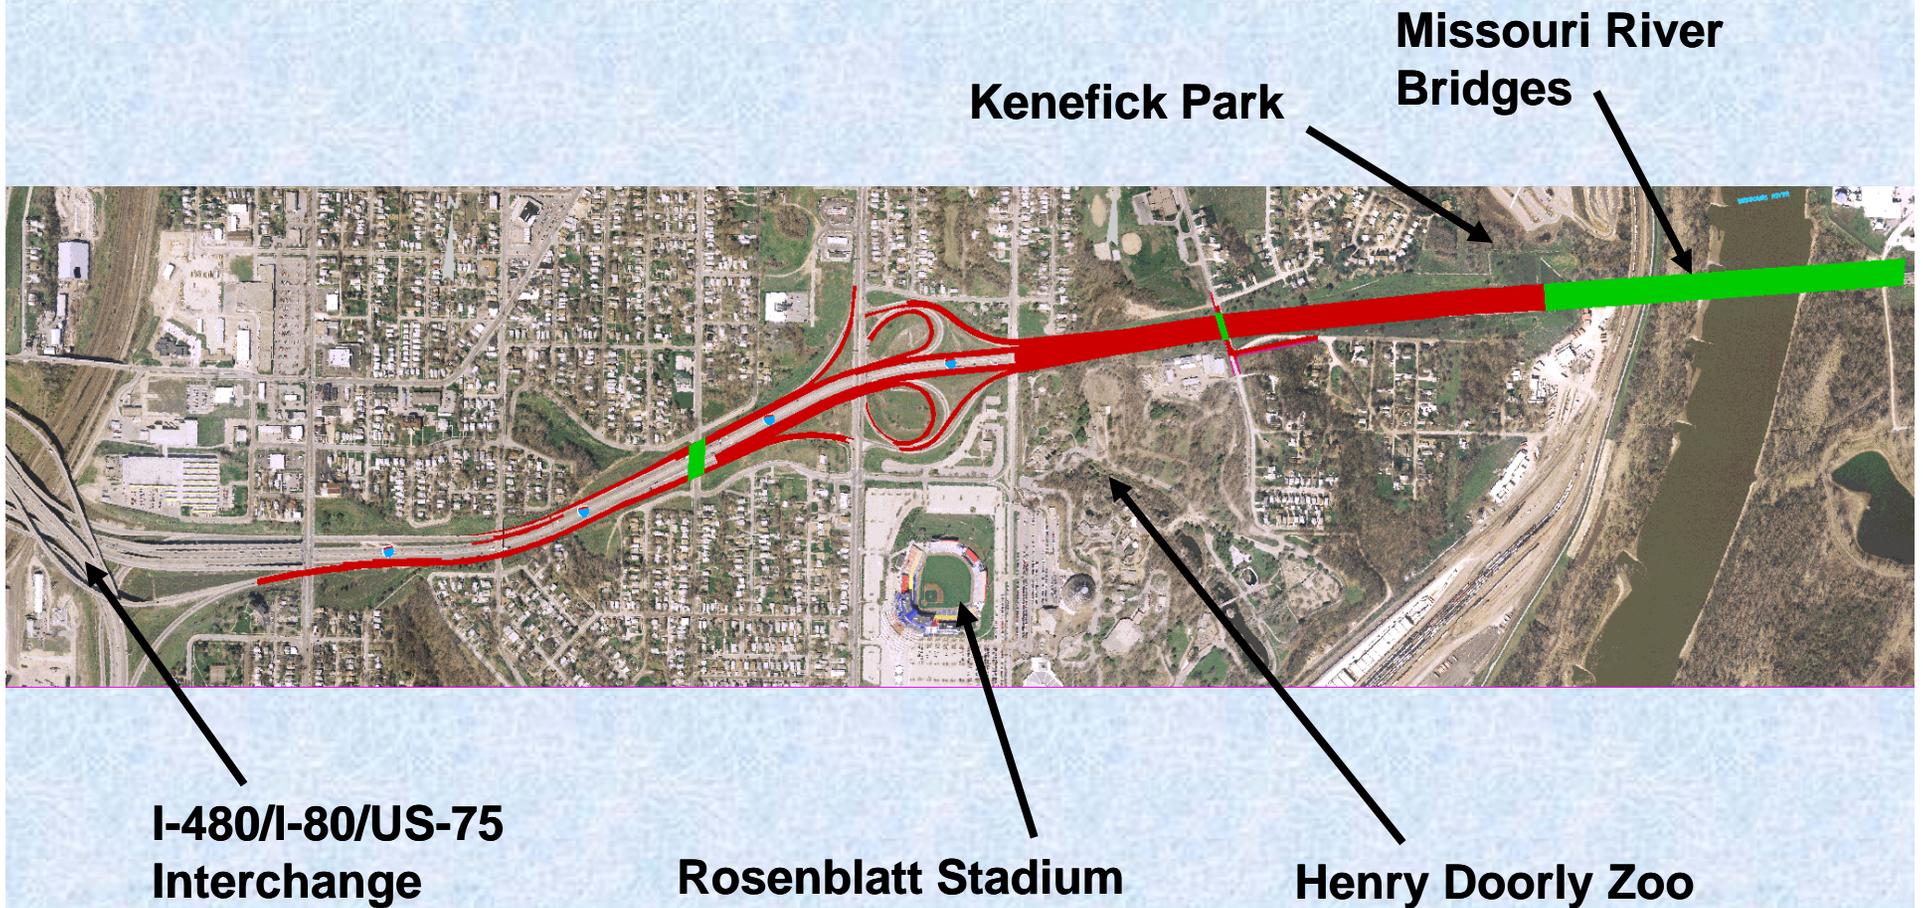
Retaining Wall Locations

24th Street to Missouri River

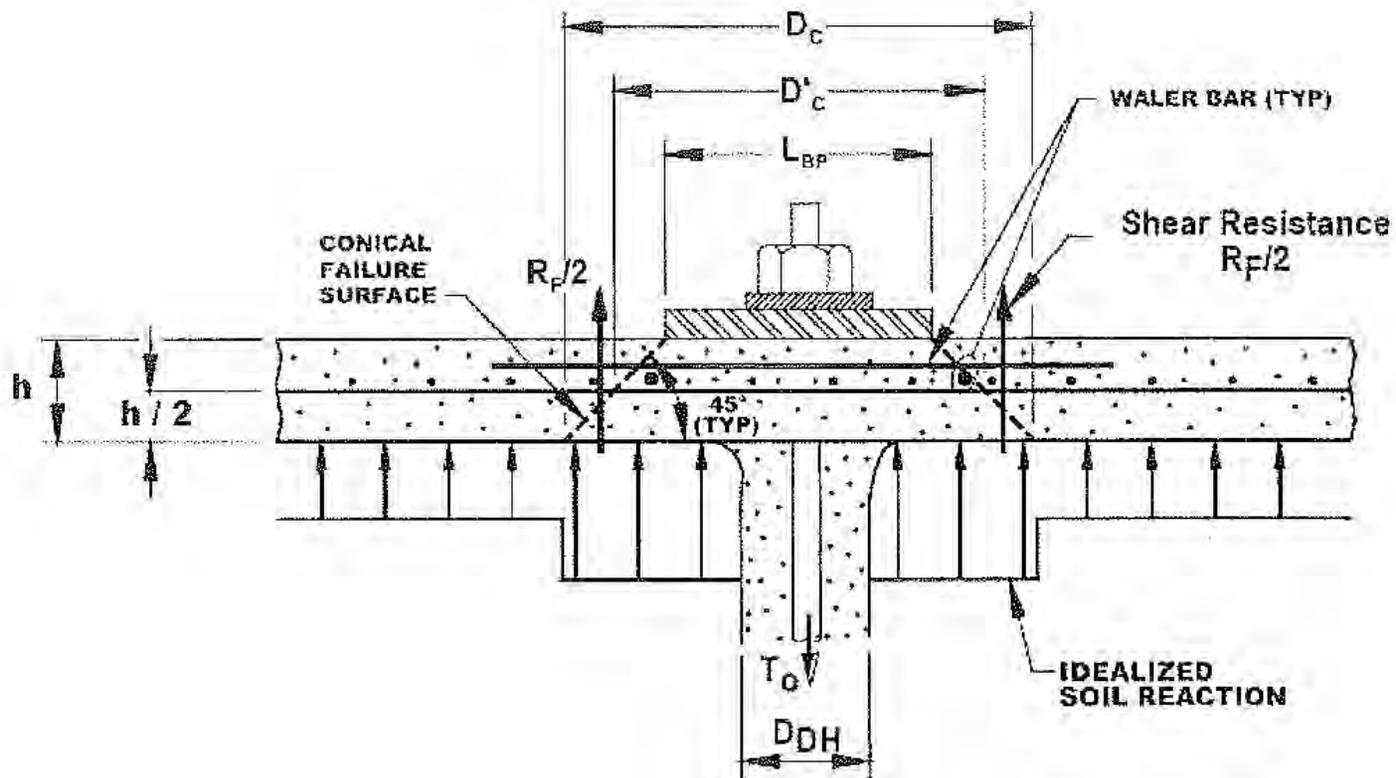
Figure 3. Shotcrete facing details
 (See Page 101 of FHWA Circular 7 for details)

Note: Because it is a permanent wall, though not show in this diagram, the plates will be studded.

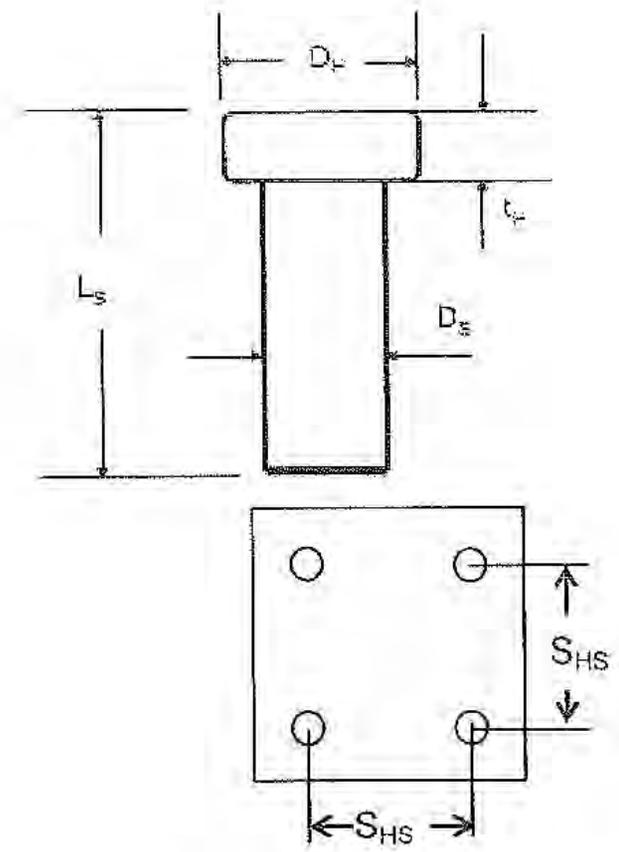
Figure 4. CIP facing details

Nail Head Details
